*Home inspection for*  
**Sample Report**  
Somewhere  
Longview TX 75601

## PROPERTY INSPECTION REPORT

**Concerning:** Somewhere, Longview, TX 75601  
(Address or Other Identification of Inspected Property)

**By:** David Smith, Lic #21666 01/23/2020  
(Name and License Number of Inspector) (Date)

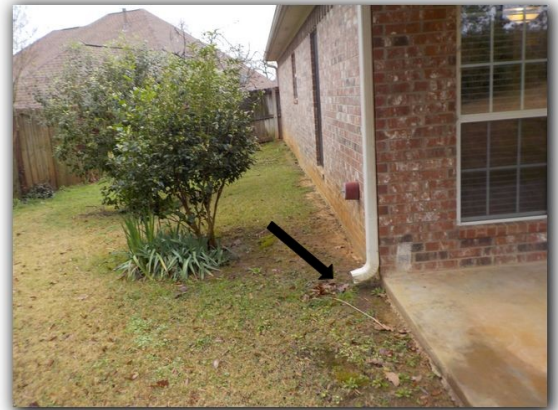
Gutters / down spouts found draining too close to the structure at the time of inspection. Water terminating near slab can create conducive conditions for slab undermining. Recommend termination point at least 16-24 inches from foundation. Recommend installing extensions onto gutters or adding splash blocks allowing water to move away from home efficiently.

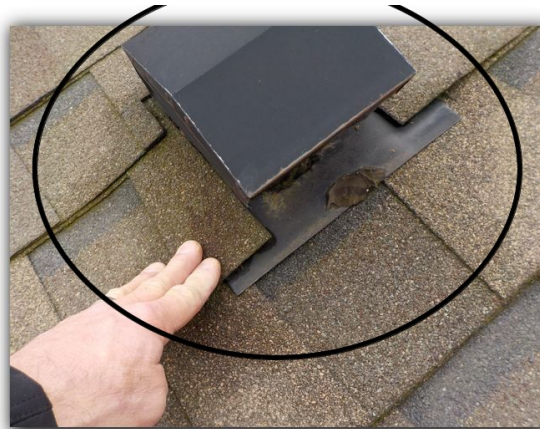
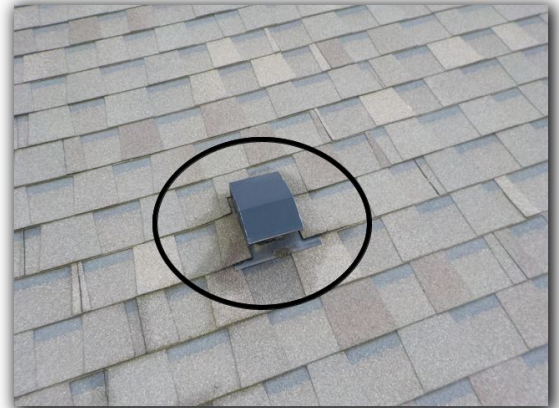
I observed evidence of moisture staining in laundry room area and inside corner of garage below noted dryer vent cover at time of inspection. Hands on in attic finding evidence of moisture entry below dryer vent with obvious evidence of entry for some time. No obvious evidence of deficiencies noted to dryer vent cover? Possible north facing cover allowing for wind blown rain to make entry under the right conditions. Please see ceiling section for further information / evidence of moisture entry. Recommend evaluation for repairs allowing home to work as efficient as possible.

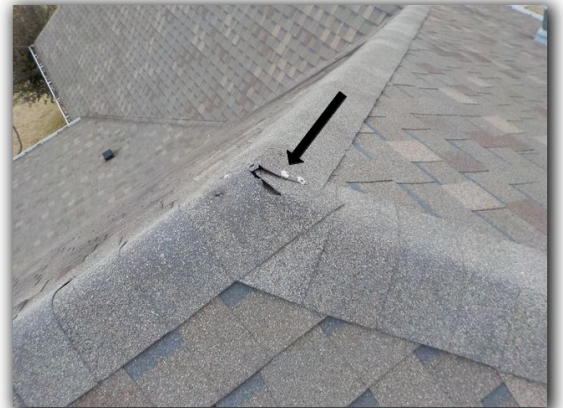
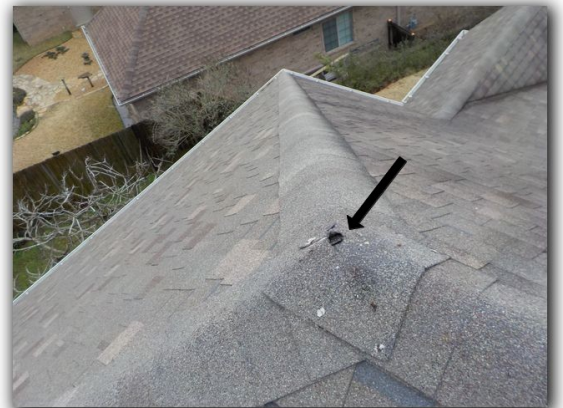
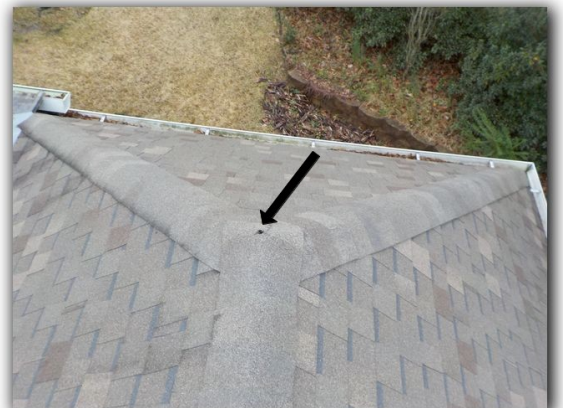
I observed various areas of mechanical damage to asphalt roof at time of inspection. Most of the damage noted on shingle ridge and hip caps. This could be due to excessive bending needed to cover ridge and hips. This can be more often seen in thicker shingles that will fail with such a significant bend. No moisture penetrations noted under areas with decking exposed through cracks/hole. Recommend evaluation by qualified roofer for areas of possible repair and/or replacement.

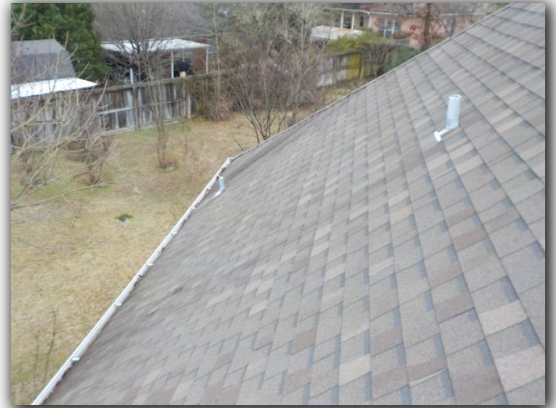
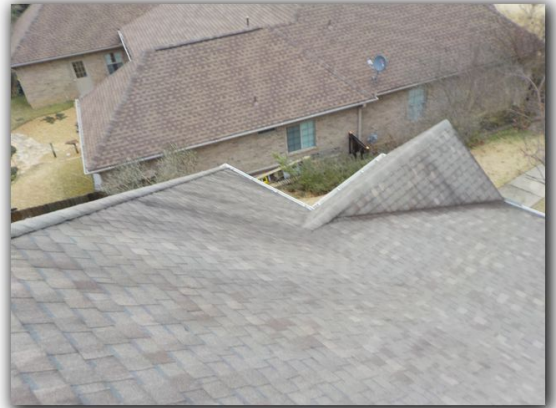
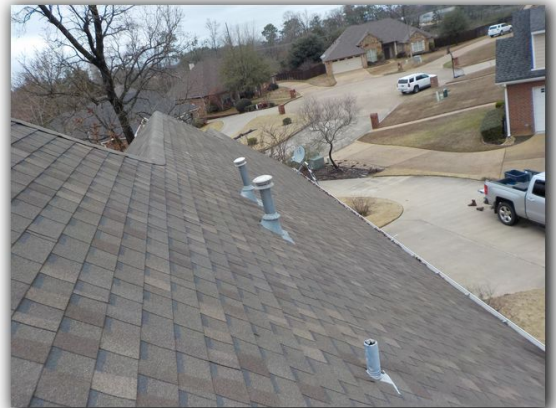
I observed where gutters filled with areas of debris at time of inspection. Debris in gutters are create conducive conditions for water penetrations and / or mechanical failure due to extreme water/debris weight or possible water leaking into living space / soffit areas. Recommend cleaning of gutters allowing water to flow / terminate from roof area as should.

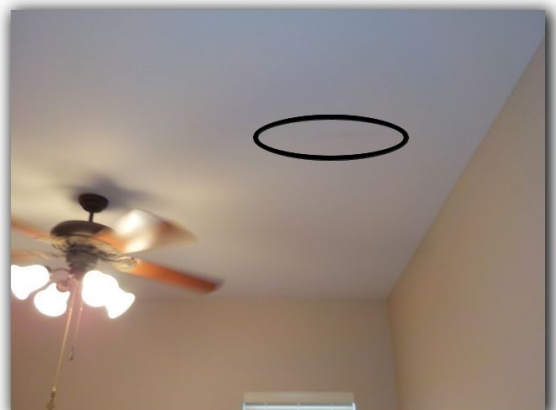
Left middle bedroom

***Moisture Staining noted in left middle bedroom***

I observed an area of moisture staining noted on ceiling in left middle bedroom at time of inspection. Further investigation found areas of moisture noted on roof decking below exhaust vent stack, evidence of moisture on insulation, and finally obvious evidence of moisture damage found on sheet rock ( ceiling ). No obvious moisture noted with meter and thermal camera. No obvious evidence of moisture noted with hands on. ( Note: rain times 2 days in area. Rain day of inspection allowing for wet conditions if water made entry into attic area. ) No obvious evidence of moisture entry points found on roof area near vent stack. Recommend evaluation from qualified roofer for possible repairs if needed. Noted deficiencies called out in roof section.

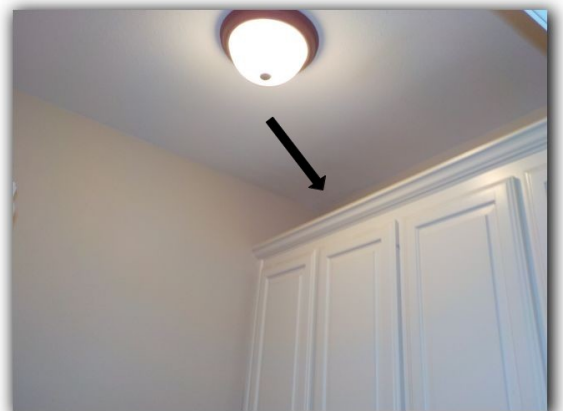
Laundry room

***Moisture Staining noted in laundry room and garage area***

I observed areas of moisture staining / moisture damage noted on inside corner of laundry room and inside corner of garage at time of inspection. Further investigation found obvious evidence of moisture noted with moisture meter and/or thermal camera. Moisture staining with hands on finding moisture on top plates, decking, and sheet rock. Appears roof top dryer vent cover leaking allowing water to make entry into interior walls. Recommend evaluation from qualified roofer for appropriate repairs. Noted deficiencies called out in roof section.

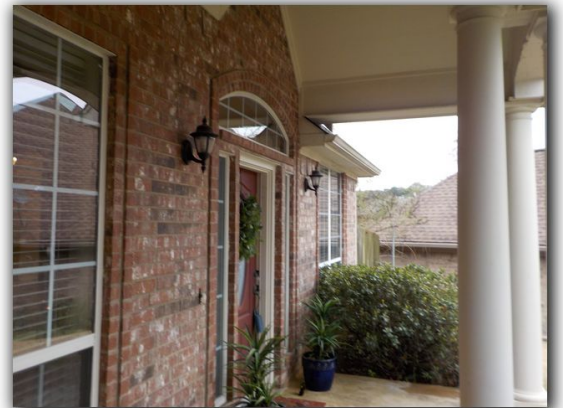
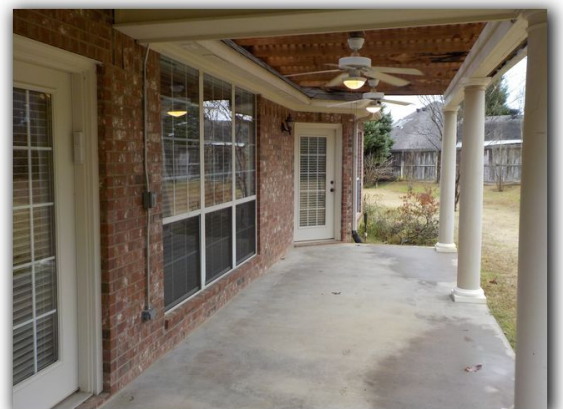
I observed areas with minor damage noted to porch post surround / trim at time of inspection. Damage appears to have been caused by possible weed eater. Trim has been painted which is added protection. Recommend evaluation for possible repairs if desired keeping areas painted for added protection.

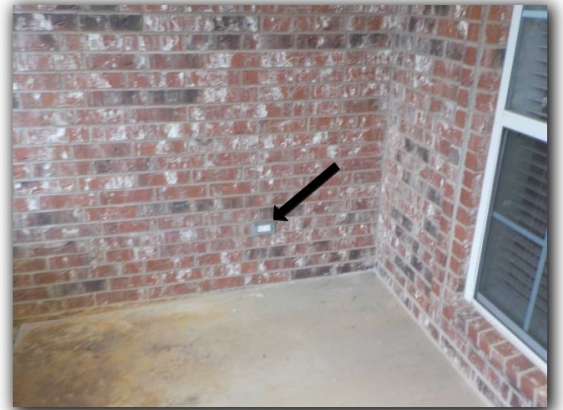
I observed where outdoor receptacle cover was missing / damaged at time of inspection. Recommend replacing with appropriate outdoor outlet cover that is watertight allowing for safe and normal use.

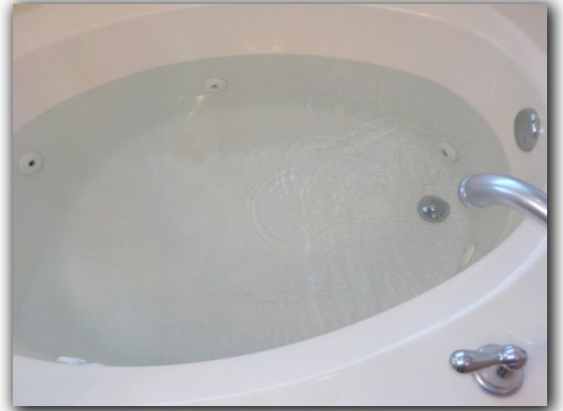
Access panel in inaccessible / missing at time of inspection. This is commonly seen with the cosmetic appeal more apparent than ease for possible repairs to unit if ever needed. Mind set is that it would be better to remove noted surround(s) on spa tub for access if needed than having a possible unattractive opening under / near tub. Recommend evaluation for repairs if desired and/or monitor area in case ever needed.

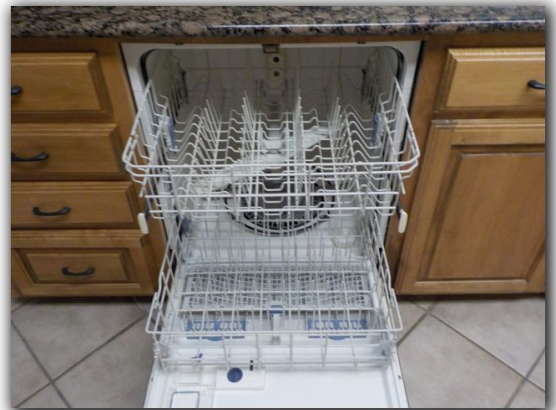
I observed where dishwasher drain has been installed incorrectly. As it is now, wastewater from sink can be allowed to siphon into dishwasher. Recommend placing a high loop or air gap to prevent potential back flow contamination of the dishwasher.

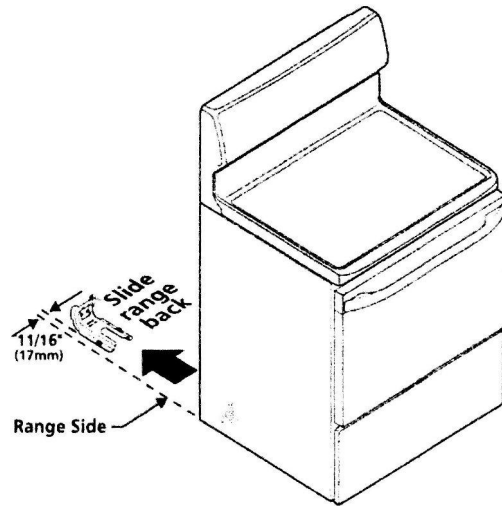
- Absence of anti-tilt device at time of inspection.
  - *Equipment and appliances should be installed as required by the terms of their approval, in accordance with the conditions of the listing, the manufacturer's installation instructions and this code.*

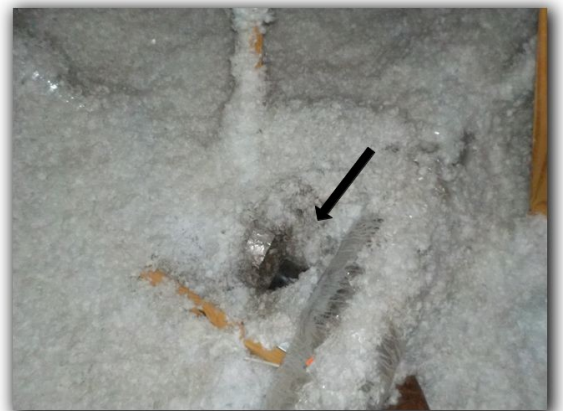
I observed where master bathroom exhaust fan / duct has separated at time of inspection. Noted area allowing warm moist air to blow into attic area allowing conducive conditions for possible moisture buildup, staining, possible mildew, etc. Recommend evaluation for repairs allowing exhaust vent to terminate outside as should.

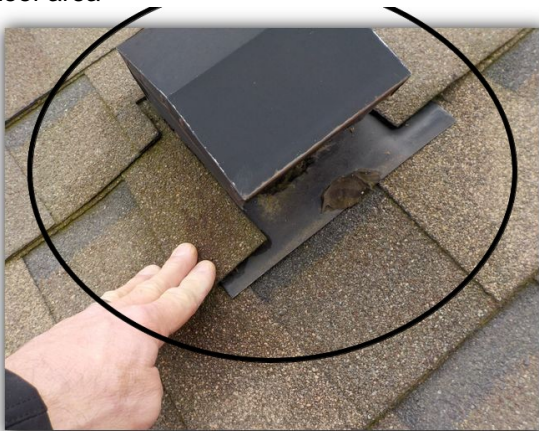
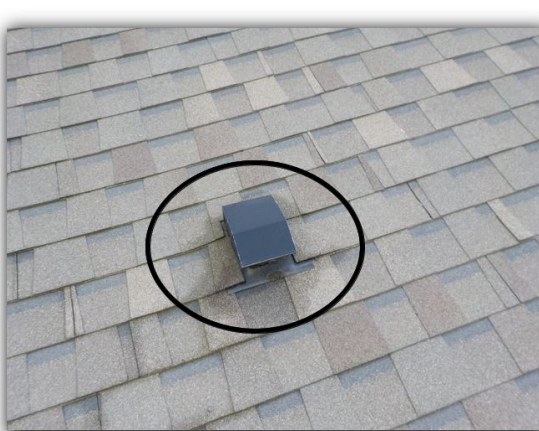
Roof area

I observed areas of moisture staining / moisture damage noted on inside corner of laundry room and inside corner of garage at time of inspection. Further investigation found obvious evidence of moisture noted with moisture meter and/or thermal camera. Moisture staining with hands on finding moisture on top plates, decking, and sheet rock. Appears roof top dryer vent cover leaking allowing water to make entry into interior walls. Recommend evaluation from qualified roofer for appropriate repairs. Noted deficiencies called out in roof section.
