*Home inspection for
Sample Report
Somewhere
Longview TX 75601*

David Smith Inspections

PROPERTY INSPECTION REPORT

Concerning: Somewhere, Longview, TX 75601
(Address or Other Identification of Inspected Property)

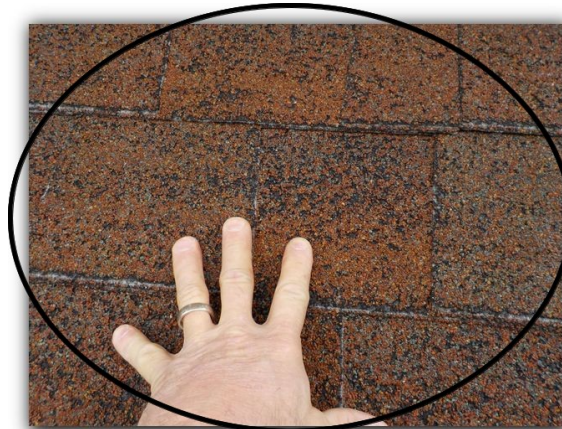
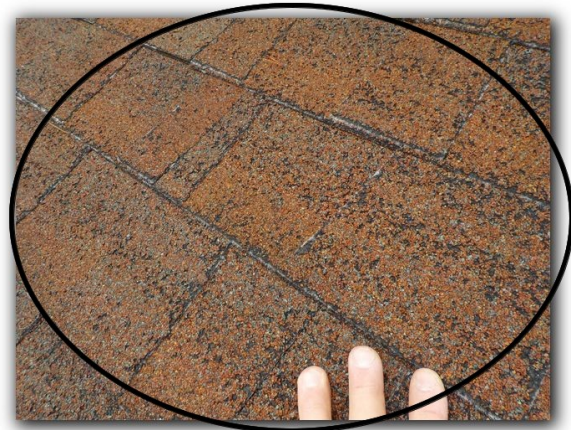
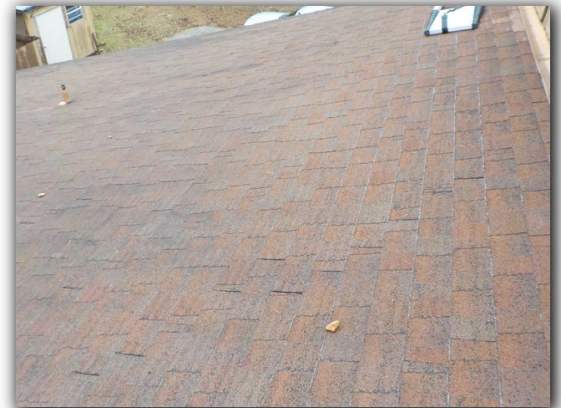
I observed areas of mechanical wear along with possible hail damage noted on roof area at time of inspection. Mechanical or normal wear is considered to be part of the normal aging process and may all depend on quality of shingle(s) or climate zone of home. Rate of gravel loss may appear to be excessive for age and quality of roof. Recommend evaluation from qualified roofer to verify whether noted gravel loss is premature and/or normal in nature.

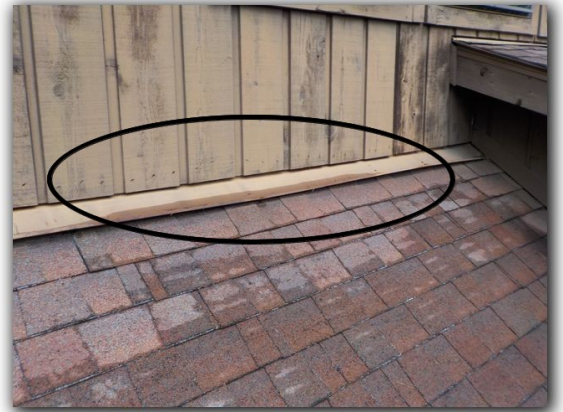
I observed areas on roof with exposed nails in flashing at time of inspection. Over time, nails have a tendency to work themselves out creating possible conducive conditions for water penetrations. Recommend evaluation for repairs placing some fashion of water proofing material over noted nails (silicone) allowing home to work as efficiently as possible.

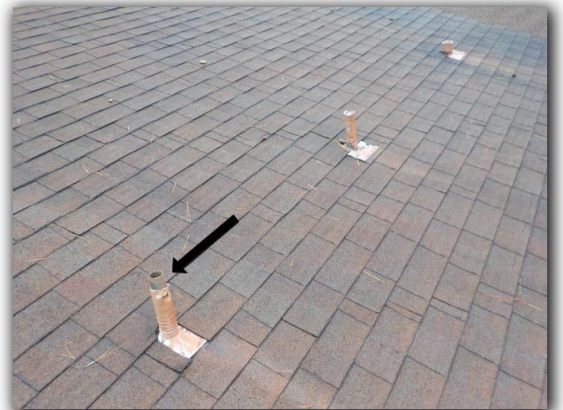
I observed where the lead jack flashing that covers plumbing vent stack(s) was observed to be improperly installed at one or more of the roof level plumbing vent pipes. The lead flashing should run full length of the vent pipe and turn down into the top of the vent pipe to help prevent water intrusion at this point

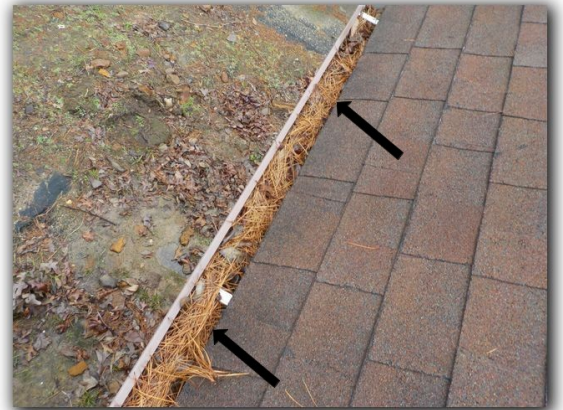
I observed where gutters filled with areas of debris at time of inspection. Debris in gutters are create conducive conditions for water penetrations and / or mechanical failure due to extreme water/debris weight or possible water leaking into living space / soffit areas. Recommend cleaning of gutters allowing water to flow / terminate from roof area as should.

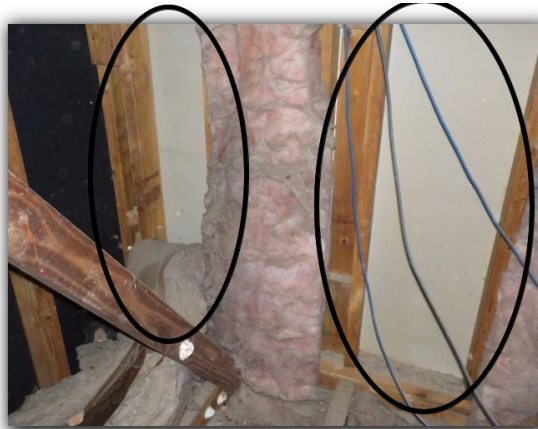
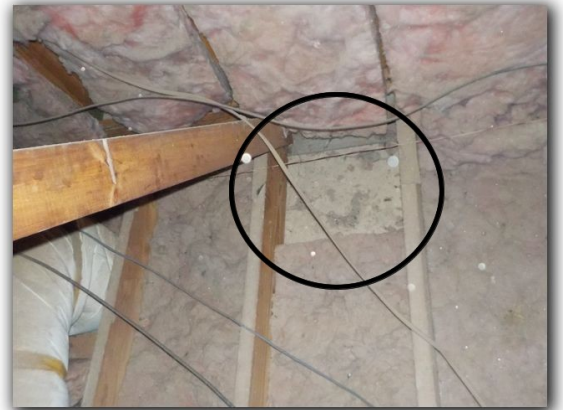
I observed various areas in attic where it appears that vertical rolled batting insulation has fallen away from interior walls. Typically rolled batting insulation stapled to stud walls in attic area adjacent to living areas in home. When rolled batting falls away it exposes home / exposed sheet rock to hot / cold attic. Recommend evaluation for replacing / repairing missing insulation in attic allowing home to work as efficiently as possible.

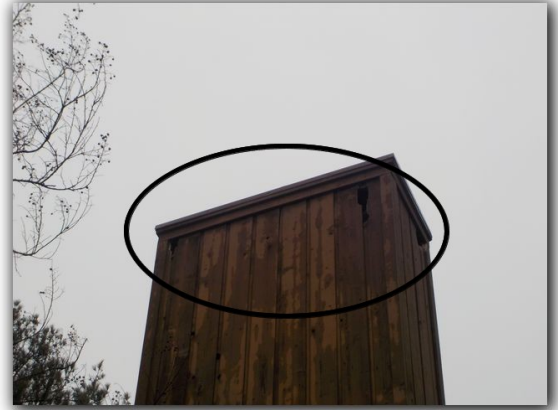
I observed obvious areas of damage noted to wood exterior chimney surround at time of inspection. Noted area conducive for possible unwanted animals and birds to make entry. Area noted also conducive for water entry under the right situation. No obvious evidence of moisture noted around veneer fireplace surround below affected area. Recommend evaluation for necessary repairs.

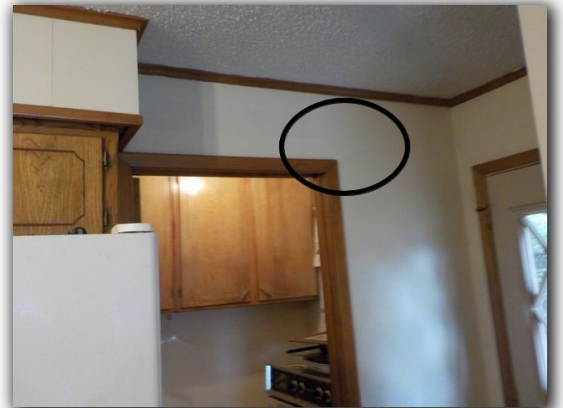
I observed minor seam crack(s) in the interior sheet rock walls at time of inspection. Areas noted appear to have been cause from settlement of the homes foundation and/or thermal expansion. Recommend monitoring noted areas for any noticeable changes

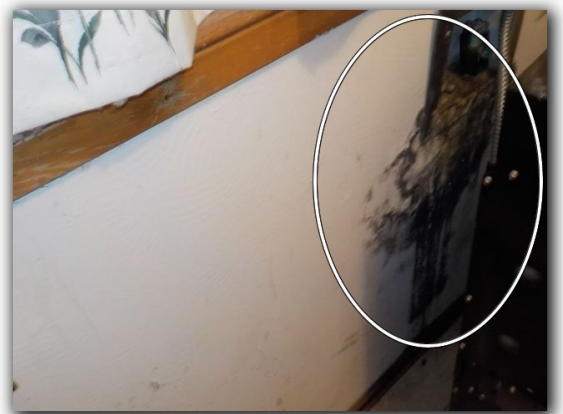
I observed an area near washing machine connections with active leak noted on water fixtures at time of inspection. Appears that wall drain box filled with debris and not allowing for drainage as should. Noted area presenting with what appears to be possible black mold. This is common and found with extended exposures to water along with being in cooler and darker areas. Recommend evaluation for repairs to damaged wall and washing machine wall drain box.

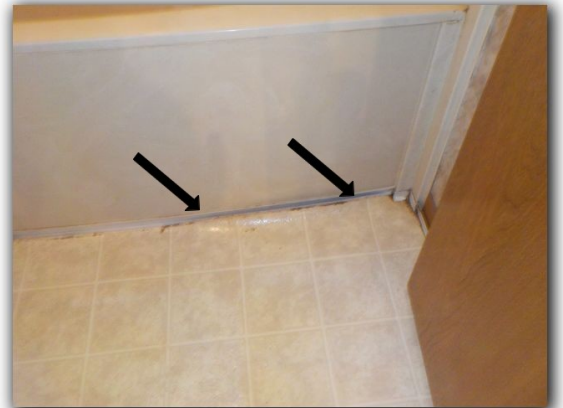
I observed possible areas with damaged linoleum flooring near upstairs master bathroom / tub at time of inspection. No obvious evidence of moisture near affected area when assessed with

moisture meter. No obvious evidence of moisture staining / damage noted in living area below affected area. Recommend evaluation for possible repairs allowing flooring to work as efficiently as possible.

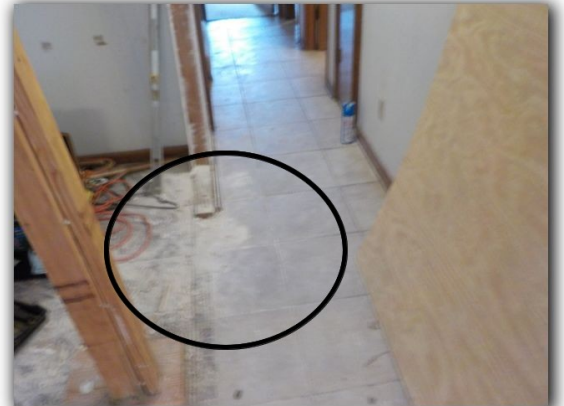
I observed 2 areas in home near kitchen and foyer / hallway where there appears to be minor low spot in concrete at time of inspection. Does not appear to be structural in nature with no obvious residual damage noted to interior walls, ceilings, and / or floor tile. Slabs are not perfectly flat when poured with possible areas of depressions found. Any certain issues with cracked, heaved, and/or settled slab would create obvious damage to noted tile over affected areas with possible differential heights. Areas difficult to observe but inspector just making note for possible reference.

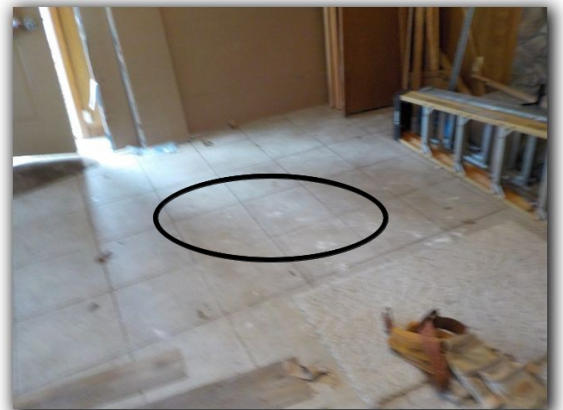
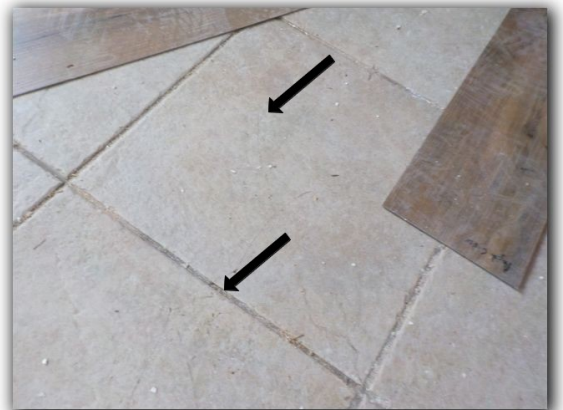
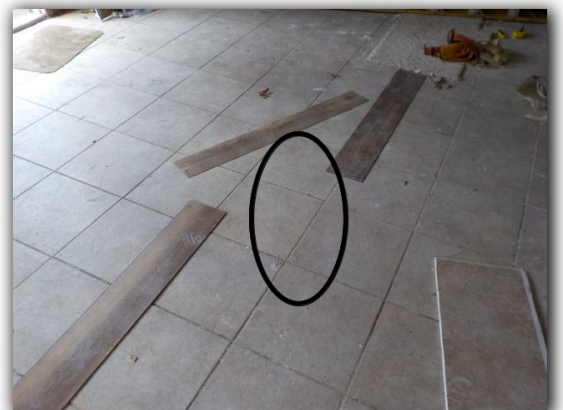
Living room area

I observed minor tile cracks in various areas of living room at time of inspection. Area(s) appear to have been cause from normal settlement of the homes foundation, typical stress or shrinkage crack, and/or thermal expansion / shrinkage of cured concrete. Areas found do not exhibit horizontal movement (normal) found on all slabs without the proper control joints. These are very typical and even happen in slabs with control joints. No other evidence of possible movement noted near affected areas in kitchen and foyer area. Cracks should be monitored for any noticeable changes.

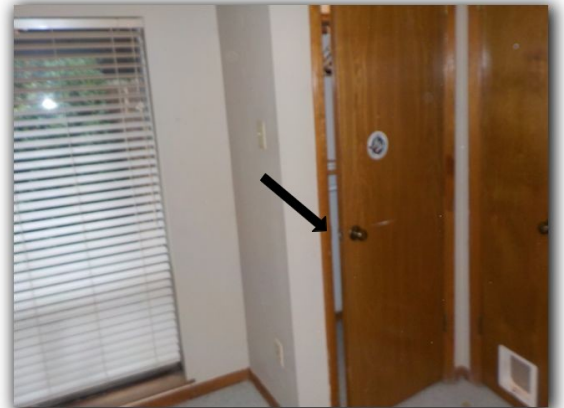
I observed where left rear bedroom closet door assembly missing at time of inspection.

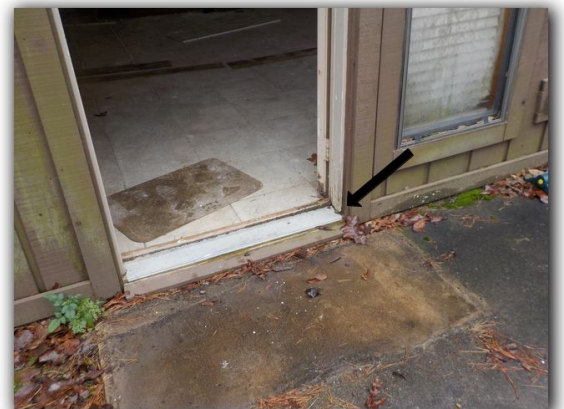
I observed areas near exterior door with minor moisture damage noted to wood surround / trim at time of inspection. Typical with contact from wind blown rain and possible wood to grade contact. Recommend evaluation for possible repairs if desired keeping area(s) painted for added protection.

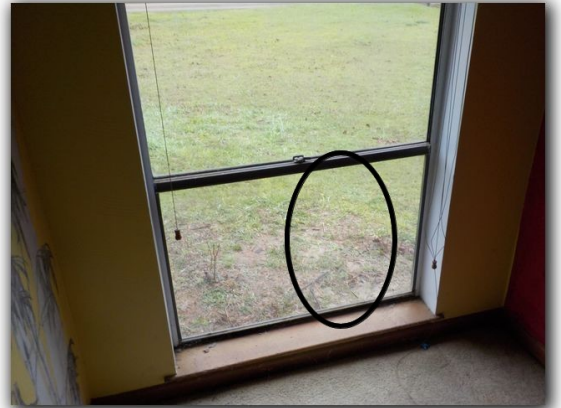
I observed a single cracked window pane in front left bedroom at time of inspection.

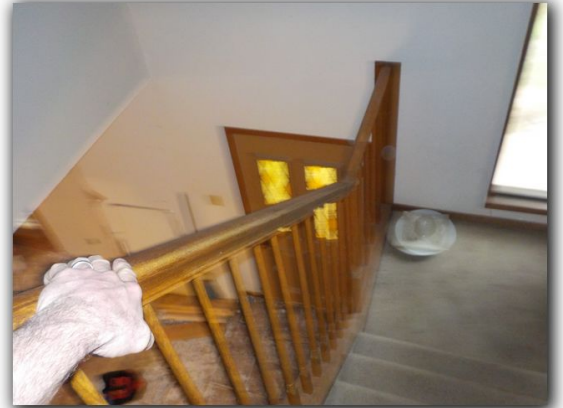
I observed where stair railing over foyer / landing found loose to touch at time of inspection. Recommend evaluation for securing noted railing allowing for safe access / egress.

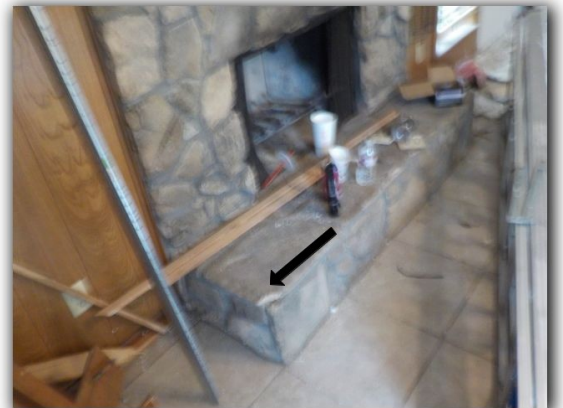
I observed a minor area of damage noted on fireplace hearth. Appears corner crack to rock veneer.

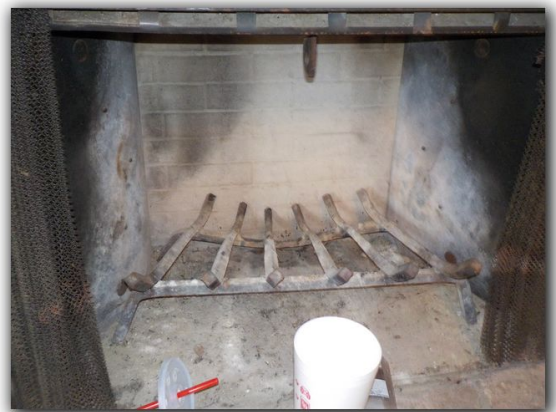
I observed where fireplace damper found open at time of inspection. Inspector was unable to close damper with attempts at time of inspection. Recommend evaluation for obvious repairs allowing home to work as efficiently as possible.

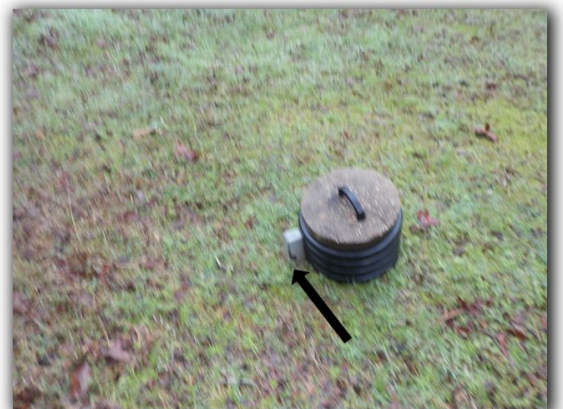
I observed where exterior junction box damaged near aerobic system found in front yard at time of inspection. Found open junction box with hot wires when assessed. Recommend evaluation for repairs allowing area to be as safe as possible.

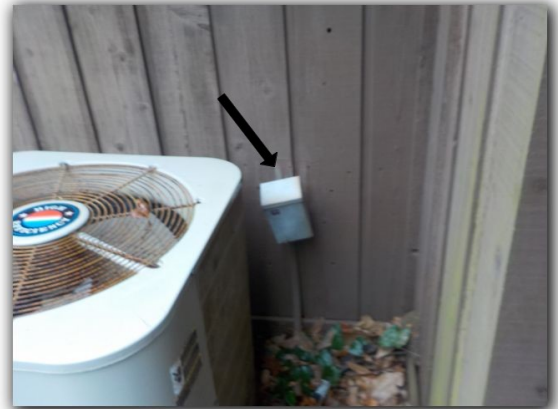
I observed where disconnect for downstairs condenser / outside unit found loose to touch at time of inspection. Noted area could obviously be a possible shock hazard. Recommend evaluation for securing noted disconnect allowing for safe function.

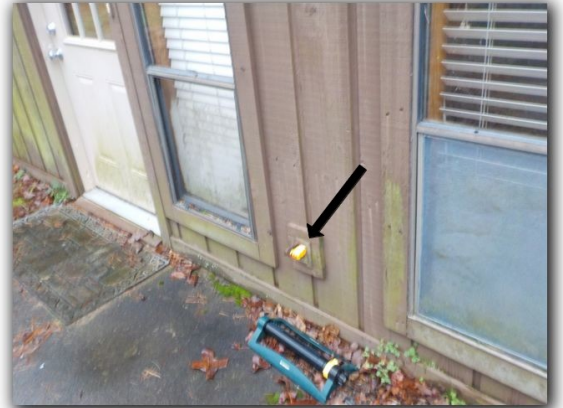
Missing GFCI protection on exterior of home

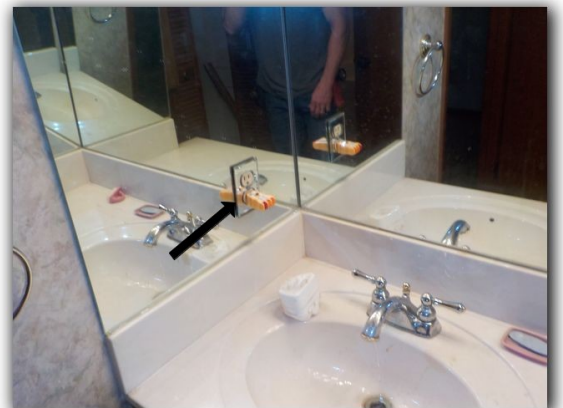
Master bathroom
Missing GFCI protection in bathrooms

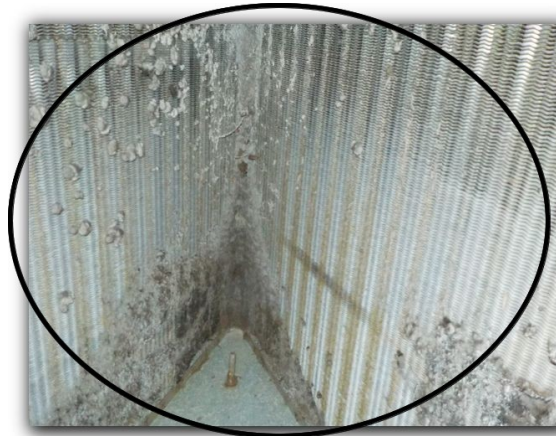
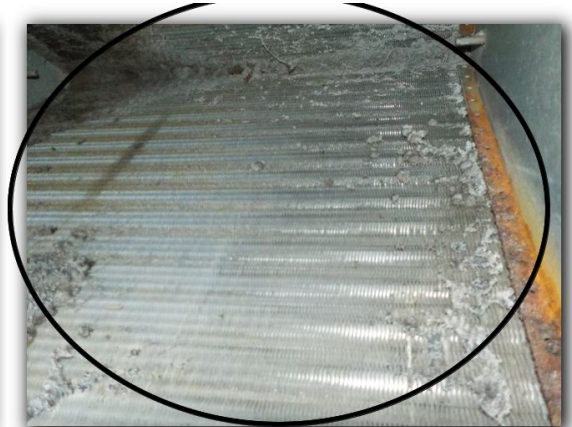
I observed where downstairs AC system shows signs of being dirty at time of inspection. Areas noted typically seen when unit run for any amount of time without appropriate air filter and/or air escaping around noted filter. Recommend evaluation for from qualified technician for servicing if needed.

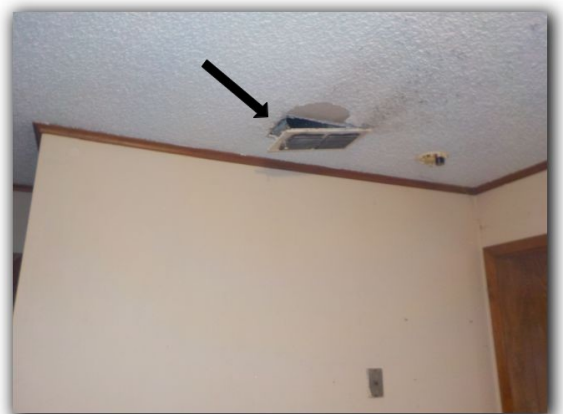
I observed where grill / register in kitchen area has separated from ceiling area at time of assessment.

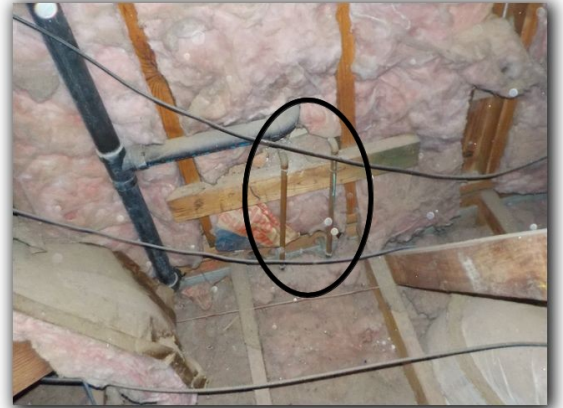
I observed where copper water lines in attic over living room area found without adequate insulation at time of inspection. Areas such as attic area could be exposed to freezing temperatures creating conducive conditions for pipes to possibly burst. Recommend evaluation for adding appropriate insulation on exposed pipes allowing home to work as efficiently as possible.

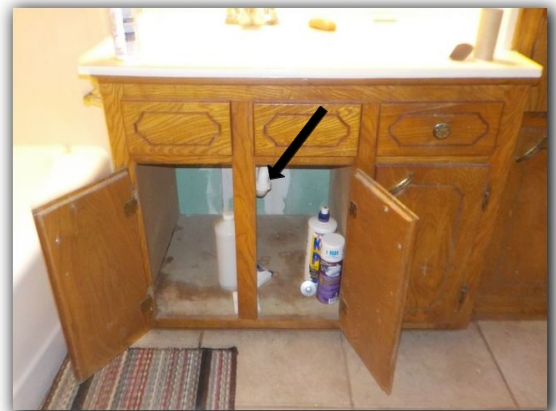
I observed where hallway bathroom sink / drain presenting with flex drain line at time of inspection Flexible and / or corrugated drainpipe may contribute to possible blockages at a bathroom sink(s). Although currently functioning, it is recommended that this be replaced with the proper drain material.

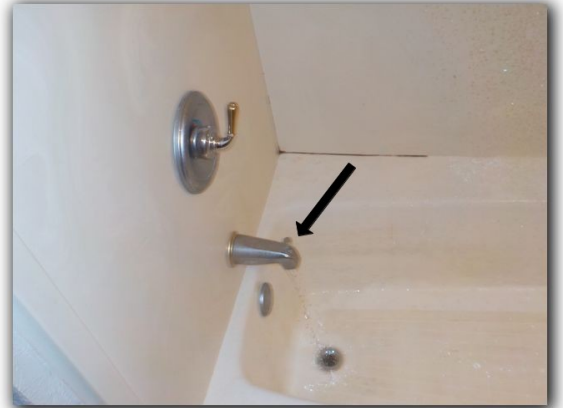
I observed where hallway bathroom tub / shower diverter would not open and/or close all the way when in use. Water found to flow when shower in use. Recommend evaluation for possible repairs and/or replacement allowing for normal function. *Note: Noticeable mineral buildup / deposits noted on bathroom fixtures at time of inspection. This lime scale type build up is not considered to be harmful but may clog various fixtures as well as making cleaning noted areas more difficult. Vinegar, baking soda, or lemon juice are a few ideas for cleaning noted surfaces. Areas noted appear to be cosmetic in nature and not considered a deficiency.*

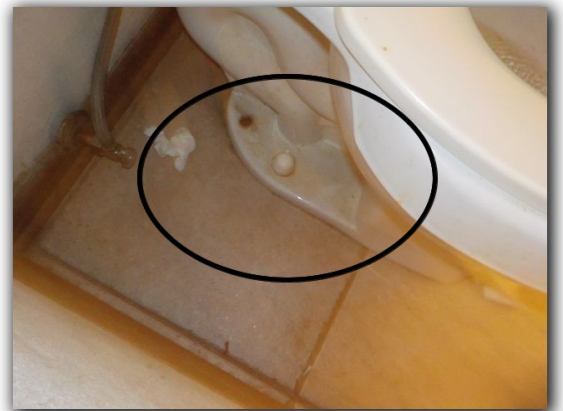
I observed where hallway bathroom commode found loose to touch at time of inspection. No evidence of leaks noted along commode flange during assessment. Recommend evaluation for securing commode appropriately allowing for normal use.

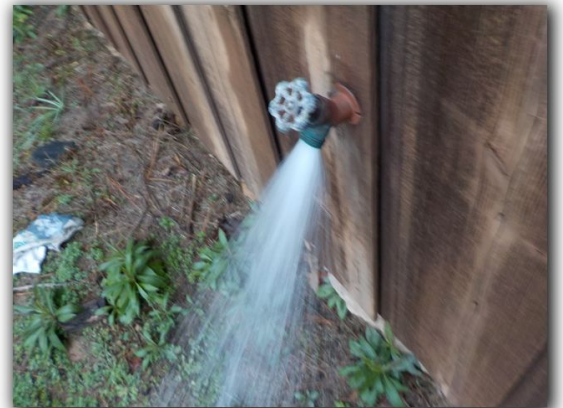
Missing back flow preventer. The back flow preventer keeps contaminated water from entering potable (drinking) water.

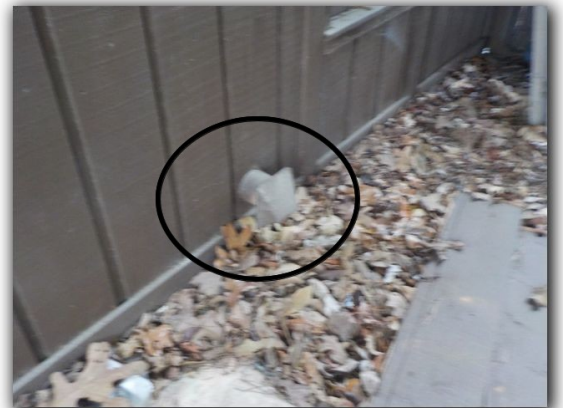
Dryer not connected at time of inspection.

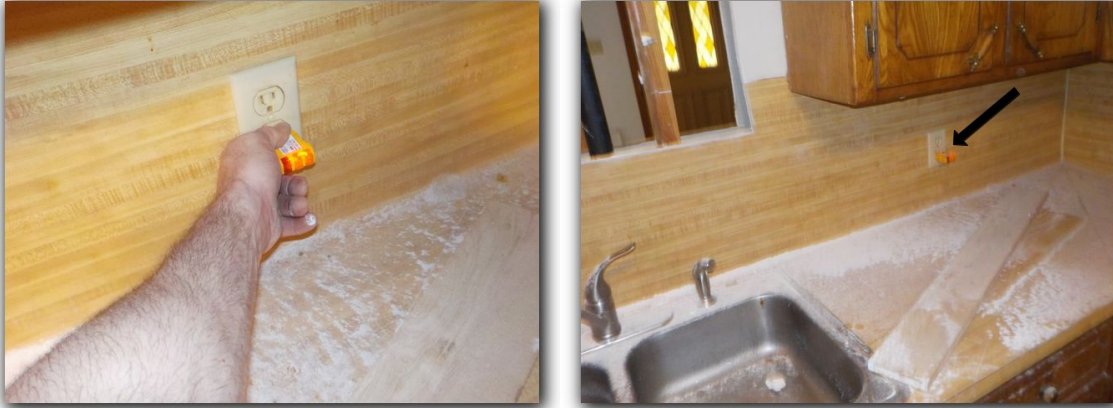
Missing GFCI protection in kitchen area

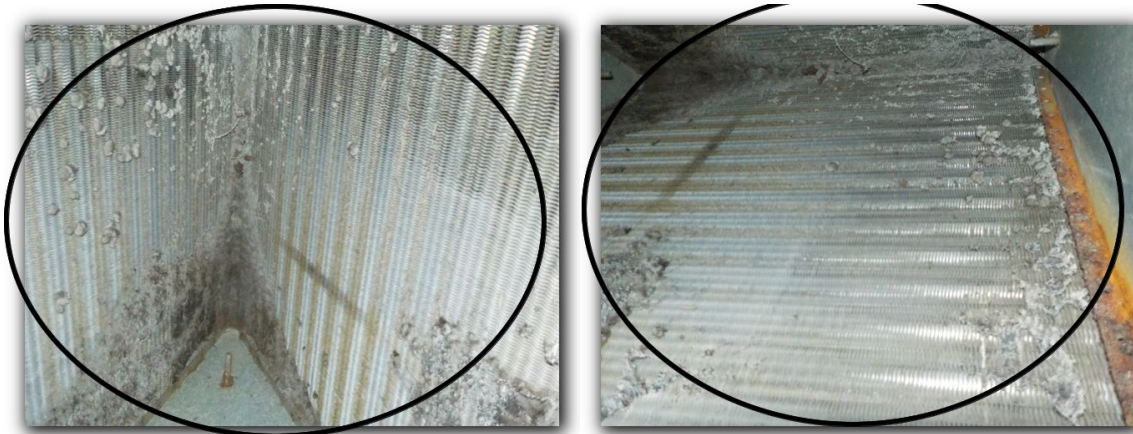
I observed where downstairs AC system shows signs of being dirty at time of inspection. Areas noted typically seen when unit run for any amount of time without appropriate air filter and/or air escaping around noted filter. Recommend evaluation for from qualified technician for servicing if needed.

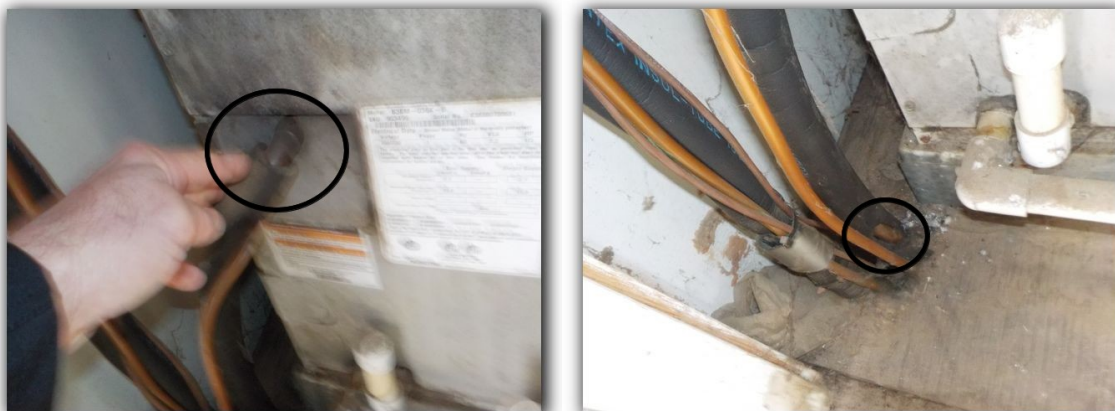
I observed where downstairs air handler found without any filter coverage at time of inspection. Areas of debris noted on A coil near affected area. Recommend evaluation for sealing noted area with appropriate filter allowing unit to work as should.
