*Home inspection for
Sample
Somewhere
Henderson TX*

PROPERTY INSPECTION REPORT

Concerning: Somewhere, Henderson, TX
(Address or Other Identification of Inspected Property)

By: David Smith, Lic #21666 12/07/2019
(Name and License Number of Inspector) (Date)

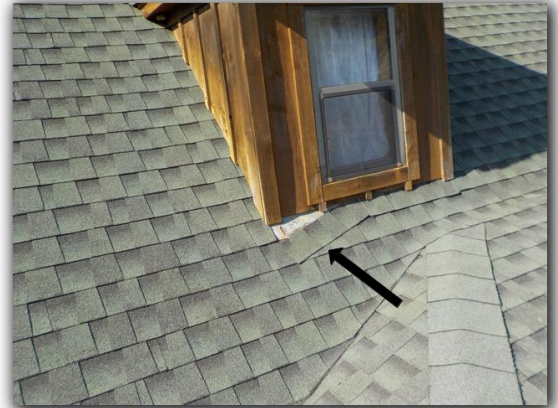
☒ I observed where a single shingle has pulled loose from top left upstairs bedroom near dormer at time of inspection. Shingle appears to be cosmetic in nature covering window / dormer base flashing. Recommend repairs keeping shingle from possible tearing away completely.

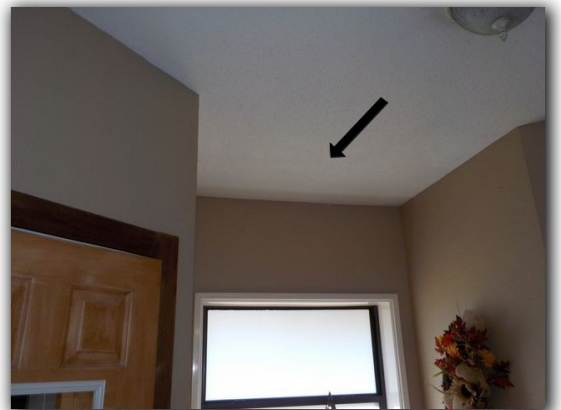
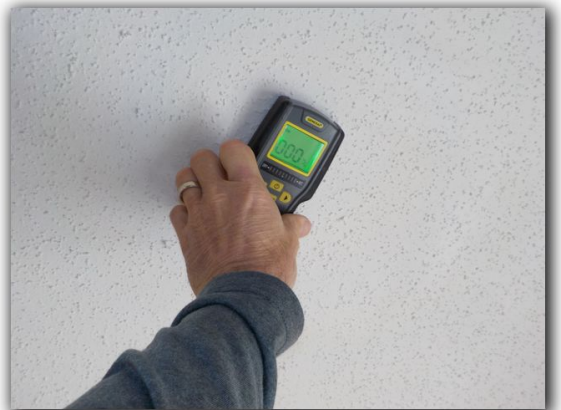
Master bathroom ceiling

☒ I observed an area of moisture staining in master bathroom over bathtub at time of inspection. Further evaluation found no obvious moisture with meter and/or thermal camera. Roof area finding areas of possible repairs with silicone having been used to seal possible seams in exterior siding. Possible that newer roof has remedied any past moisture entry concerns. Recommend monitoring noted area(s) for any noticeable changes.

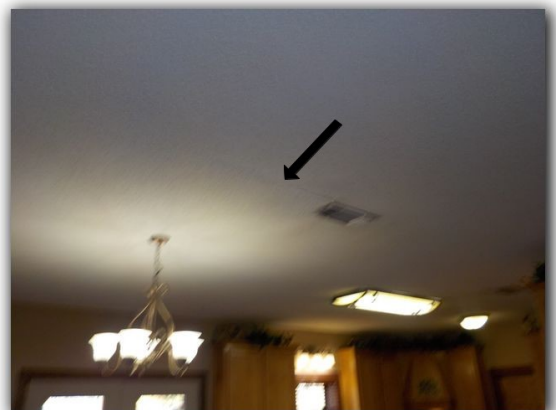
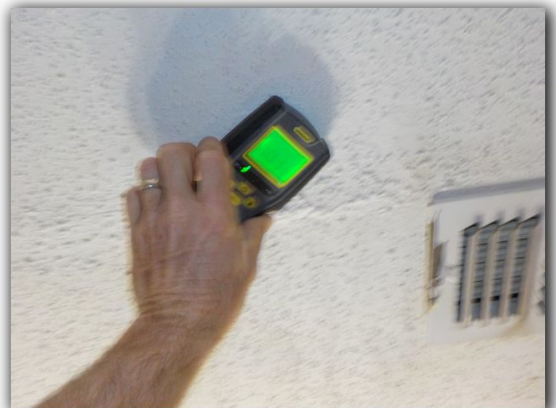
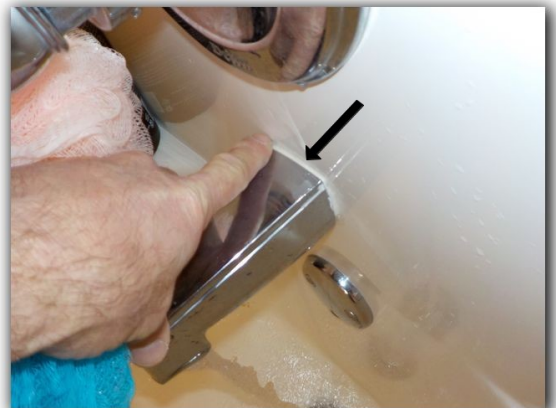
Kitchen / nook area

☒ I observed an area of moisture staining in nook / living room area at time of inspection. Further evaluation found no obvious evidence of moisture when assessed with meter and/or thermal camera. Appears area lies below upstairs hallway bathroom. Evidence of caulk placed near tub/floor and shower spout. Note: shower spouts very typically create conducive conditions for leaks when not sealed appropriately. Recommend monitoring areas for any noticeable changes.

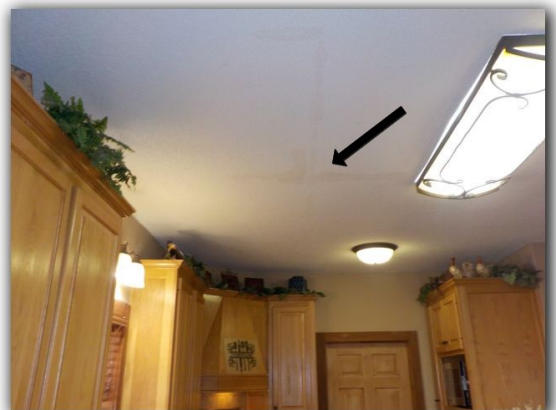
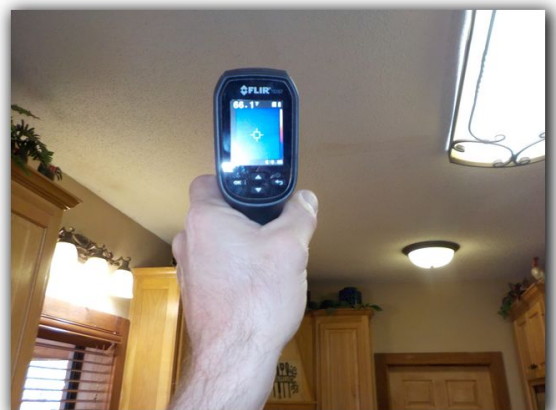
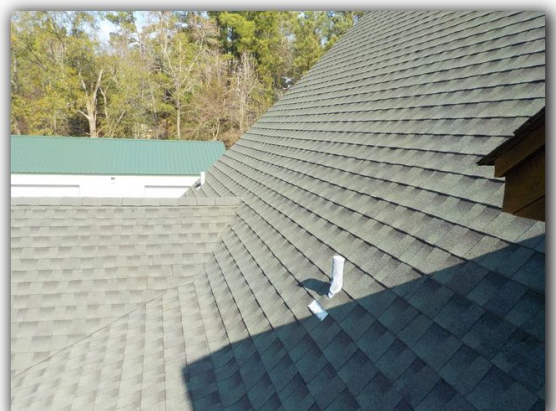
Kitchen area

☒ I observed an area of moisture staining found in kitchen area at time of inspection. Further investigation did not find positive evidence of moisture with meter and/or thermal camera during assessment. Roof evaluation found roof valley which may have allowing for possible water entry in the past. Most likely newer roof has remedied any moisture entry concerns. Recommend monitoring noted area for any noticeable changes.

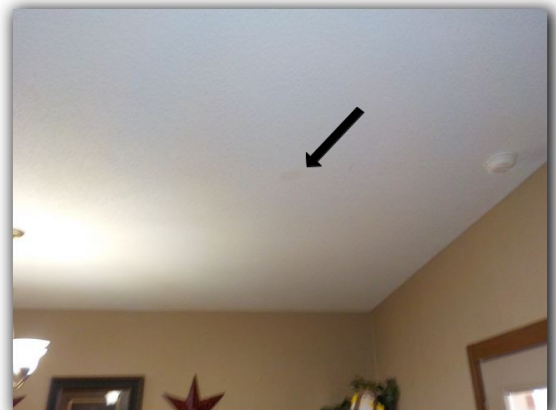
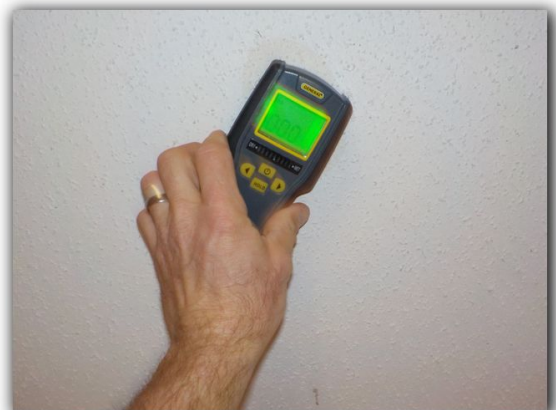
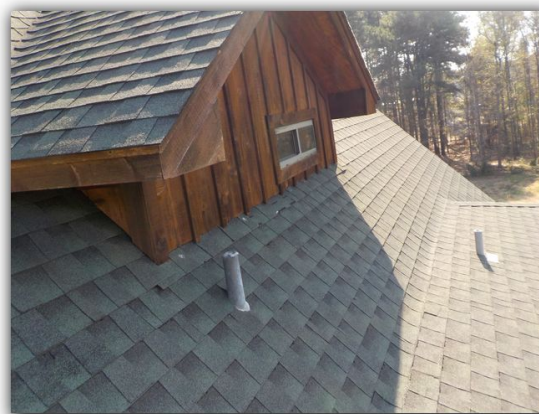
Nook area

☒ I observed a minor area of moisture staining near breakfast nook / back door off kitchen area at time of inspection. No obvious moisture noted with moisture meter and / or thermal camera. Roof area above finding no obvious evidence of moisture entry concerns. Possible damaged plumbing vent stack over affected area. Appears newer roof remedied any past concerns. Recommend monitoring noted area for any noticeable changes.

- *Note: unable to verify if newer roof has remedied any past moisture entry concerns at time of inspection.*

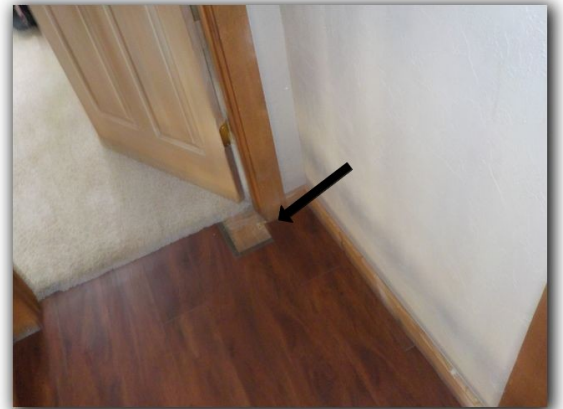
☒ I observed a minor area near top left bedroom where piece of vinyl flooring missing at time of inspection.

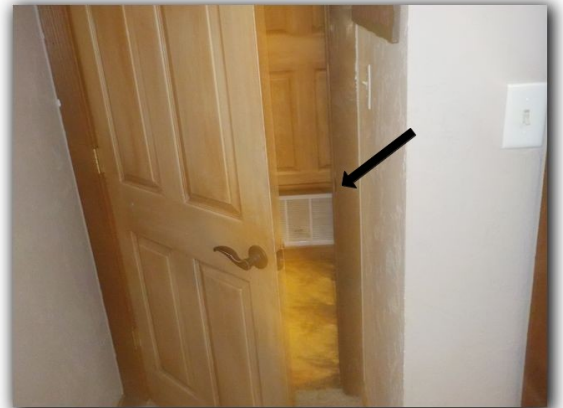
Downstairs bedroom door

☒ I observed where door would not close properly at time of inspection. Most likely door out of alignment. Recommend possibly moving strike plate on door jam allowing door assembly to latch and close as should.

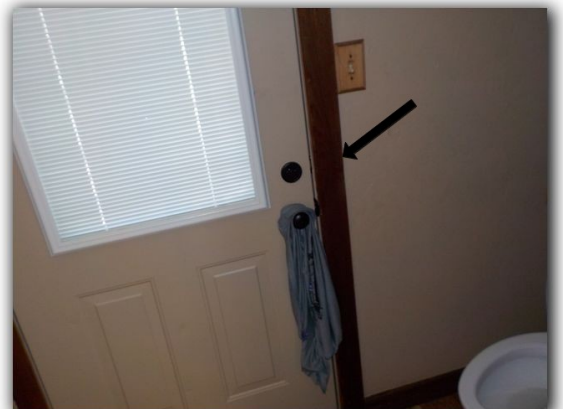
☒ I observed where master bathroom exterior door found out of alignment making use of deadbolt difficult to lock / unlock. Found damaged / loose hinge near top of door. Recommend evaluation for securing noted anchors for door allowing door to work as should.

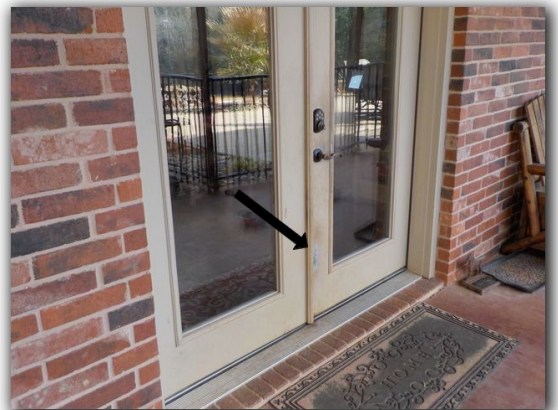
☒ I observed an area of cosmetic damage noted to French doors near back porch at time of inspection. Damaged noted appears to have been created by family pet(s).

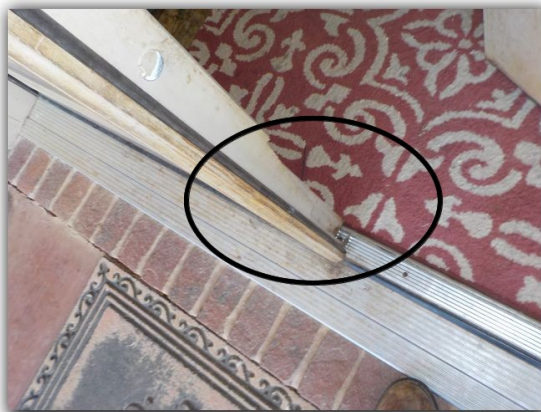
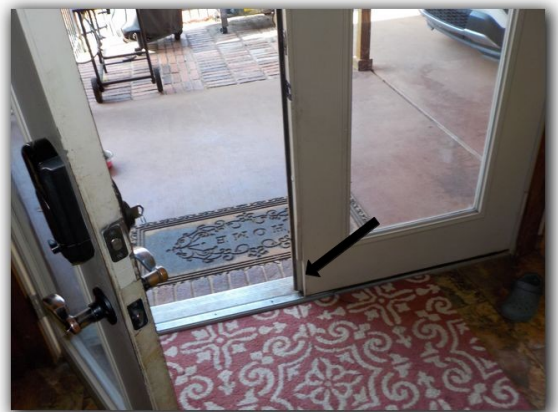
☒ I observed where bottom flush bolt damaged / missing from rear French door(s) at time of inspection. Noted missing sliding flush bolt keeps double doors from locking appropriately. Recommend evaluation for repairs allowing door(s) to work as should.

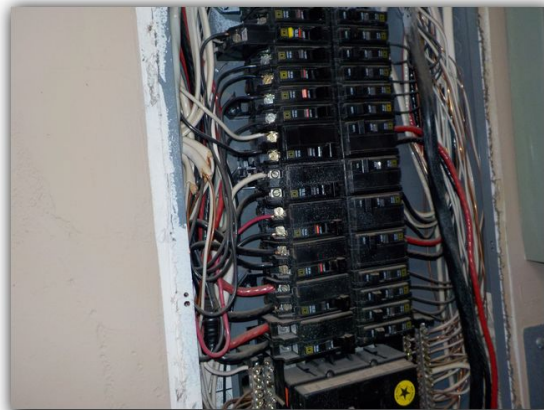
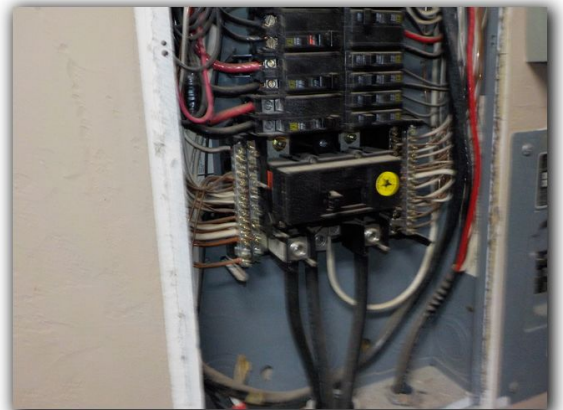
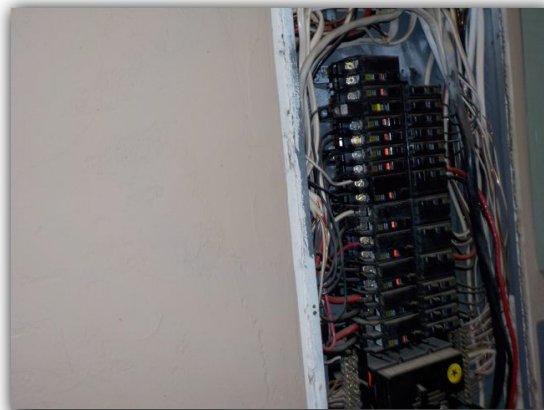
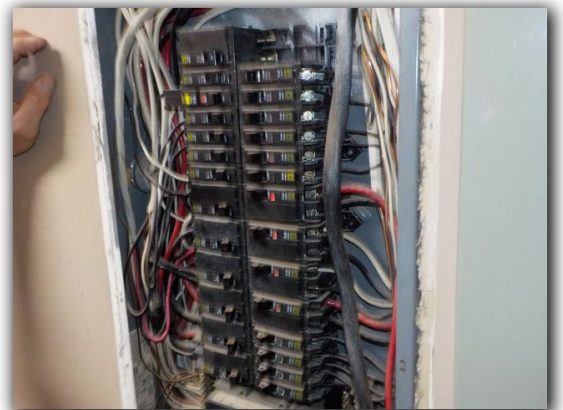
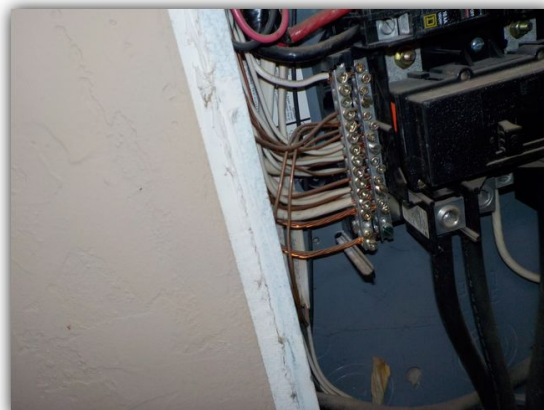
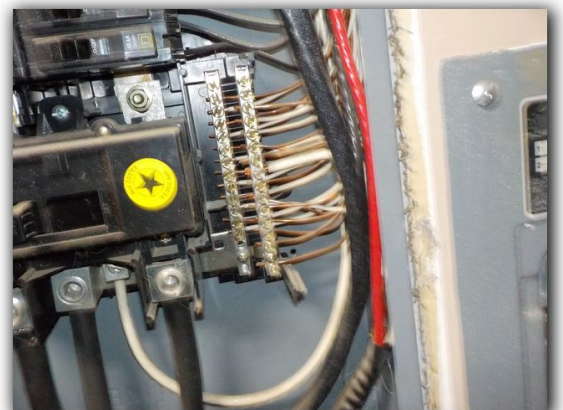
☒ Lack of AFCI breakers servicing the bedrooms, living room, dining room, and any other similar rooms in the home. This was not available at the time this house was constructed and is considered a safety upgrade.

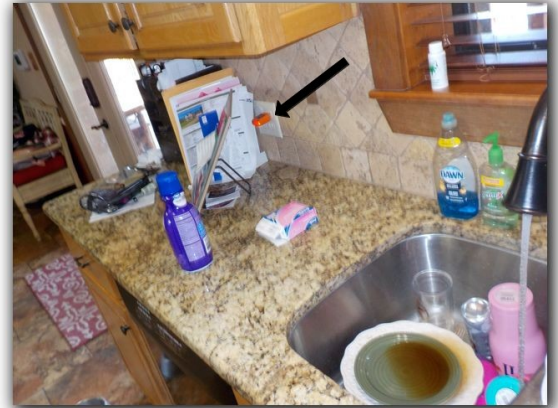
Missing GFCI protection in kitchen area

☒ No GFCI/ARC Fault protection at one or more location. This is considered a recognized safety hazard. GFCI protection was not provided in the home at locations where it is now deemed necessary. GFCI protection may not have been required at the time the home was built, but for safety reasons it is recommended that GFCI protection be installed at all the following locations: • Bathrooms • Exterior • Garages • Crawlspace (at or below grade) • Unfinished basements • Kitchens • Laundry rooms • Within 6 feet of all plumbing fixtures. Recommend evaluation for possible repairs and / or replacement of deficient receptacles for added safety.

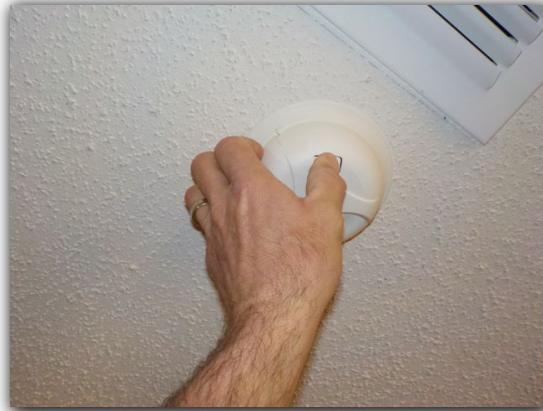
☒ Smoke alarms are not present in each sleeping area

☒ Smoke alarms are recommended in the following area(s):

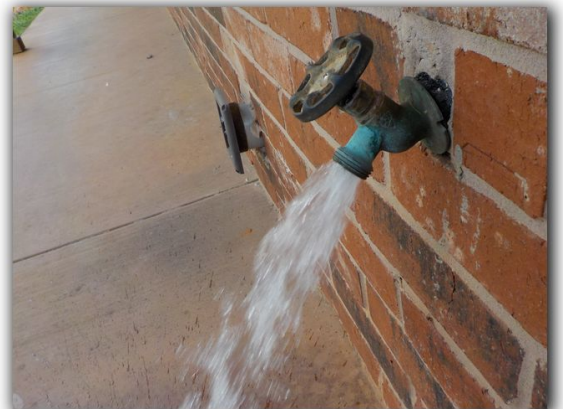
☒ Missing back flow preventer. The back flow preventer keeps contaminated water from entering potable (drinking) water.

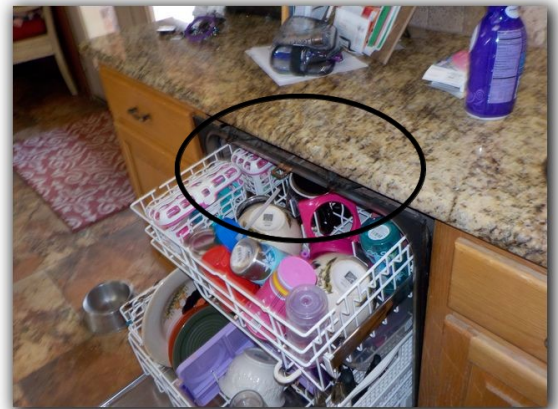
☒ I observed where dishwasher found loose to the touch at time of inspection. Found where unit was not securely appropriately during assessment. Recommend evaluation for securing appropriate anchors allowing unit to work as should.

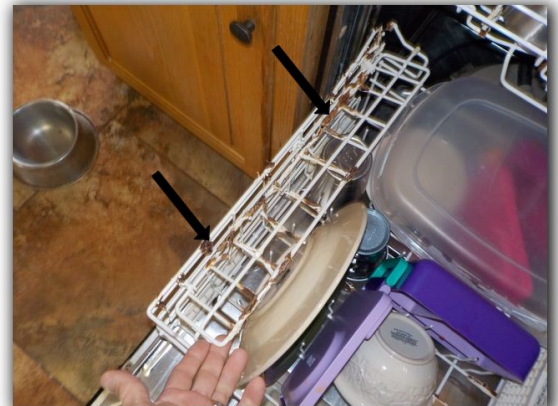
☒ I observed where lower dishwasher rack presenting with significant signs of rust / damage at time of inspection. Recommend evaluation for possible repairs and/or replacement allowing dishwasher to work efficiently.

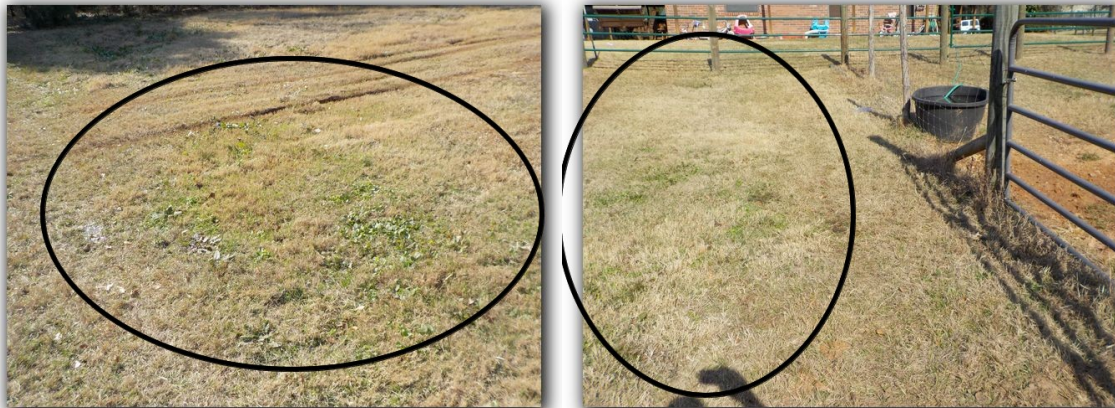
☒ I observed obvious areas of water flow on ground from septic system near left rear corner of home at time of inspection. Noted area with obvious moving water during assessment. Appears to be a failed system with noted areas of ruts in yard from possible water flow for some time. Recommend evaluation for repairs allowing home septic system to work as should.

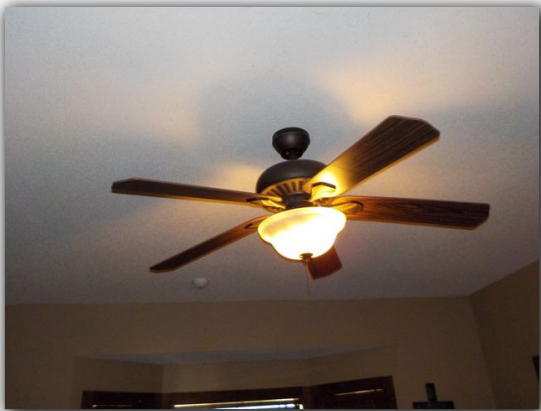
☒ I observed where ceiling fan in master bedroom would not work with attempts at time of inspection. Appears pull cord for fan is missing. Recommend evaluation for repairs allowing ceiling fan to work as should.

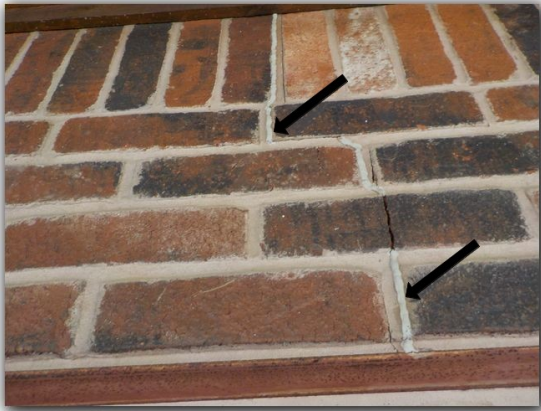
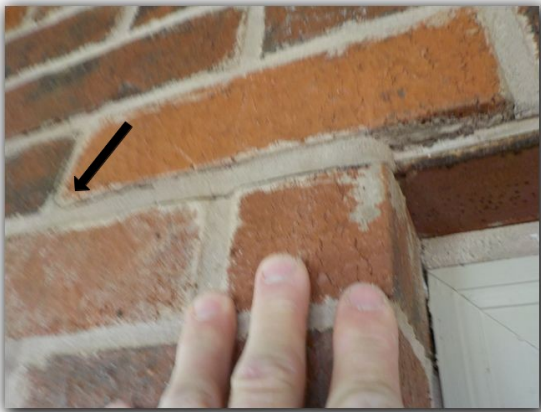
☒ I observed minor mortar cracking in veneer siding at time of inspection. These cracks are typically due to thermal expansion and/or minor structural movement. Brick walls may expand (when heated) and contract (when cooled) and by doing so may do sufficiently enough to cause damage in mortar joints. These areas should be monitored for any noticeable changes that may occur.

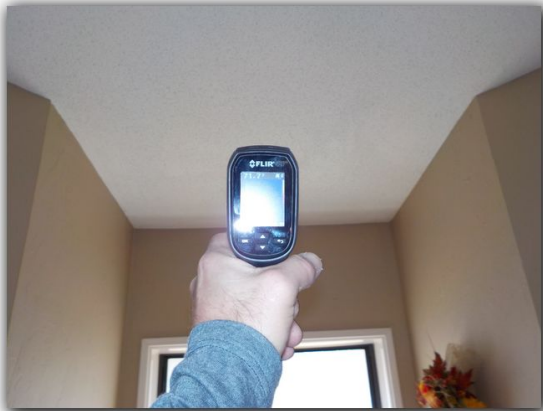
Master bathroom ceiling

☒ I observed an area of moisture staining in master bathroom over bathtub at time of inspection. Further evaluation found no obvious moisture with meter and/or thermal camera. Roof area finding areas of possible repairs with silicone having been used to seal possible seams in exterior siding. Possible that newer roof has remedied any past moisture entry concerns. Recommend monitoring noted area(s) for any noticeable changes.

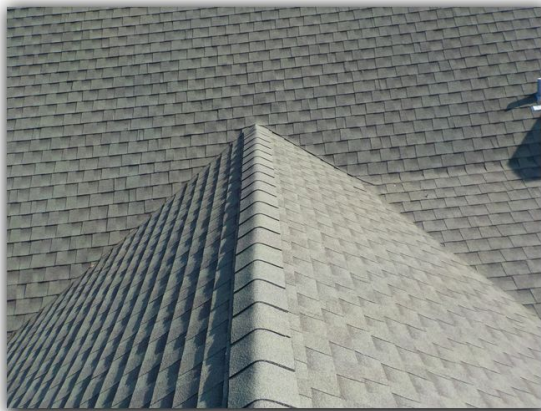
Kitchen area

☒ I observed an area of moisture staining found in kitchen area at time of inspection. Further investigation did not find positive evidence of moisture with meter and/or thermal camera during assessment. Roof evaluation found roof valley which may have allowing for possible water entry in the past. Most likely newer roof has remedied any moisture entry concerns. Recommend monitoring noted area for any noticeable changes.

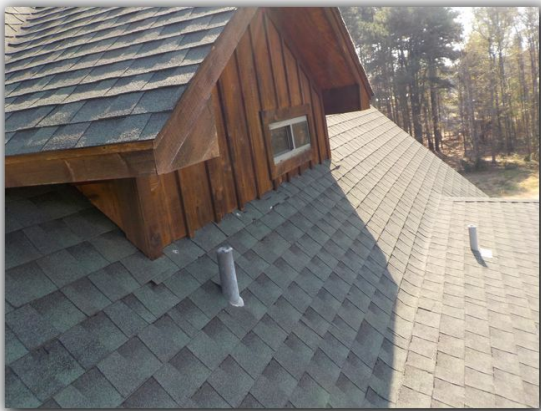
☒ I observed a minor area of moisture staining near breakfast nook / back door off kitchen area at time of inspection. No obvious moisture noted with moisture meter and / or thermal camera. Roof area above finding no obvious evidence of moisture entry concerns. Possible damaged plumbing vent stack over affected area. Appears newer roof remedied any past concerns. Recommend monitoring noted area for any noticeable changes.
