*Home inspection for*  
**Sample Report**  
Somewhere  
Longview TX 75601

## PROPERTY INSPECTION REPORT

**Concerning:** Somewhere, Longview, TX 75601  
(Address or Other Identification of Inspected Property)

**By:** David Smith, Lic #21666 01/23/2020  
(Name and License Number of Inspector) (Date)

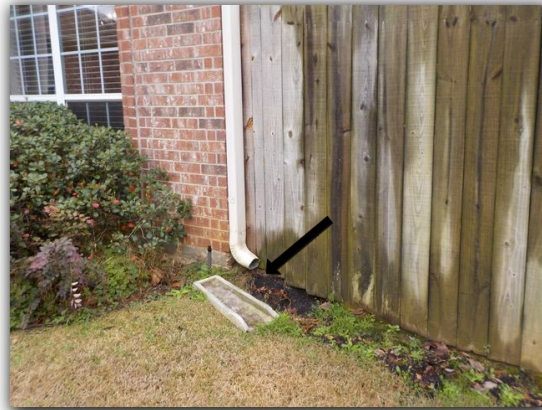
Gutters / down spouts found draining too close to the structure at the time of inspection. Water terminating near slab can create conducive conditions for slab undermining. Recommend termination point at least 16-24 inches from foundation. Recommend installing extensions onto gutters or adding splash blocks allowing water to move away from home efficiently.

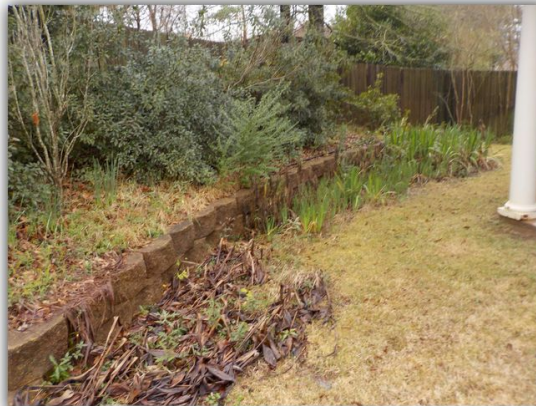
Retaining wall appears to be in good working condition at time of assessment.

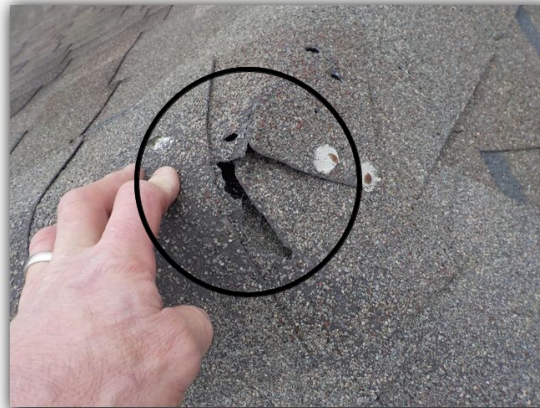
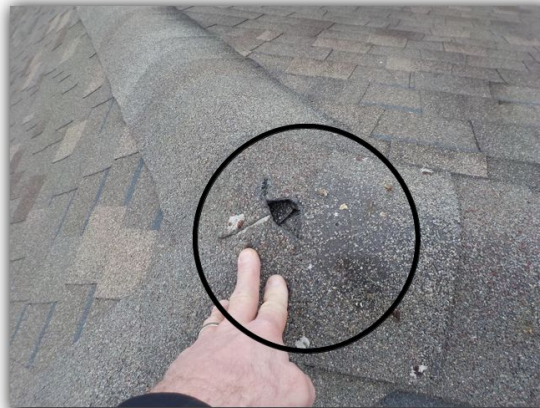
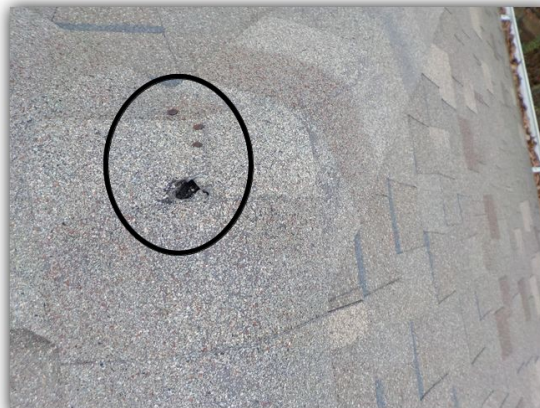
I observed various areas of mechanical damage to asphalt roof at time of inspection. Most of the damage noted on shingle ridge and hip caps. This could be due to excessive bending needed to cover ridge and hips. This can be more often seen in thicker shingles that will fail with such a significant bend. No moisture penetrations noted under areas with decking exposed through cracks/hole. Recommend evaluation by qualified roofer for areas of possible repair and/or replacement.

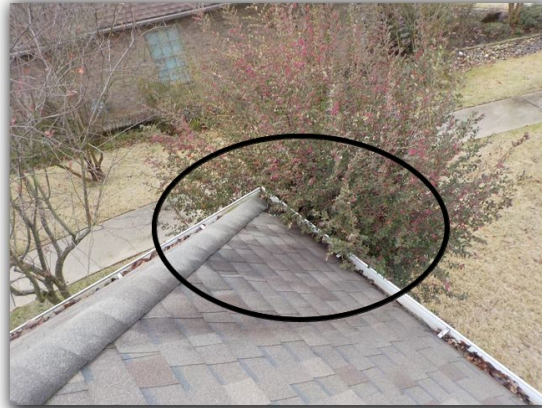
I observed where tree limbs are physically touching roof at time of inspection. Wind blown limbs can cause significant damage to shingles, fascia, trim, and soffits. Recommend trimming limbs away from home.

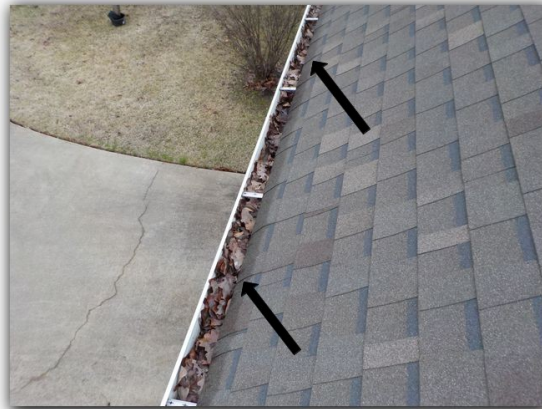
I observed where gutters filled with areas of debris at time of inspection. Debris in gutters are create conducive conditions for water penetrations and / or mechanical failure due to extreme water/debris weight or possible water leaking into living space / soffit areas. Recommend cleaning of gutters allowing water to flow / terminate from roof area as should.

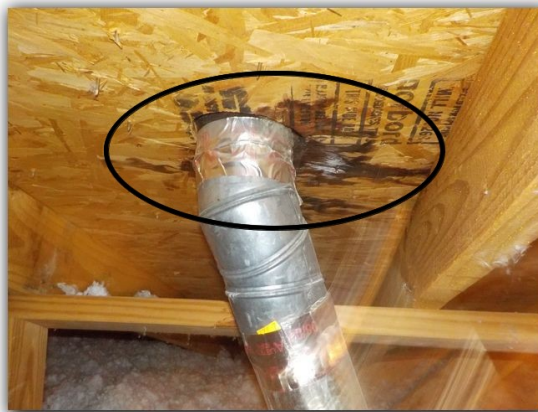
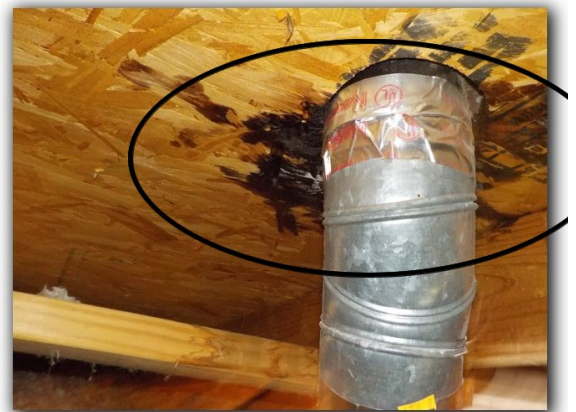
Over laundry room

I observed evidence of moisture staining in attic area over 2 separate areas at time of inspection. Noted areas found with moisture staining below noted areas. Areas called on in roofing section for possible repairs as well as a complete run through in ceilings section of report.

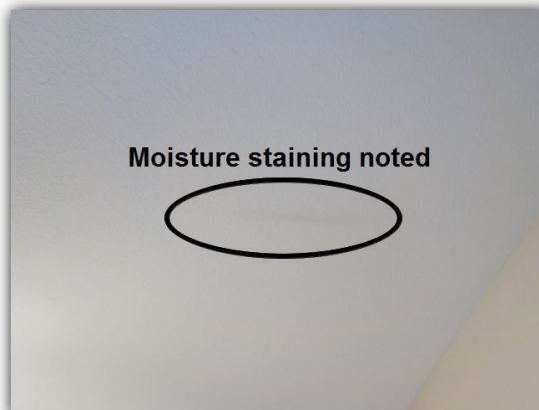
Left middle bedroom

***Moisture Staining noted in left middle bedroom***

I observed an area of moisture staining noted on ceiling in left middle bedroom at time of inspection. Further investigation found areas of moisture noted on roof decking below exhaust vent stack, evidence of moisture on insulation, and finally obvious evidence of moisture damage found on sheet rock ( ceiling ). No obvious moisture noted with meter and thermal camera. No obvious evidence of moisture noted with hands on. ( Note: rain times 2 days in area. Rain day of inspection allowing for wet conditions if water made entry into attic area. ) No obvious evidence of moisture entry points found on roof area near vent stack. Recommend evaluation from qualified roofer for possible repairs if needed. Noted deficiencies called out in roof section.

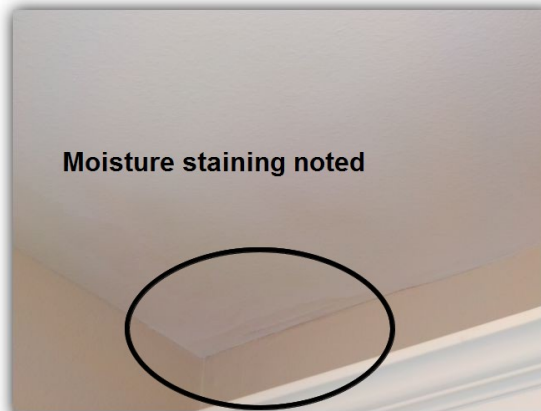
Laundry room

***Moisture Staining noted in laundry room and garage area***

I observed areas of moisture staining / moisture damage noted on inside corner of laundry room and inside corner of garage at time of inspection. Further investigation found obvious evidence of moisture noted with moisture meter and/or thermal camera. Moisture staining with hands on finding moisture on top plates, decking, and sheet rock. Appears roof top dryer vent cover leaking allowing water to make entry into interior walls. Recommend evaluation from qualified roofer for appropriate repairs. Noted deficiencies called out in roof section.

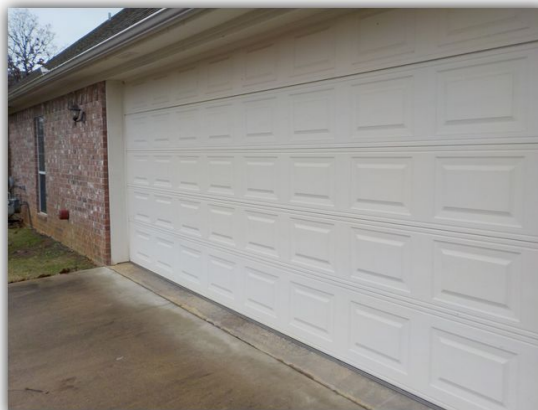
comments: Garage door working well at time of inspection

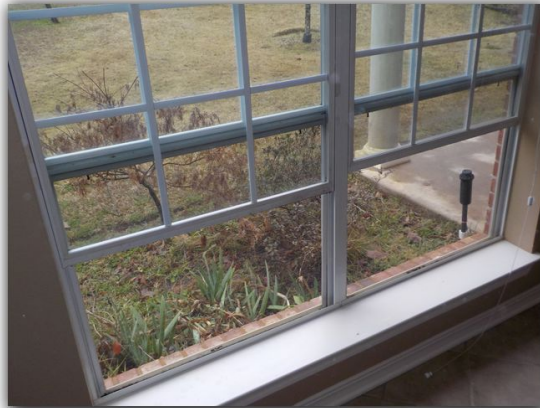
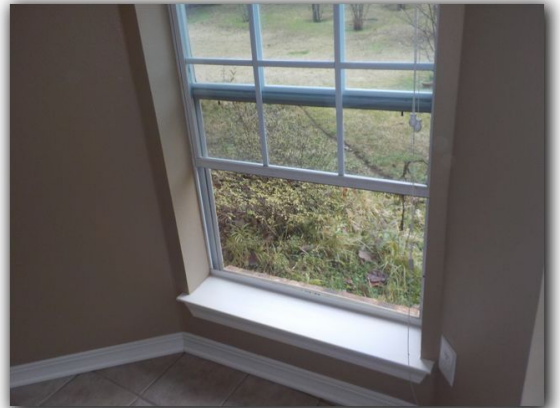
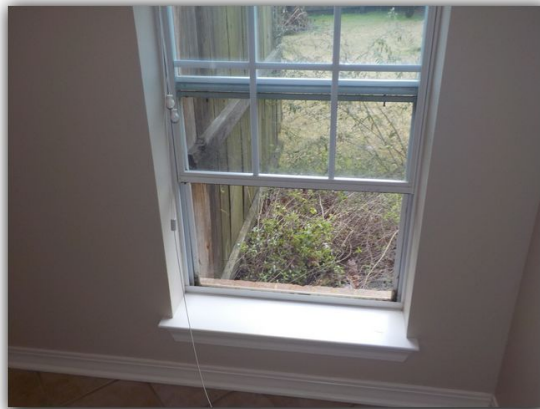
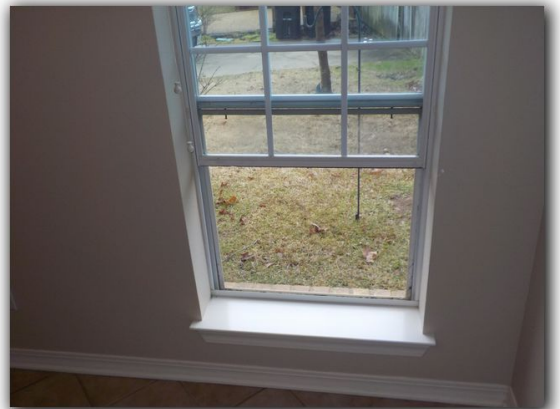
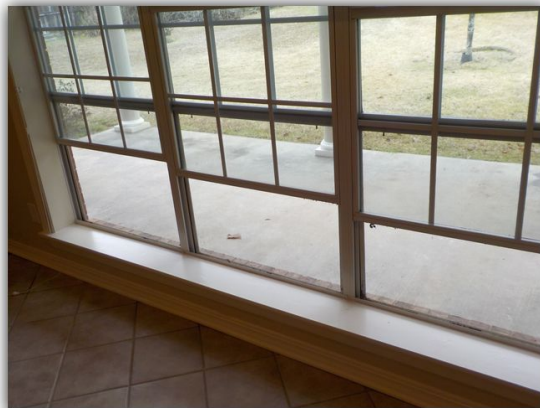
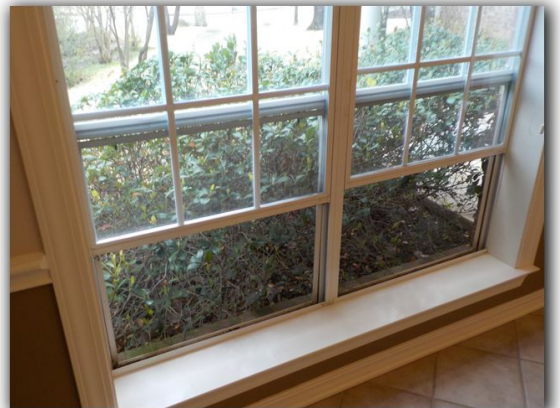
Views of windows

*Comments:* All windows double pane case windows and appeared to be in satisfactory condition at time of inspection

*Note:* window sills very dirty at time of assessment.

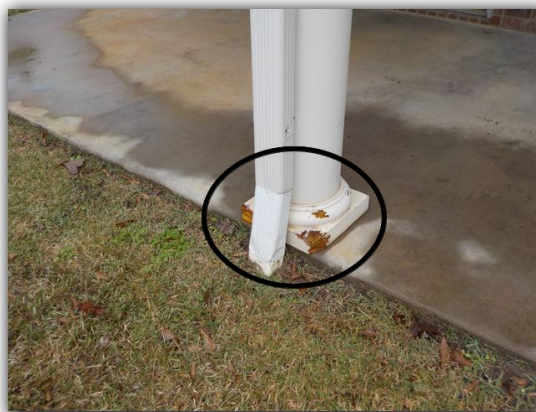
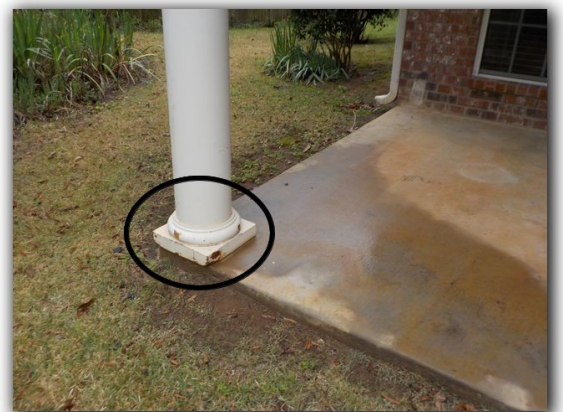
*Comments:* Front and back porch appeared to be in good working condition at time of inspection.

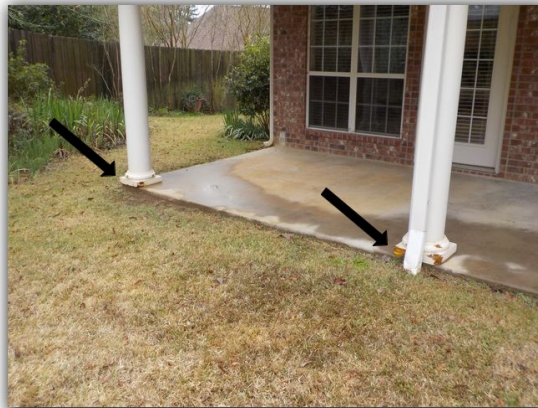
I observed areas with minor damage noted to porch post surround / trim at time of inspection. Damage appears to have been caused by possible weed eater. Trim has been painted which is added protection. Recommend evaluation for possible repairs if desired keeping areas painted for added protection.

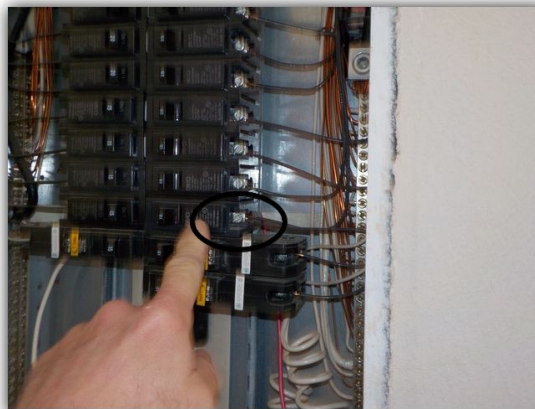
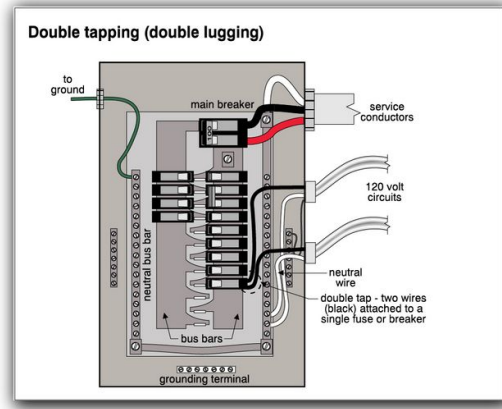
- Example / diagram of double lugged breaker

I observe a single double lugged / tapped breaker at time of inspection. Found where door bell transformer tapped into existing breaker inside home load center. A double tap is a defect because if the circuit breaker may not be designed to hold two conductors. The conductors could come loose at some point in the future allowing leads to possibly overheat, arcing, and possibly a fire. Recommend evaluation for possible repairs allowing load center to work as should.

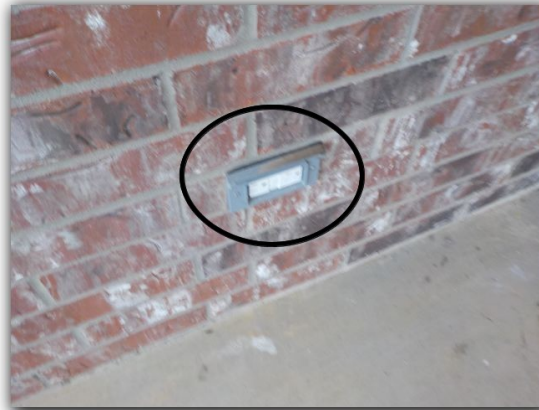
I observed where outdoor receptacle cover was missing / damaged at time of inspection. Recommend replacing with appropriate outdoor outlet cover that is watertight allowing for safe and normal use.

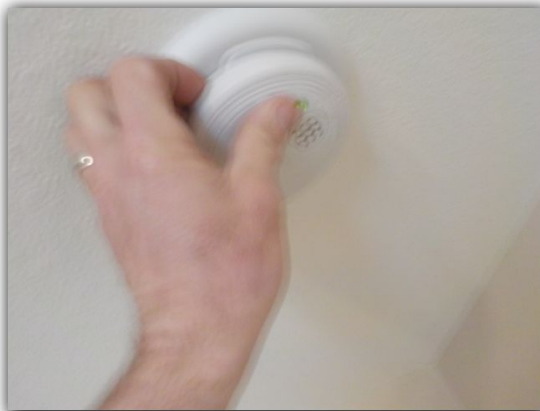
- Smoke alarms present and working properly at time of inspection

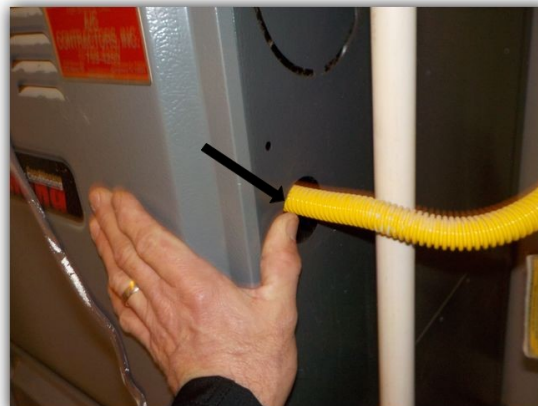
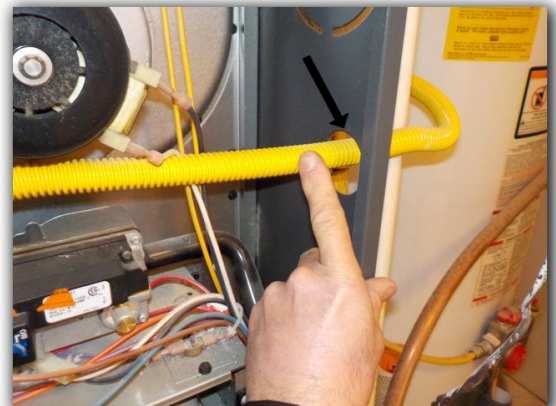
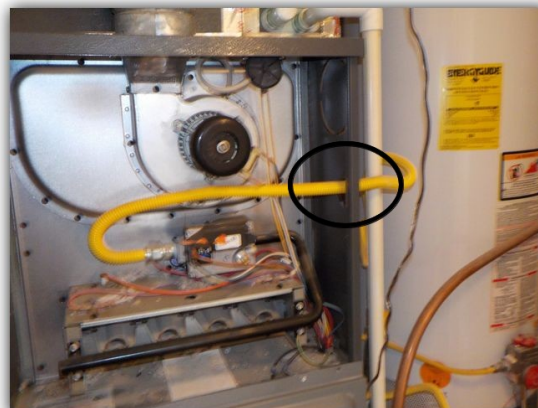
*Comments:* Heating unit in good working condition at time of inspection with deficiencies noted

The gas supply flex connector was observed to be passing through the heating unit cabinet at time of inspection. Under today's current mechanical installation standards, this is no longer an accepted practice. Recommendation is only rigid black gas pipe should be allowed to pass through the heating unit cabinet. Recommend evaluation for possible repairs per manufacturer

specifications.

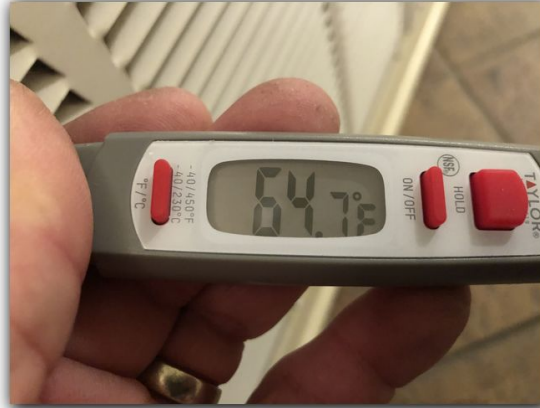
TEMPERATURE RISE BETWEEN SUPPLY AND RETURN AIR WAS: 36 degrees

Return / room air temperature

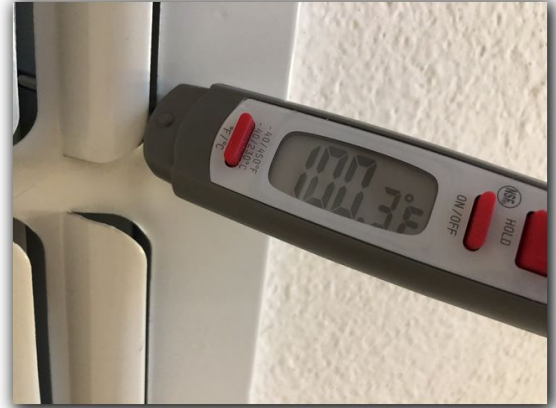
Supply air / differential

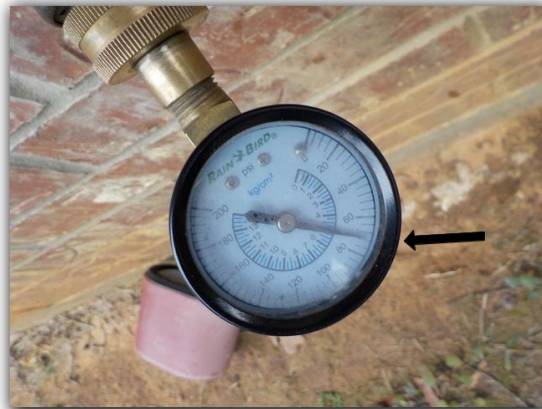
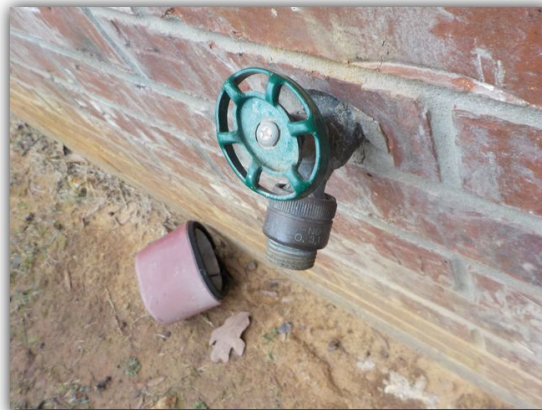
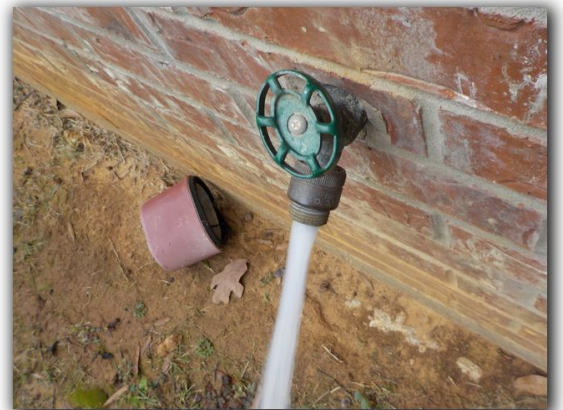
Comments: Approximately 70 psi noted on home at time of inspection. *Note: Water pressure between 40 and 80 psi (pounds per square inch) is considered normal in a residential setting. May consider possible pressure reducer on home if elevated psi found.*

Back flow preventer in place at time of inspection.

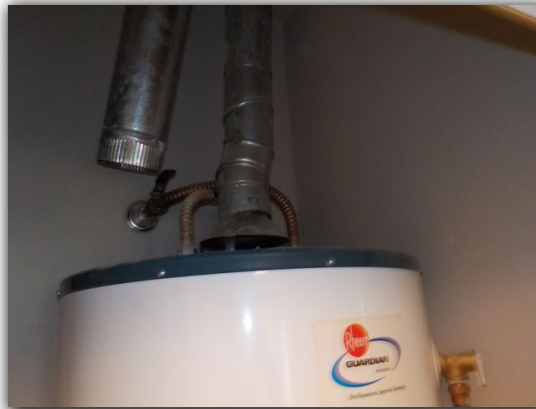
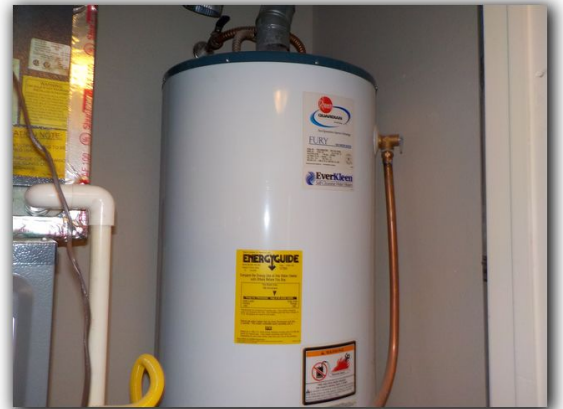
View of water heater

*Comments:* Performing as it should at time of inspection

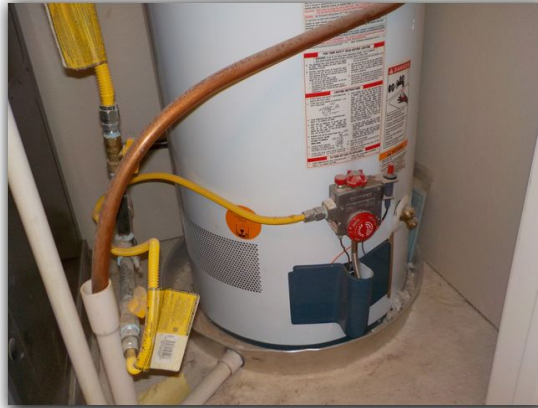
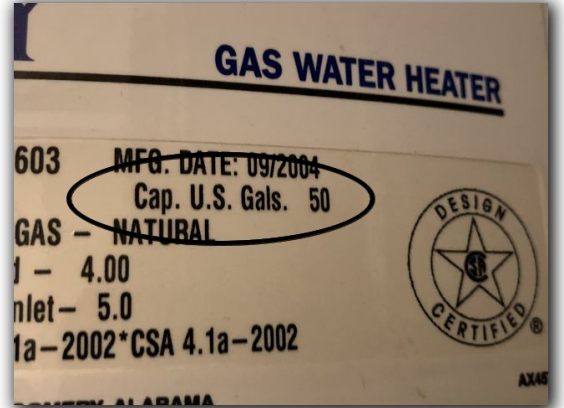
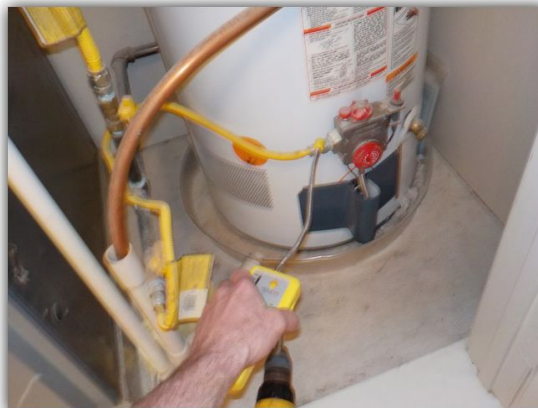
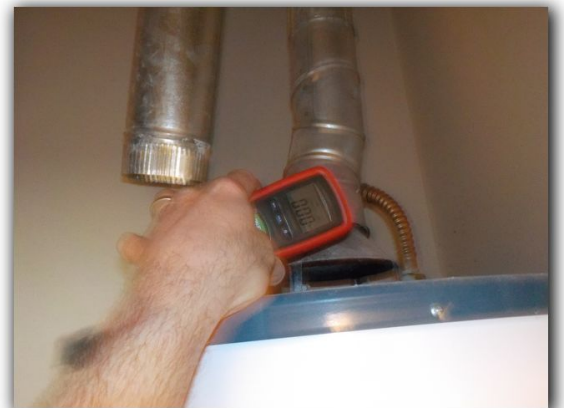
0 PPM found with CO and gas meters

Water temperatures assessed

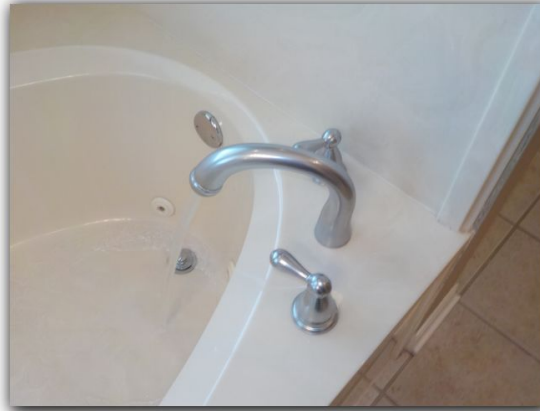
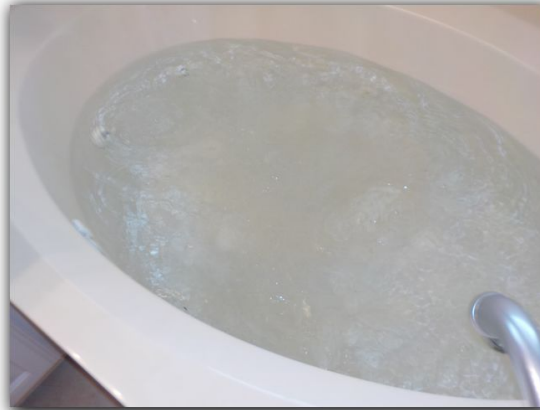
Access panel in inaccessible / missing at time of inspection. This is commonly seen with the cosmetic appeal more apparent than ease for possible repairs to unit if ever needed. Mind set is that it would be better to remove noted surround(s) on spa tub for access if needed than having a possible unattractive opening under / near tub. Recommend evaluation for repairs if desired and/or monitor area in case ever needed.

Jets working as should.

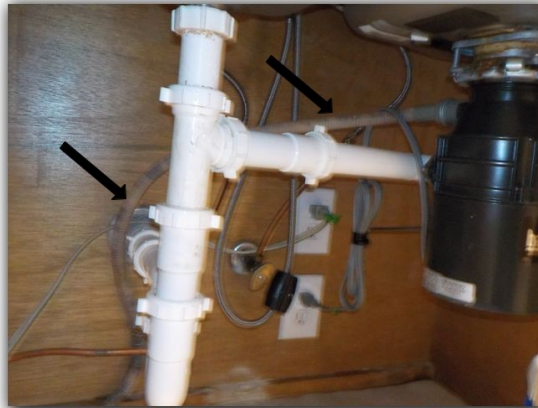
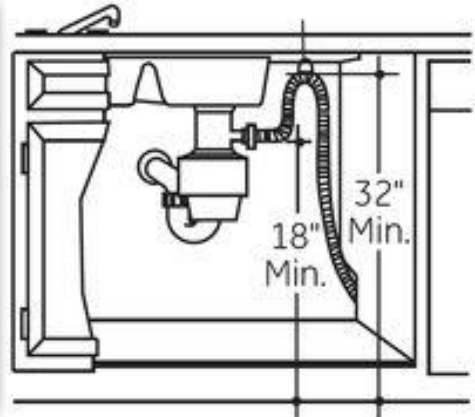
I observed where dishwasher drain has been installed incorrectly. As it is now, wastewater from sink can be allowed to siphon into dishwasher. Recommend placing a high loop or air gap to prevent potential back flow contamination of the dishwasher.

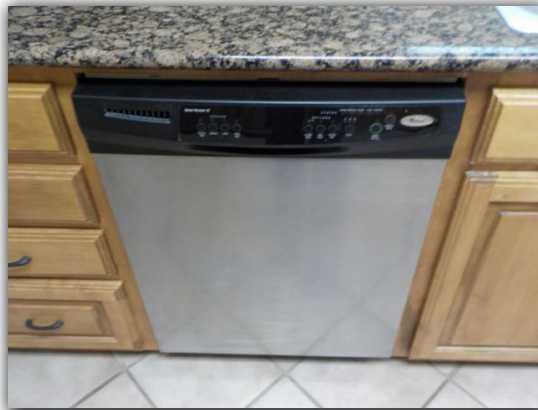
Views of dishwasher before and after running unit.

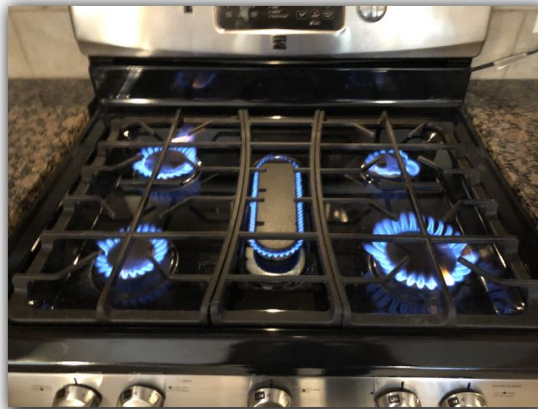
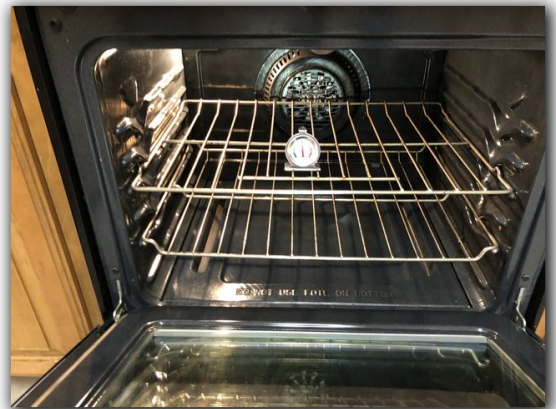
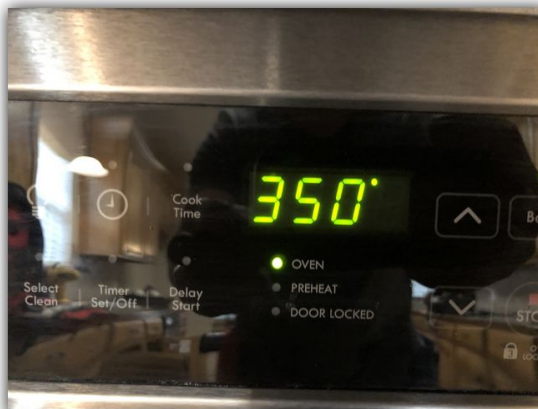
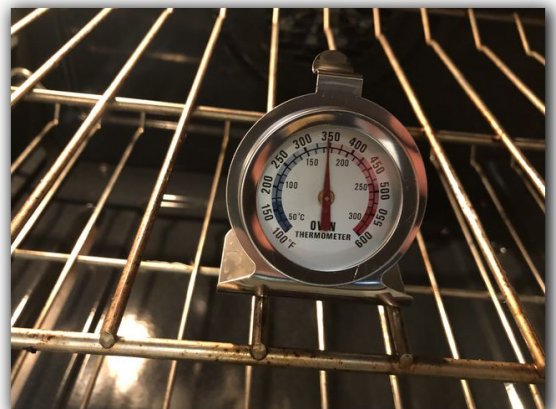
- Absence of anti-tilt device at time of inspection.
  - *Equipment and appliances should be installed as required by the terms of their approval, in accordance with the conditions of the listing, the manufacturer's installation instructions and this code.*

Oven assessed at 350 at time of inspection.

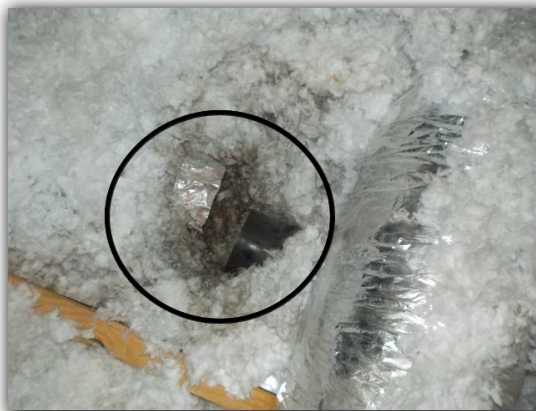
I observed where master bathroom exhaust fan / duct has separated at time of inspection. Noted area allowing warm moist air to blow into attic area allowing conducive conditions for possible moisture buildup, staining, possible mildew, etc. Recommend evaluation for repairs allowing exhaust vent to terminate outside as should.

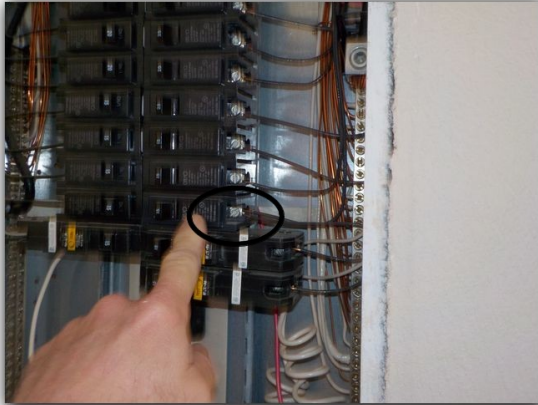
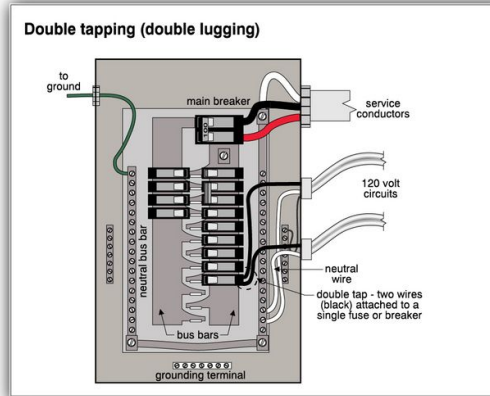
- Example / diagram of double lugged breaker

☑ I observe a single double lugged / tapped breaker at time of inspection. Found where door bell transformer tapped into existing breaker inside home load center. A double tap is a defect because if the circuit breaker may not be designed to hold two conductors. The conductors could come loose at some point in the future allowing leads to possibly overheat, arcing, and possibly a fire. Recommend evaluation for possible repairs allowing load center to work as should.

*Note: Some manufacturers that make circuit breakers that are designed to hold two conductors are Square D and Cutler Hammer... but not all of their circuit breakers can be double tapped. Unable to verify whether found breakers appropriate for double lugged.*

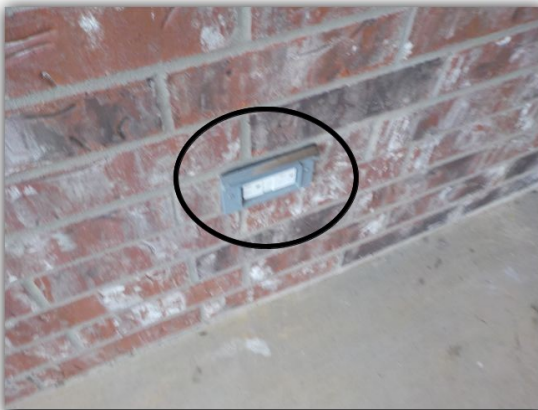
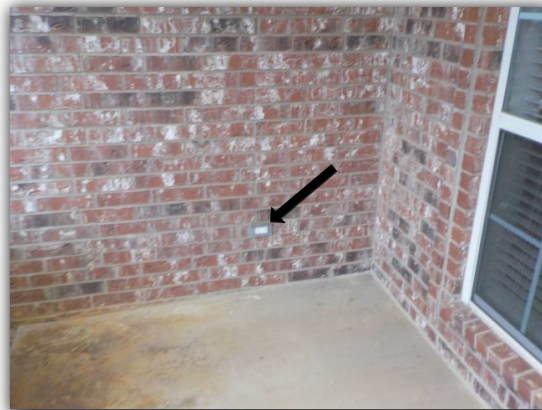
☑ I observed where outdoor receptacle cover was missing / damaged at time of inspection. Recommend replacing with appropriate outdoor outlet cover that is watertight allowing for safe and normal use.

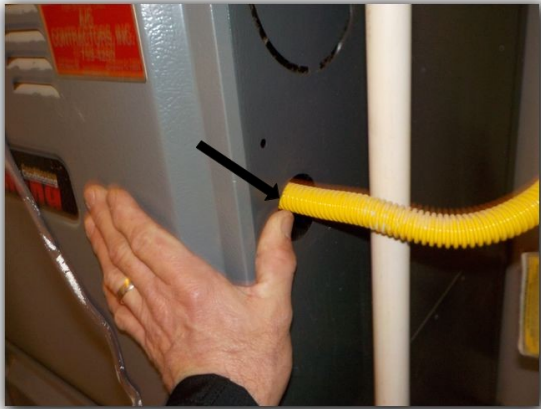
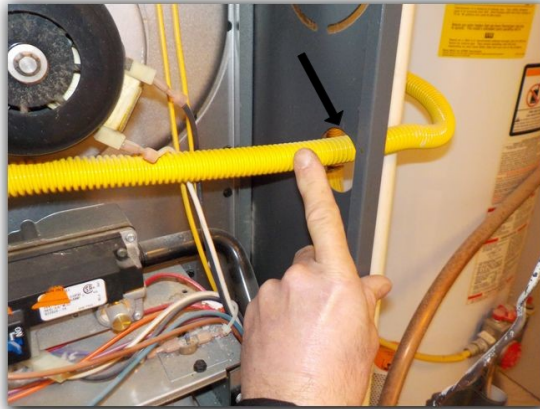
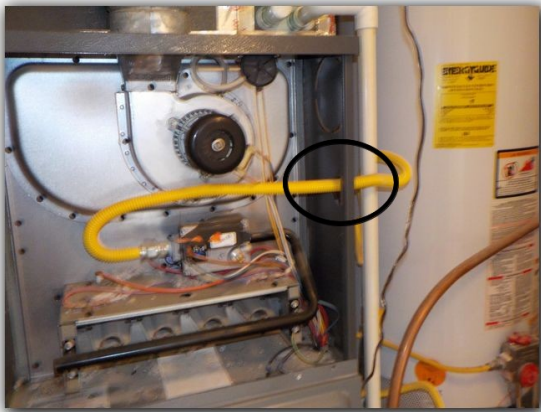
☑ The gas supply flex connector was observed to be passing through the heating unit cabinet at time of inspection. Under today's current mechanical installation standards, this is no longer an accepted practice. Recommendation is only rigid black gas pipe should be allowed to pass through the heating unit cabinet. Recommend evaluation for possible repairs per manufacturer specifications.

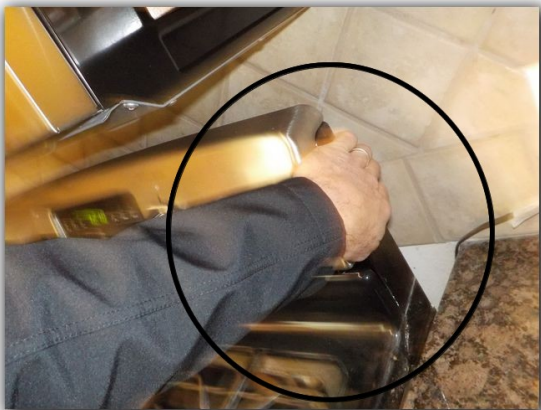
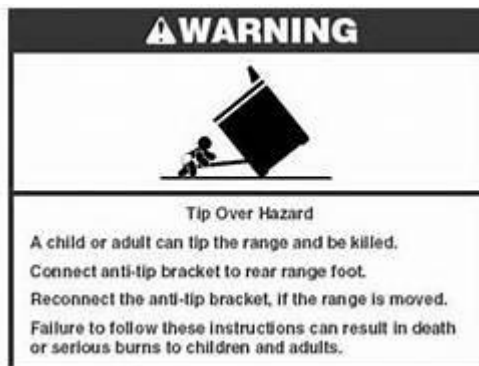
- Absence of anti-tilt device at time of inspection.
- *Equipment and appliances should be installed as required by the terms of their approval, in accordance with the conditions of the listing, the manufacturer's installation instructions and this code.*

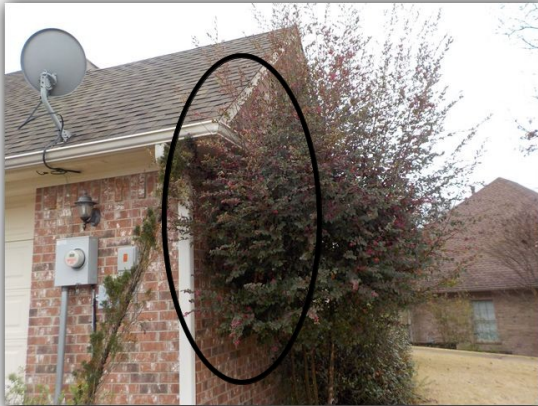
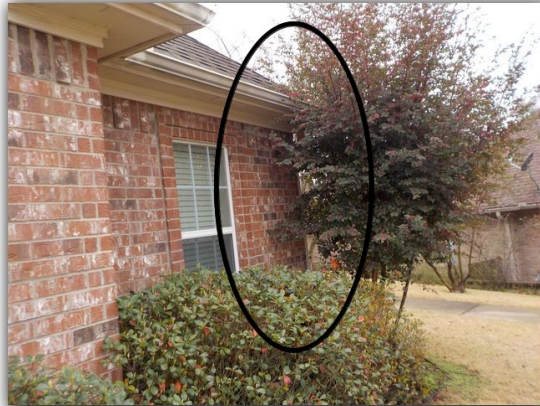
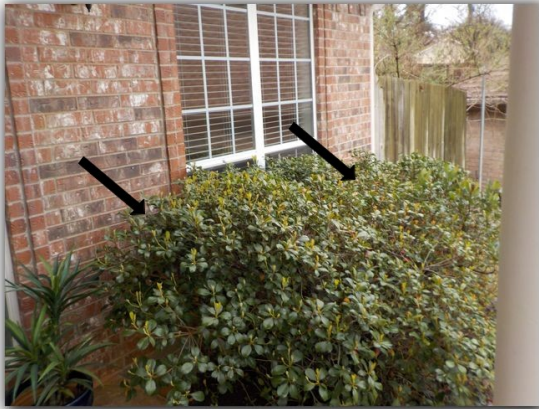
I observed where foliage found to be too close to the structure at time of inspection. It is recommended that bushes and vegetation should be at least 12 inches from wall contact. Recommend cutting or trimming noted vegetation allowing for appropriate barrier.

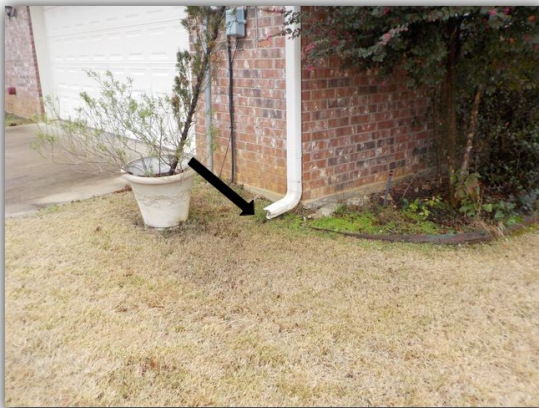
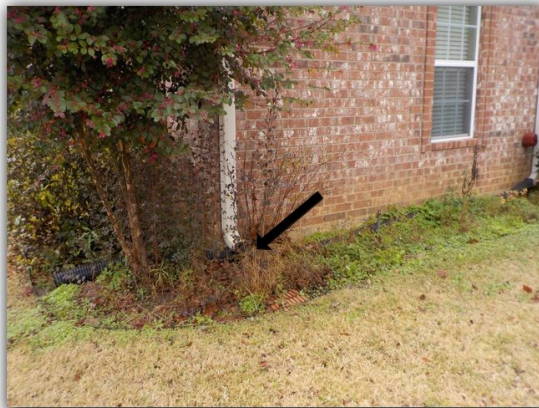
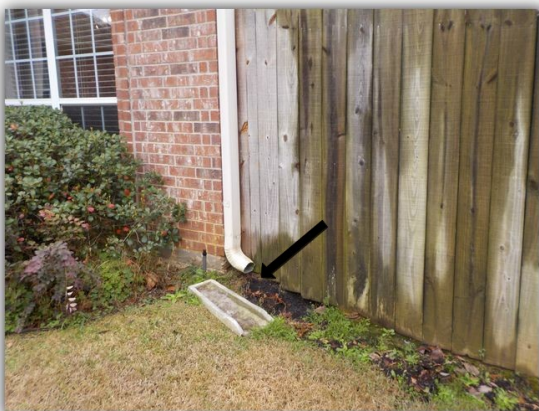
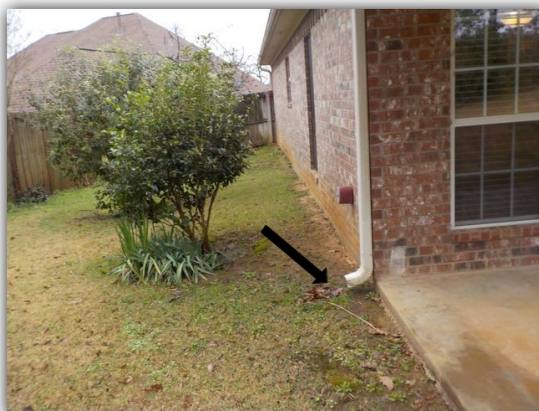
Gutters / down spouts found draining too close to the structure at the time of inspection. Water terminating near slab can create conducive conditions for slab undermining. Recommend termination point at least 16-24 inches from foundation. Recommend installing extensions onto gutters or adding splash blocks allowing water to move away from home efficiently.

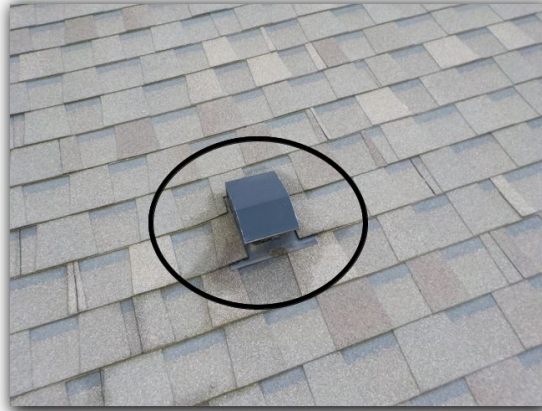
I observed evidence of moisture staining in laundry room area and inside corner of garage below noted dryer vent cover at time of inspection. Hands on in attic finding evidence of moisture entry below dryer vent with obvious evidence of entry for some time. No obvious evidence of deficiencies noted to dryer vent cover? Possible north facing cover allowing for wind blown rain to make entry under the right conditions. Please see ceiling section for further information / evidence of moisture entry. Recommend evaluation for repairs allowing home to work as efficient as possible.

I observed areas of moisture staining / moisture damage noted on inside corner of laundry room and inside corner of garage at time of inspection. Further investigation found obvious evidence of moisture noted with moisture meter and/or thermal camera. Moisture staining with hands on finding moisture on top plates, decking, and sheet rock. Appears roof top dryer vent cover leaking allowing water to make entry into interior walls. Recommend evaluation from qualified roofer for appropriate repairs. Noted deficiencies called out in roof section.

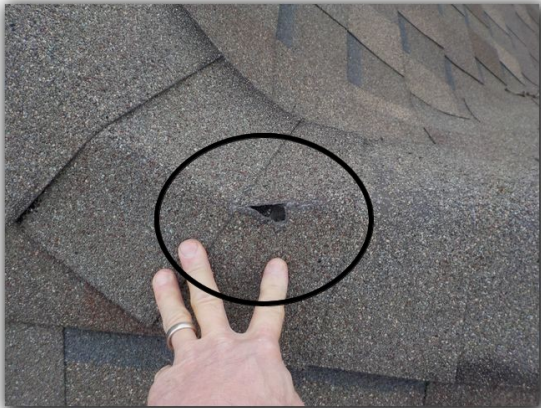
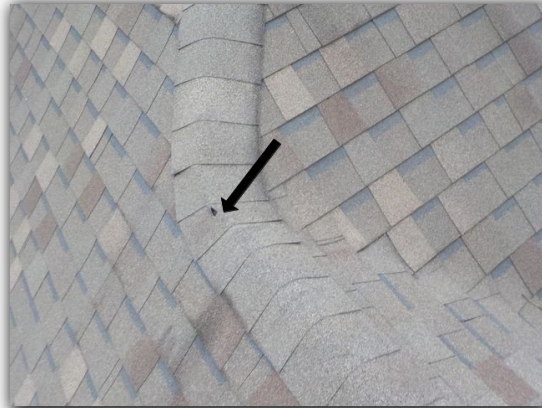
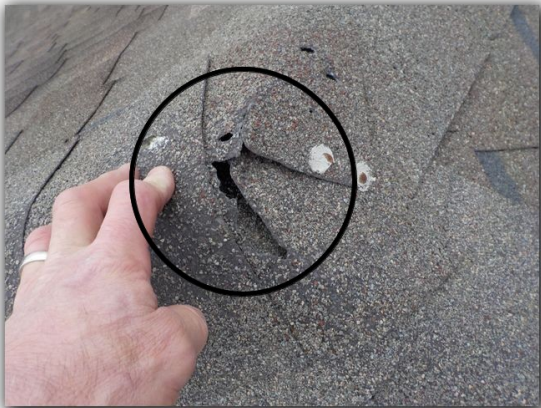
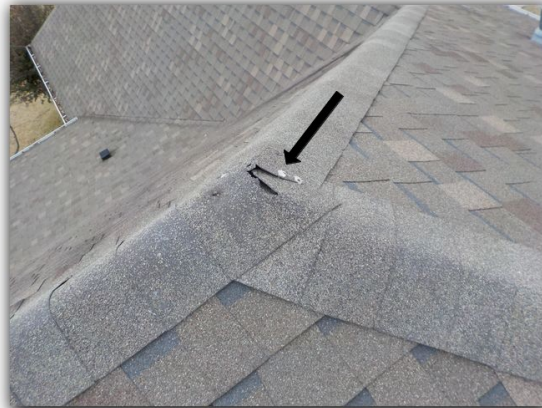
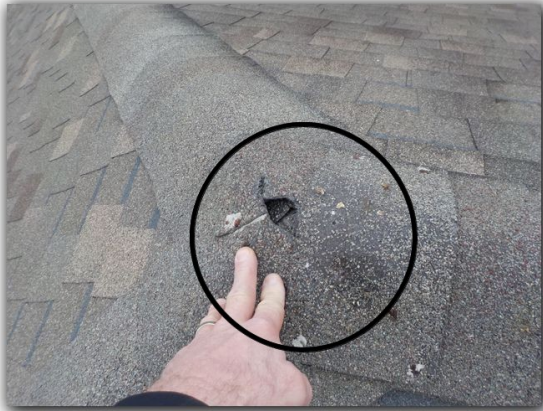
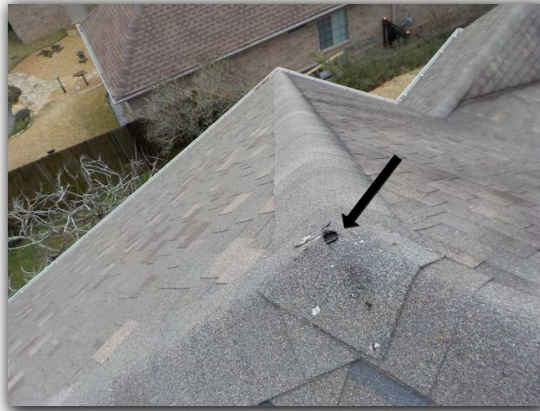
I observed various areas of mechanical damage to asphalt roof at time of inspection. Most of the damage noted on shingle ridge and hip caps. This could be due to excessive bending needed to cover ridge and hips. This can be more often seen in thicker shingles that will fail with such a significant bend. No moisture penetrations noted under areas with decking exposed through cracks/hole. Recommend evaluation by qualified roofer for areas of possible repair and/or replacement.

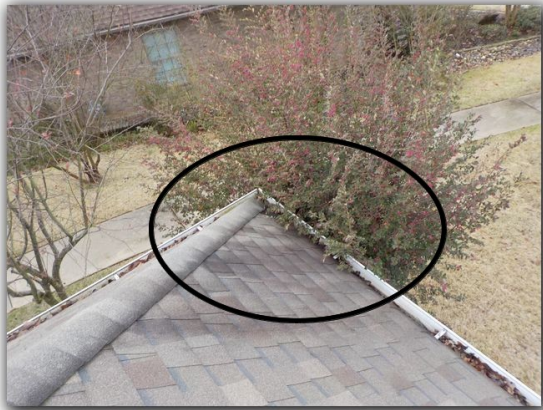
I observed where tree limbs are physically touching roof at time of inspection. Wind blown limbs can cause significant damage to shingles, fascia, trim, and soffits. Recommend trimming limbs away from home.

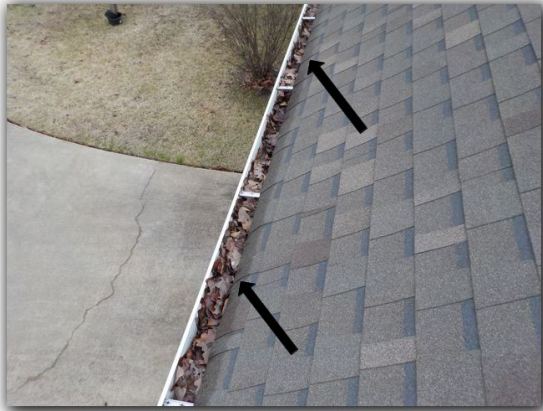
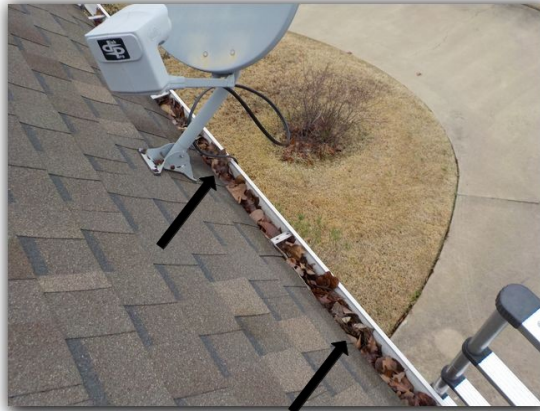
I observed where gutters filled with areas of debris at time of inspection. Debris in gutters are create conducive conditions for water penetrations and / or mechanical failure due to extreme water/debris weight or possible water leaking into living space / soffit areas. Recommend cleaning of gutters allowing water to flow / terminate from roof area as should.

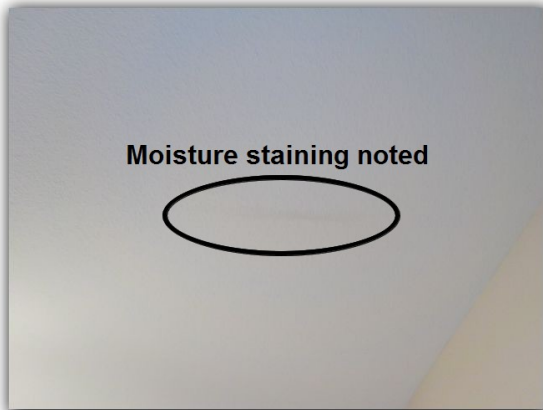
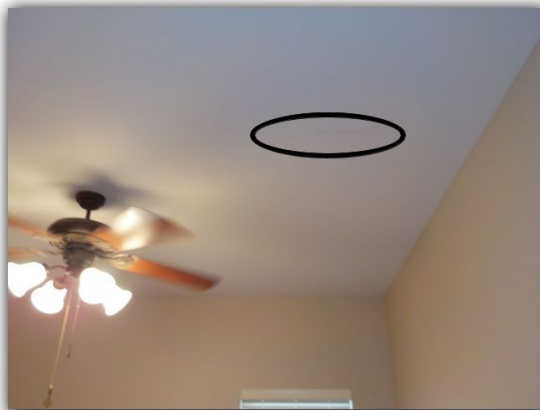
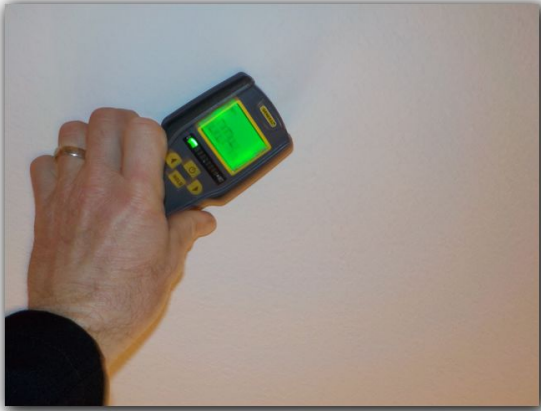
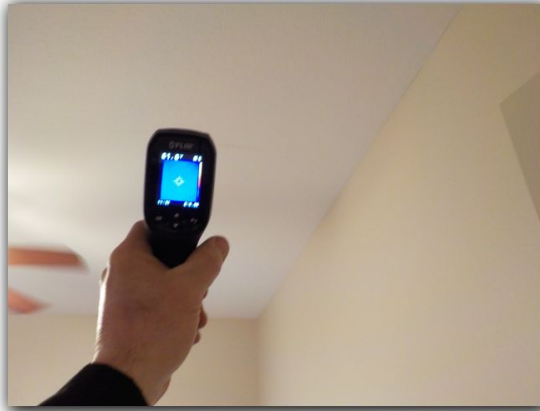
Left middle bedroom

I observed an area of moisture staining noted on ceiling in left middle bedroom at time of inspection. Further investigation found areas of moisture noted on roof decking below exhaust vent stack, evidence of moisture on insulation, and finally obvious evidence of moisture damage found on sheet rock ( ceiling ). No obvious moisture noted with meter and thermal camera. No obvious evidence of moisture noted with hands on. ( Note: rain times 2 days in area. Rain day of inspection allowing for wet conditions if water made entry into attic area. ) No obvious evidence of moisture entry points found on roof area near vent stack. Recommend evaluation from qualified roofer for possible repairs if needed. Noted deficiencies called out in roof section.

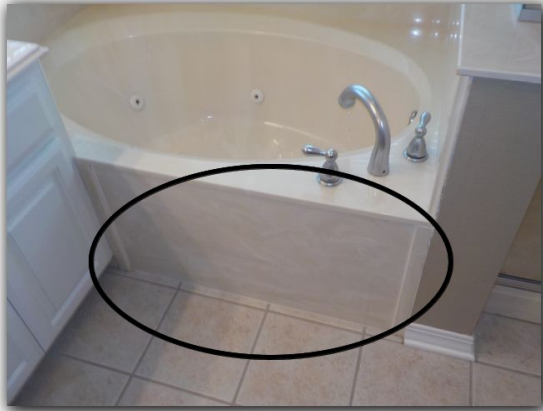
Access panel in inaccessible / missing at time of inspection. This is commonly seen with the cosmetic appeal more apparent than ease for possible repairs to unit if ever needed. Mind set is that it would be better to remove noted surround(s) on spa tub for access if needed than having a possible unattractive opening under / near tub. Recommend evaluation for repairs if desired and/or monitor area in case ever needed.
