*Home inspection for
Sample Report
Somewhere
Longview TX 75601*

David Smith Inspections

PROPERTY INSPECTION REPORT

Concerning: Somewhere, Longview, TX 75601
(Address or Other Identification of Inspected Property)

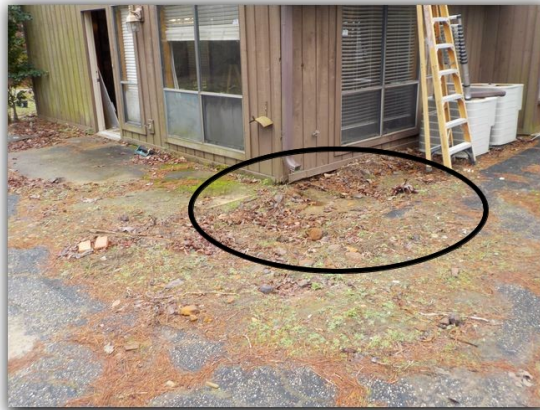
Possible improper slope of grade along the homes foundation; these areas should be monitored and if water is draining or pooling along the homes foundation then corrective action will be needed.

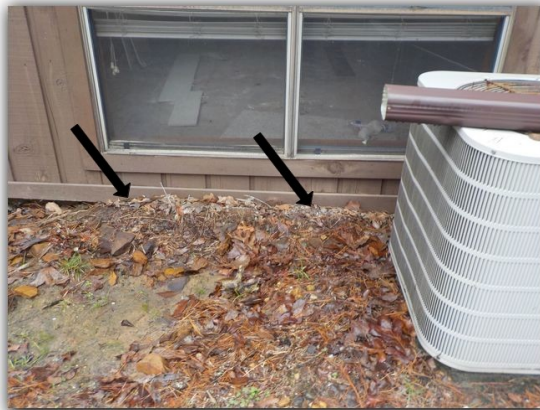
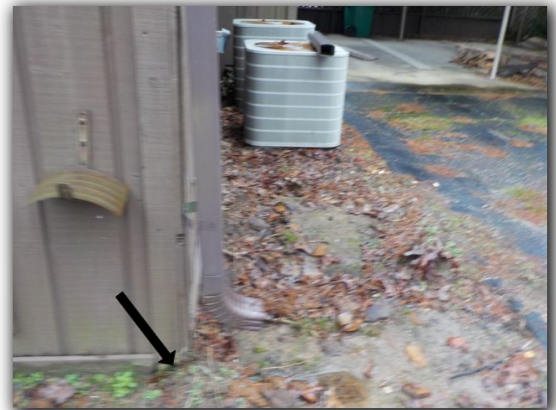
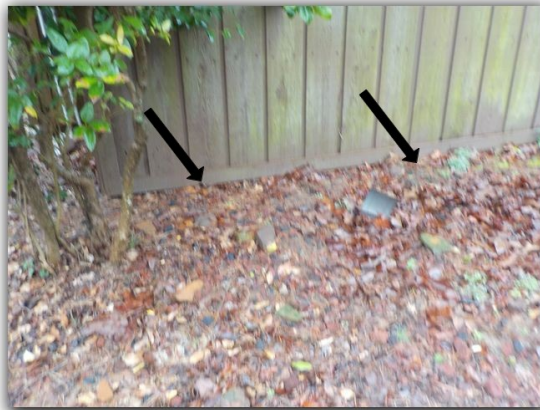
Soil levels against the exterior grade are considered to be too high at the time of inspection. When soil levels are high against the face of the foundation it promotes water penetration of the structure and insect infestation. This item should be corrected so there is some exposure of the foundation face. It is generally accepted that a brick veneer house should have about 4 inches of

clearance. Wood siding houses should have approximately 6 inches of clearance.

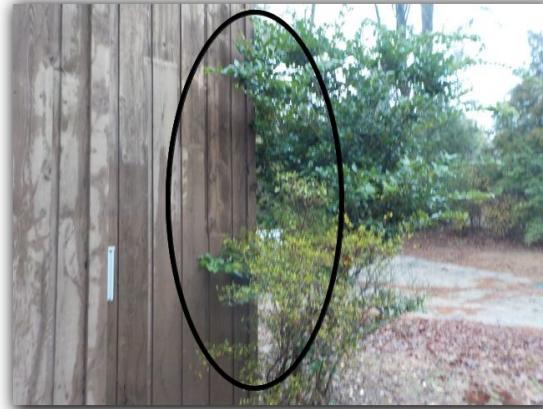
I observed where foliage found to be too close to the structure at time of inspection. It is recommended that bushes and vegetation should be at least 12 inches from wall contact. Recommend cutting or trimming noted vegetation allowing for appropriate barrier.

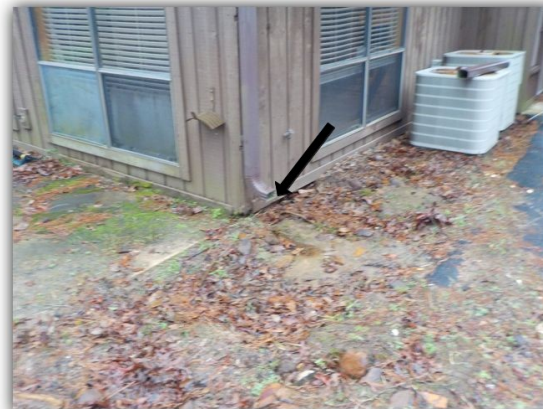
Gutters / down spouts found draining too close to the structure at the time of inspection. Water terminating near slab can create conducive conditions for slab undermining. Recommend termination point at least 16-24 inches from foundation. Recommend installing extensions onto gutters or adding splash blocks allowing water to move away from home efficiently.

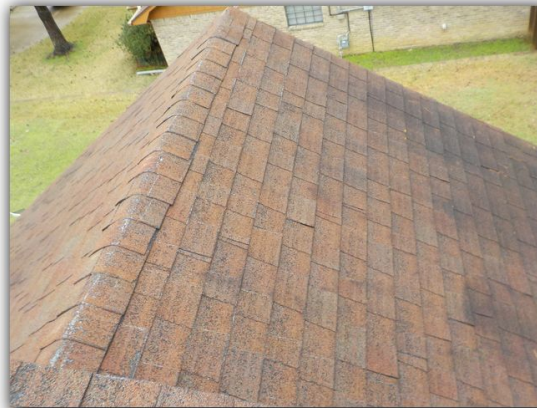
I observed areas of mechanical wear along with possible hail damage noted on roof area at time of inspection. Mechanical or normal wear is considered to be part of the normal aging process and may all depend on quality of shingle(s) or climate zone of home. Rate of gravel loss may appear to be excessive for age and quality of roof. Recommend evaluation from qualified roofer to verify whether noted gravel loss is premature and/or normal in nature.

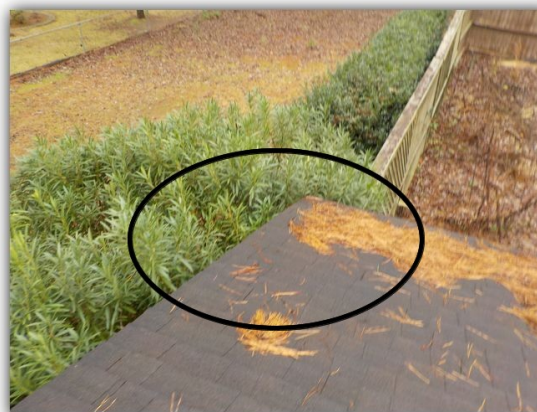
I observed where tree limbs are physically touching roof at time of inspection. Wind blown limbs can cause significant damage to shingles, fascia, trim, and soffits. Recommend trimming

limbs away from home.

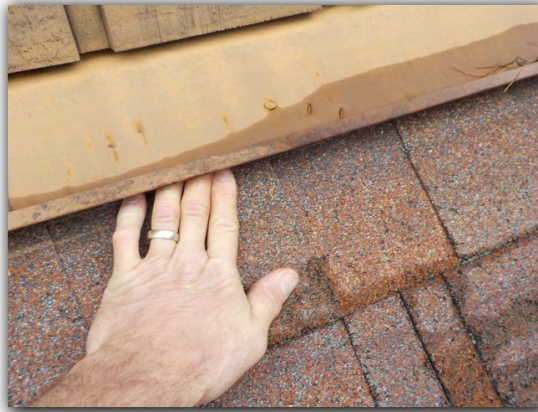
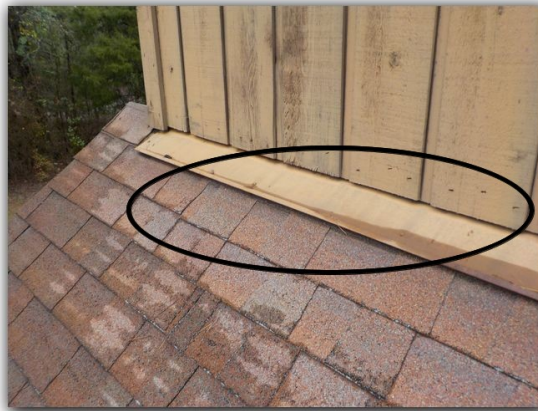
I observed areas on roof with exposed nails in flashing at time of inspection. Over time, nails have a tendency to work themselves out creating possible conducive conditions for water penetrations. Recommend evaluation for repairs placing some fashion of water proofing material over noted nails (silicone) allowing home to work as efficiently as possible.

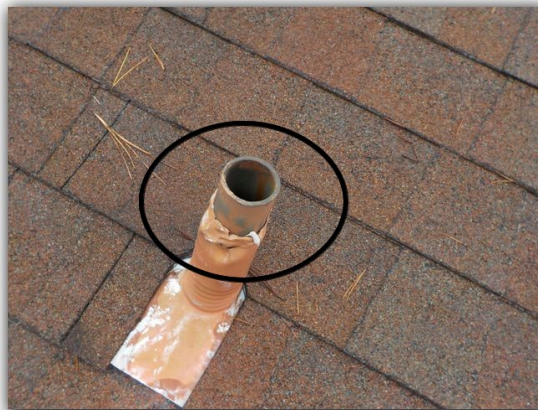
I observed where the lead jack flashing that covers plumbing vent stack(s) was observed to be improperly installed at one or more of the roof level plumbing vent pipes. The lead flashing should run full length of the vent pipe and turn down into the top of the vent pipe to help prevent water intrusion at this point

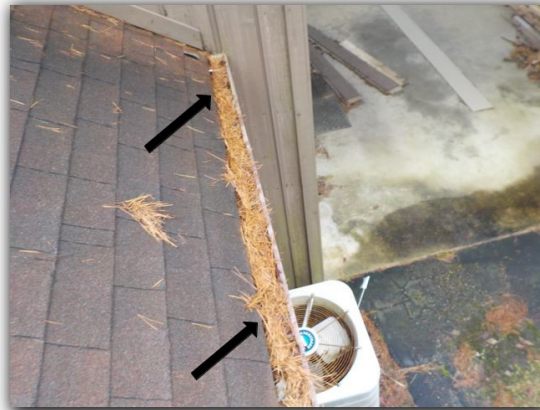
I observed where gutters filled with areas of debris at time of inspection. Debris in gutters are create conducive conditions for water penetrations and / or mechanical failure due to extreme water/debris weight or possible water leaking into living space / soffit areas. Recommend cleaning of gutters allowing water to flow / terminate from roof area as should.

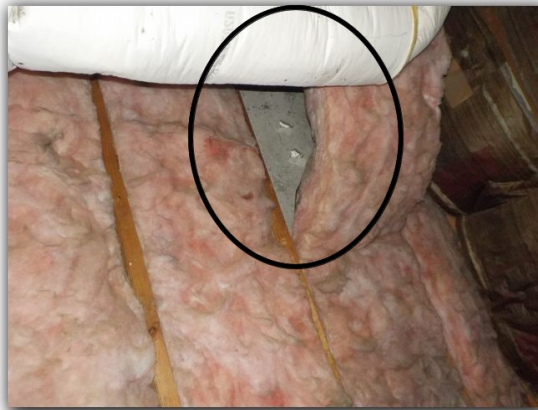
I observed various areas in attic where it appears that vertical rolled batting insulation has fallen away from interior walls. Typically rolled batting insulation stapled to stud walls in attic area adjacent to living areas in home. When rolled batting falls away it exposes home / exposed sheet rock to hot / cold attic. Recommend evaluation for replacing / repairing missing insulation in attic allowing home to work as efficiently as possible.

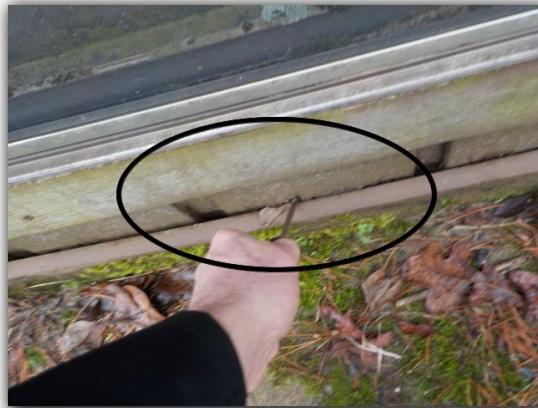
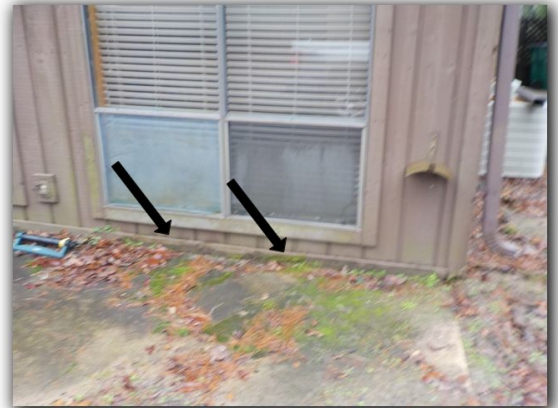
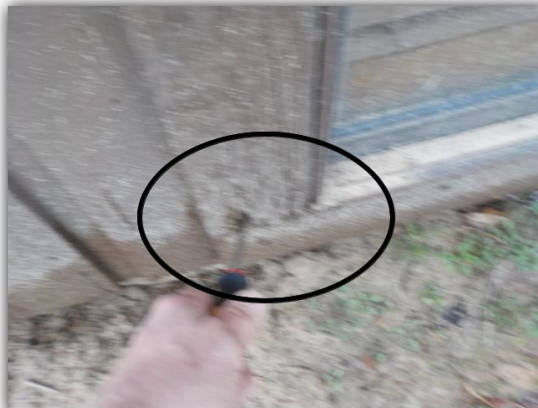
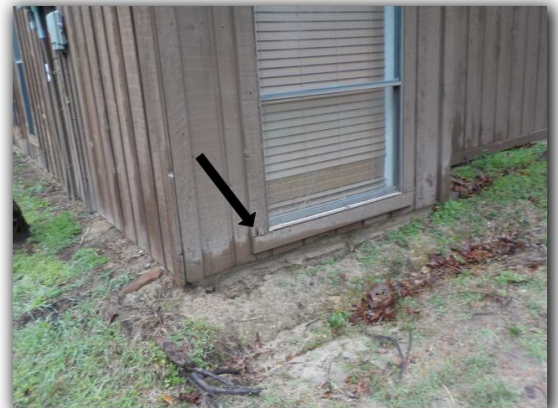
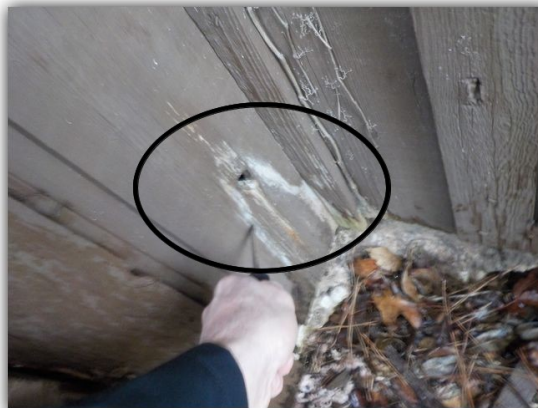
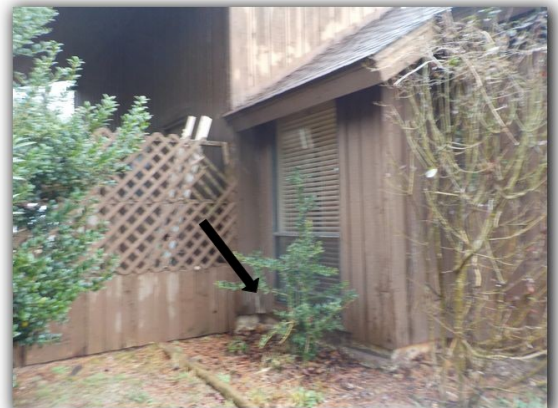
I observed various areas of very minor moisture damage noted on areas of exterior siding at

time of inspection. Noted areas appear to be isolated to where water is allowed to splash onto home / siding. Area painted which will add protection. Recommend evaluation for possible repairs if desired, monitor for any more noticeable issues, and possibly paint / keep painted for additional protection.

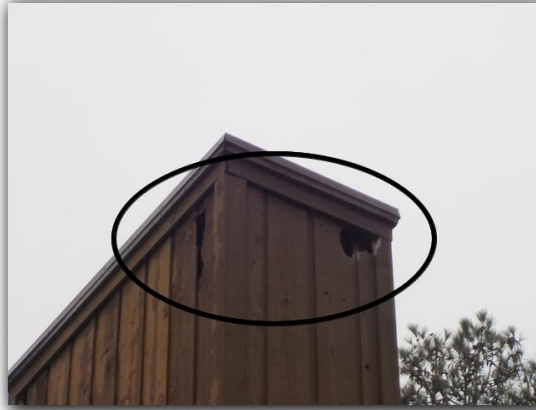
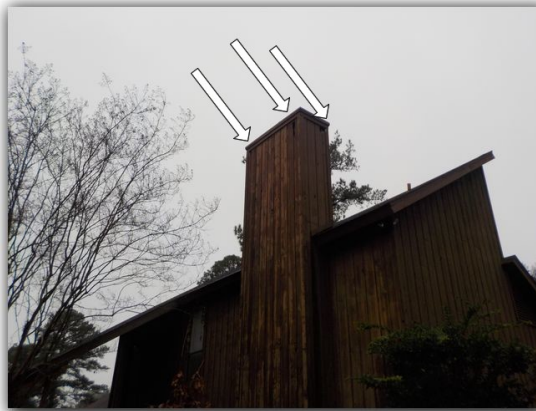
I observed obvious areas of damage noted to wood exterior chimney surround at time of inspection. Noted area conducive for possible unwanted animals and birds to make entry. Area noted also conducive for water entry under the right situation. No obvious evidence of moisture noted around veneer fireplace surround below affected area. Recommend evaluation for necessary repairs.

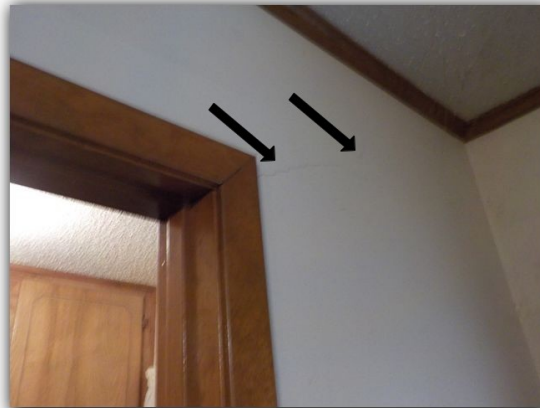
I observed minor seam crack(s) in the interior sheet rock walls at time of inspection. Areas noted appear to have been cause from settlement of the homes foundation and/or thermal expansion. Recommend monitoring noted areas for any noticeable changes

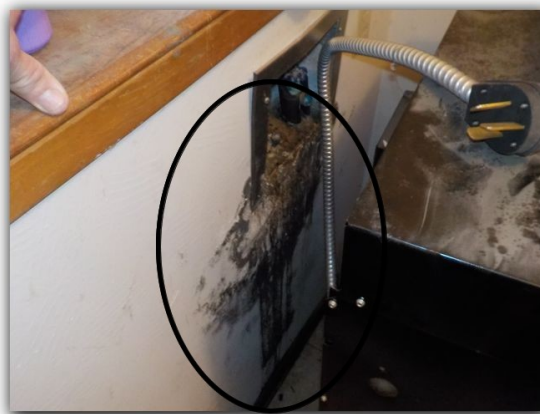
I observed an area near washing machine connections with active leak noted on water fixtures at time of inspection. Appears that wall drain box filled with debris and not allowing for drainage as should. Noted area presenting with what appears to be possible black mold. This is common and found with extended exposures to water along with being in cooler and darker areas. Recommend evaluation for repairs to damaged wall and washing machine wall drain box.

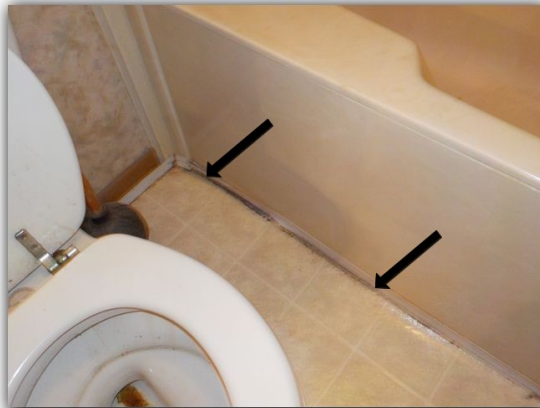
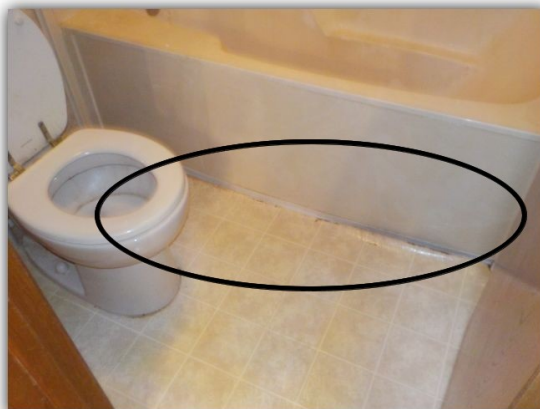
I observed possible areas with damaged linoleum flooring near upstairs master bathroom / tub at time of inspection. No obvious evidence of moisture near affected area when assessed with

moisture meter. No obvious evidence of moisture staining / damage noted in living area below affected area. Recommend evaluation for possible repairs allowing flooring to work as efficiently as possible.

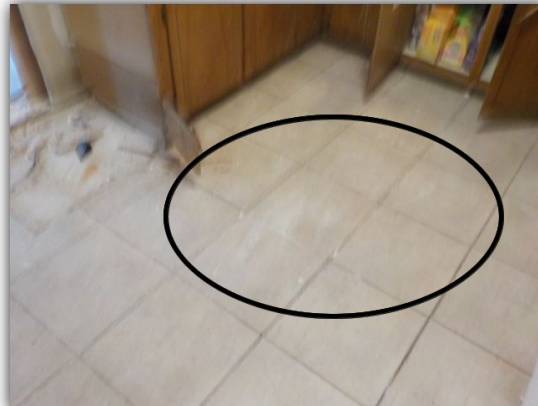
I observed 2 areas in home near kitchen and foyer / hallway where there appears to be minor low spot in concrete at time of inspection. Does not appear to be structural in nature with no obvious residual damage noted to interior walls, ceilings, and / or floor tile. Slabs are not perfectly flat when poured with possible areas of depressions found. Any certain issues with cracked, heaved, and/or settled slab would create obvious damage to noted tile over affected areas with possible differential heights. Areas difficult to observe but inspector just making note for possible reference.

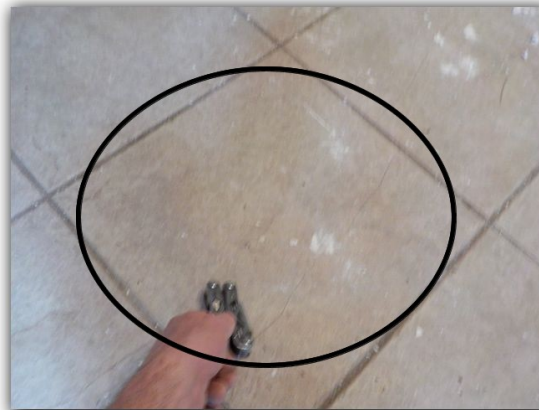
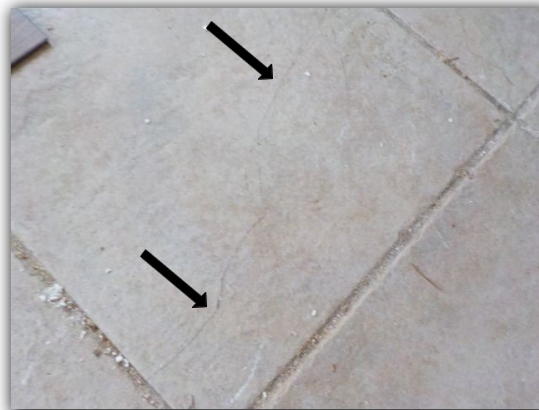
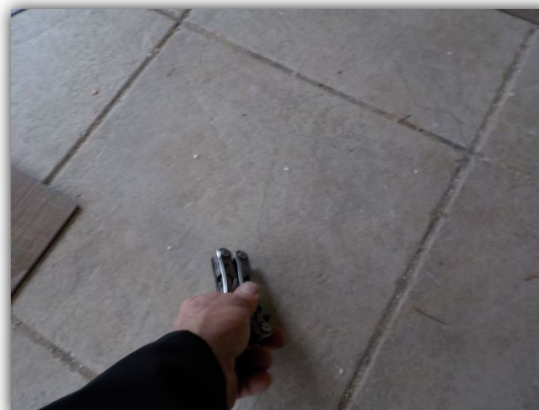
Living room area

I observed minor tile cracks in various areas of living room at time of inspection. Area(s) appear to have been cause from normal settlement of the homes foundation, typical stress or shrinkage crack, and/or thermal expansion / shrinkage of cured concrete. Areas found do not exhibit horizontal movement (normal) found on all slabs without the proper control joints. These are very typical and even happen in slabs with control joints. No other evidence of possible movement noted near affected areas in kitchen and foyer area. Cracks should be monitored for any noticeable changes.

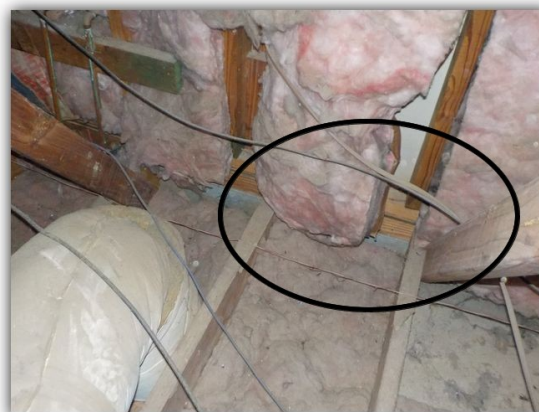
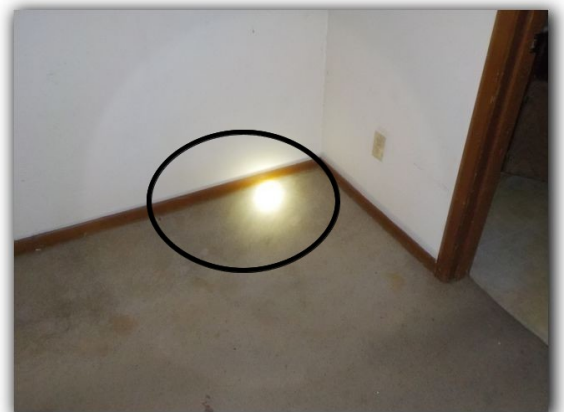
Attic / bedroom above staining

I observed an area of moisture staining noted near center of living room ceiling at time of inspection. Further investigation found no obvious evidence of moisture when assessed with moisture meter and thermal camera. Area land marked by HVAC grill in living room finding no obvious evidence of moisture concerns found in attic area above. Appears moisture staining falls under inside corner of master bedroom. No obvious evidence of moisture noted as well. Recommend monitoring noted area for any noticeable changes.

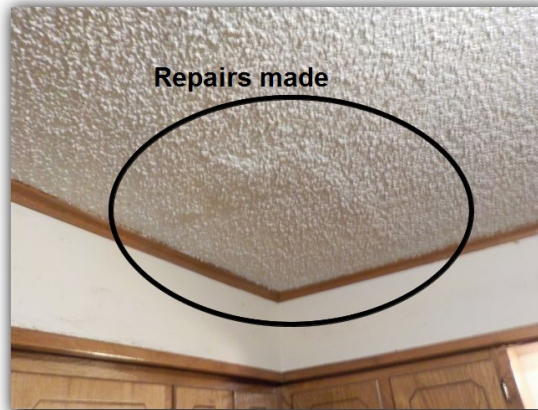
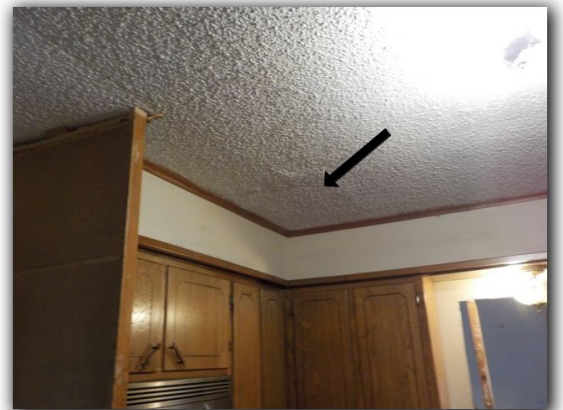
Kitchen ceiling

I observed an area of possible moisture damage with what appears to be an attempt to repair damaged sheet rock in kitchen area. No obvious discoloration noted to affected area but obvious where moisture allows for rock to fall near made up seams. Further evaluation found where HVAC closet installed directly above with area of condensate line called out for obvious moisture concerns. Appears cold condensate line in unconditioned attic / closet allowing for moisture to buildup allowing water to drip down onto noted damaged ceiling. Area called out in AC section of report.

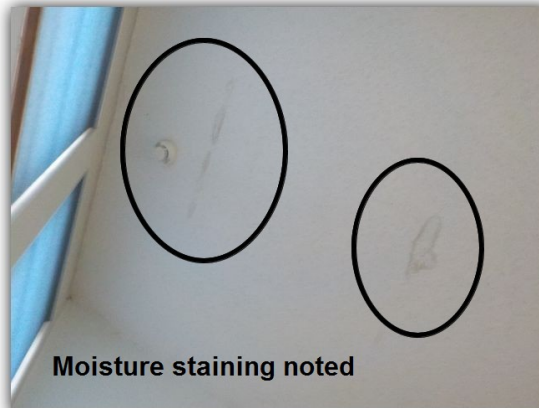
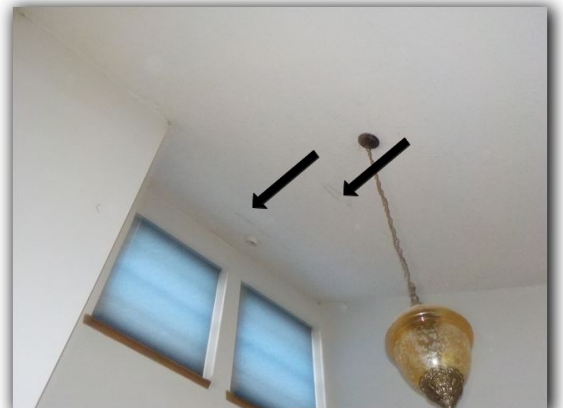
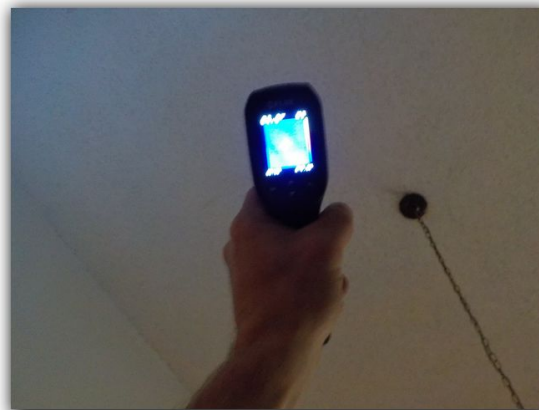
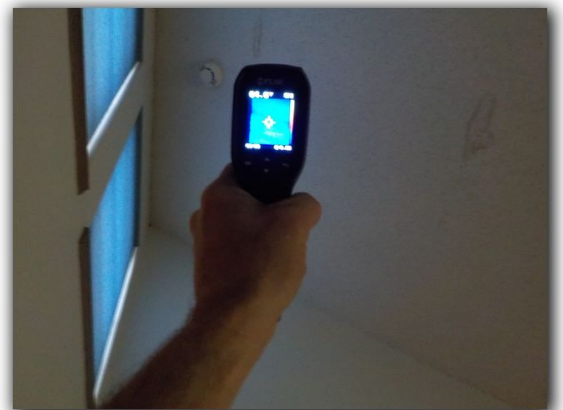
Area over stairs

I observed areas of moisture staining noted on vaulted ceilings over stairway at time of inspection. Areas too high to put hands on but moisture meter finding no obvious water entry. Roof evaluation found no obvious evidence of moisture entry noted. Recommend monitoring noted areas for any noticeable changes.

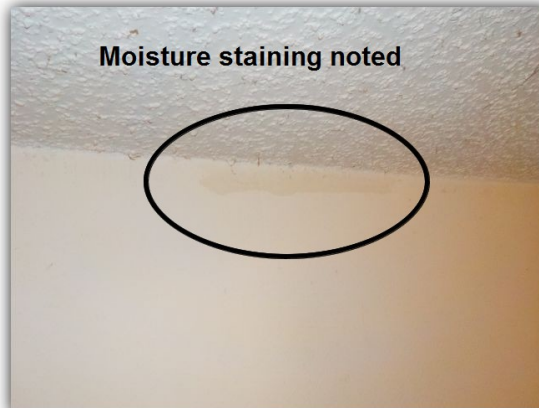
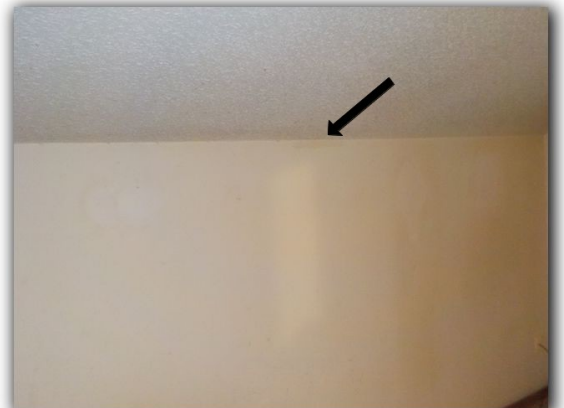
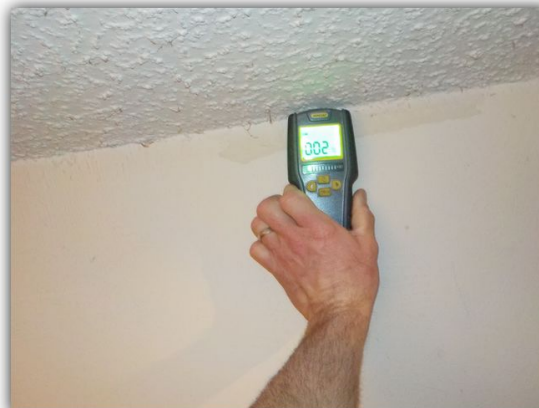
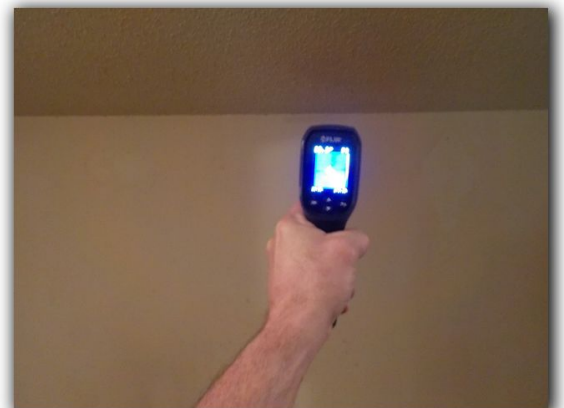
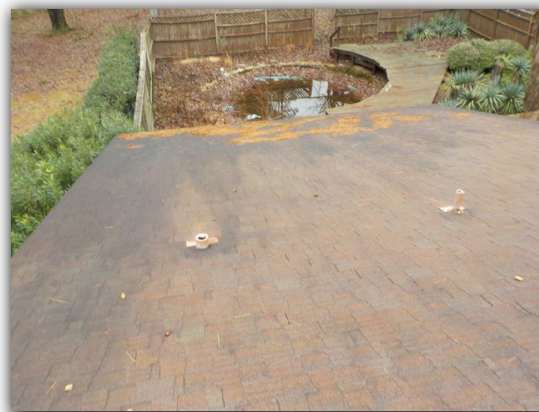
Left upstairs bedroom

I observed an area of possible moisture staining / moisture damage noted in upstairs left bedroom at time of inspection. Further investigation found no obvious evidence of moisture noted with moisture meter and/or thermal camera. No obvious evidence of deficiencies noted on roof area above all noted areas. Recommend monitoring noted areas for any noticeable changes.

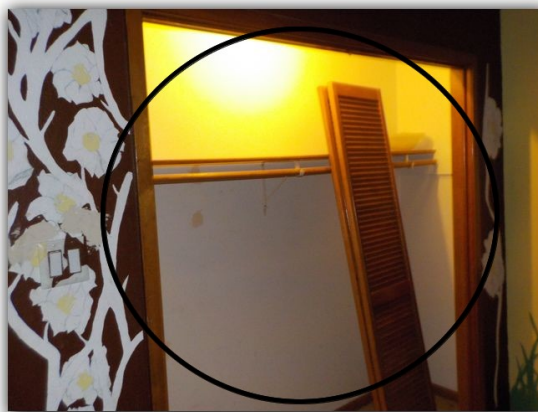
I observed where front left bedroom closet doors damaged / missing at time of inspection.

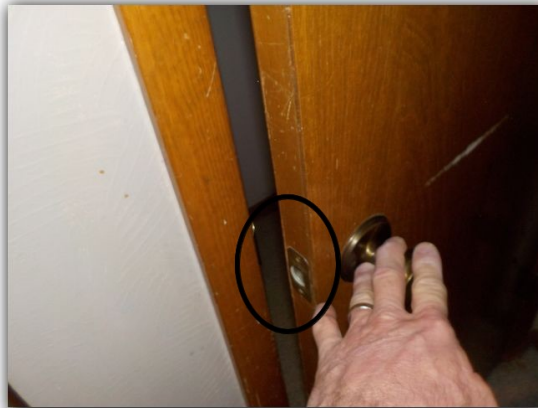
I observed where left rear bedroom closet door assembly missing at time of inspection.

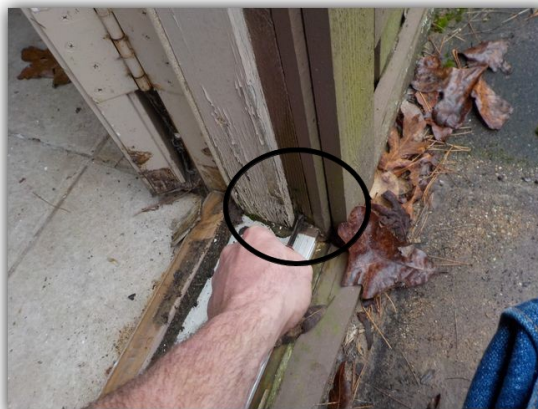
I observed areas near exterior door with minor moisture damage noted to wood surround / trim at time of inspection. Typical with contact from wind blown rain and possible wood to grade contact. Recommend evaluation for possible repairs if desired keeping area(s) painted for added protection.

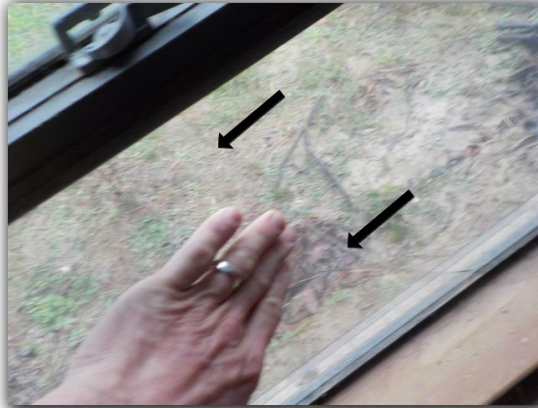
I observed a single cracked window pane in front left bedroom at time of inspection.

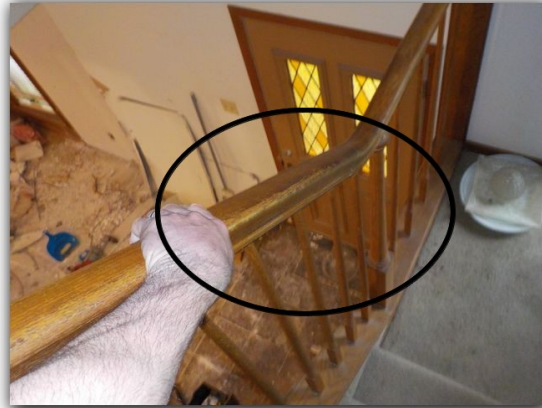
I observed where stair railing over foyer / landing found loose to touch at time of inspection. Recommend evaluation for securing noted railing allowing for safe access / egress.

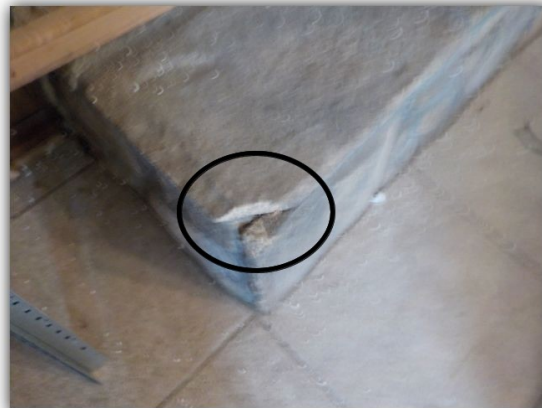
I observed a minor area of damage noted on fireplace hearth. Appears corner crack to rock veneer.

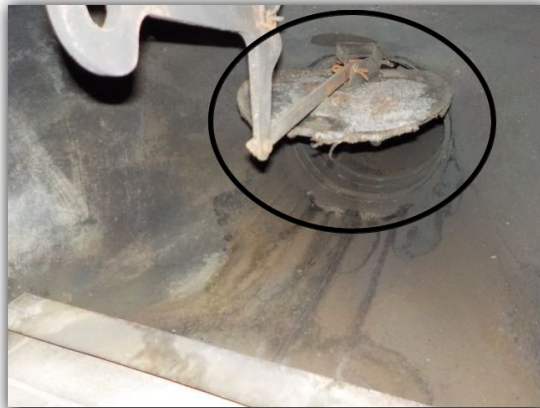
I observed where fireplace damper found open at time of inspection. Inspector was unable to close damper with attempts at time of inspection. Recommend evaluation for obvious repairs allowing home to work as efficiently as possible.

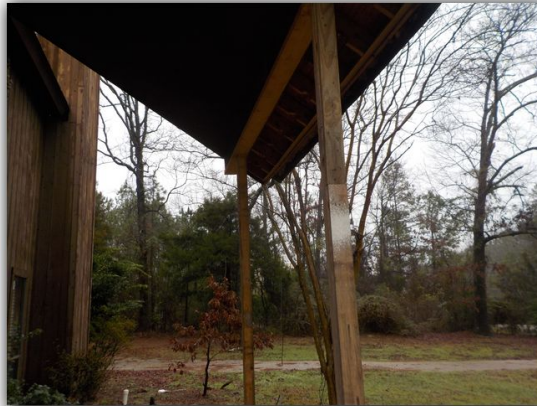
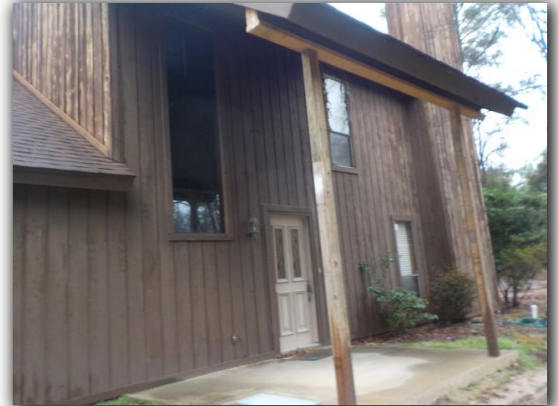
I observed where front porch secured with temporary posts at time of inspection. Recommend finishing out with appropriate and approved posts.

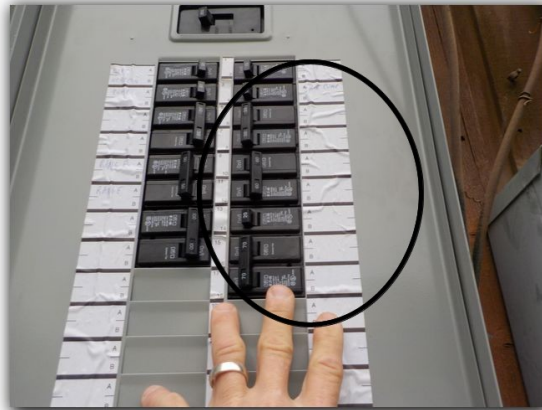
Not all breakers are labeled found to be labeled in load center / panel at time of inspection. Recommend labeling all breakers appropriately allowing for ease of shut off if needed.

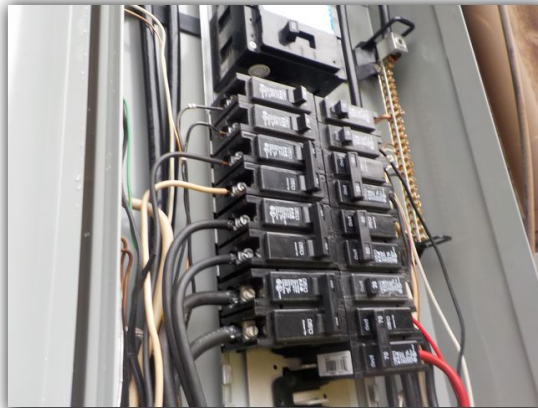
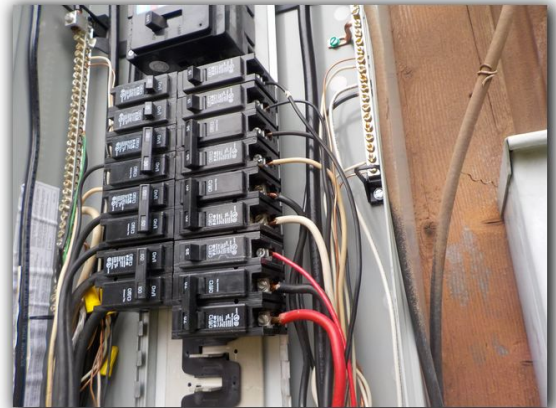
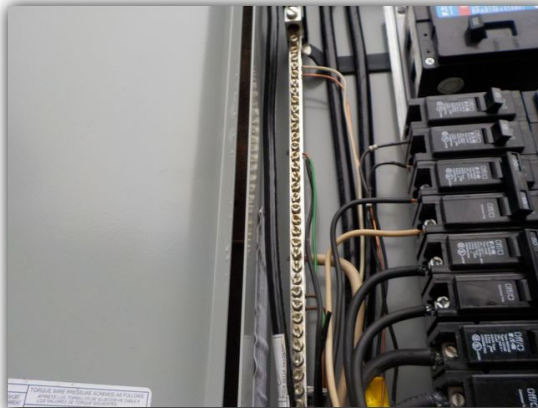
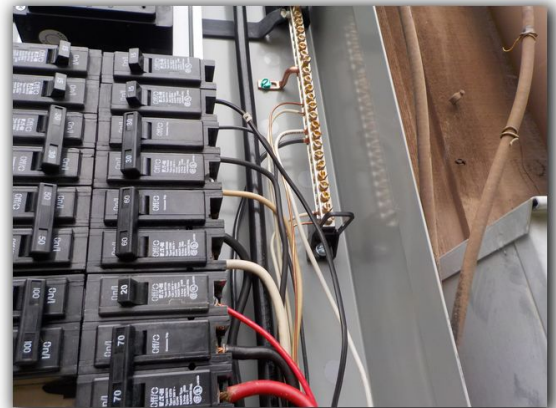
Lack of AFCI breakers servicing the bedrooms, living room, dining room, and any other similar rooms in the home. This was not available at the time this house was constructed and is considered a safety upgrade.

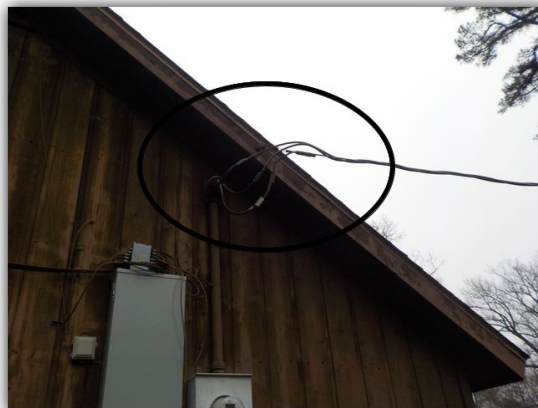
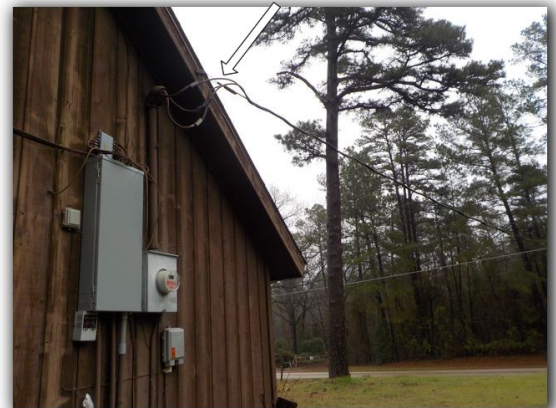
Note: I observed where weather head/ mast head for service entrance on home could be considered low for area electrical utility companies. Swepeco standards for service attachment weather/mast head should be minimum 12 above ground. Others may require 12 feet from drip loop which is obviously lower than mast head. FYI - if swepeco ever attempts reconnection to home for any reason; buyer could be responsible for moving service to appropriate height.

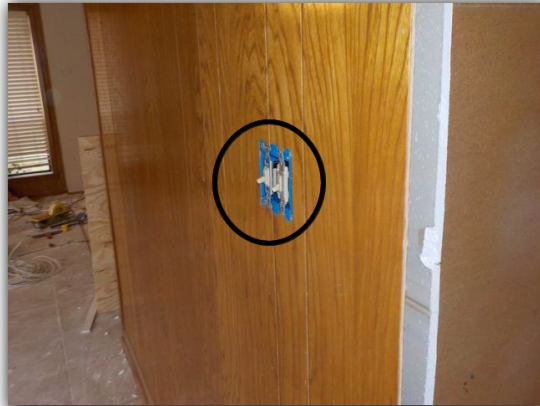
I observed various receptacles in home with missing face plates at time of inspection. Recommend evaluation for adding appropriate covers for added safety.

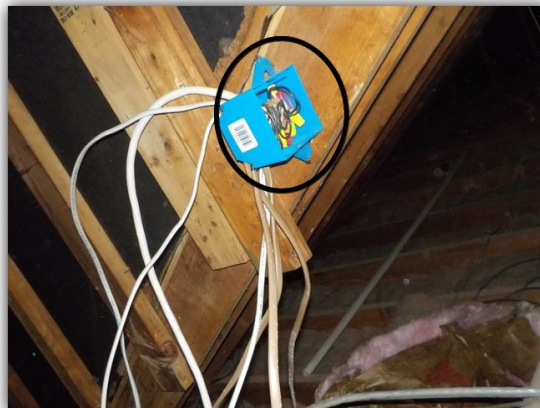
I observed an open connection or inappropriate splice in attic area at time of inspection. Areas noted should be made up in approved or appropriate junction boxes.

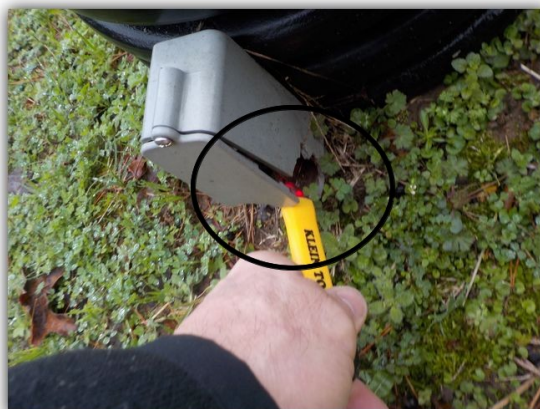
I observed where exterior junction box damaged near aerobic system found in front yard at time of inspection. Found open junction box with hot wires when assessed. Recommend evaluation for repairs allowing area to be as safe as possible.

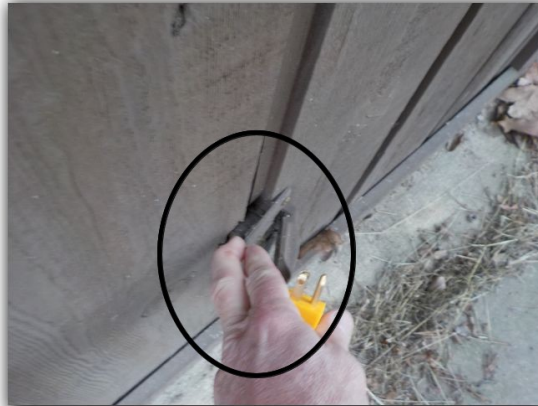
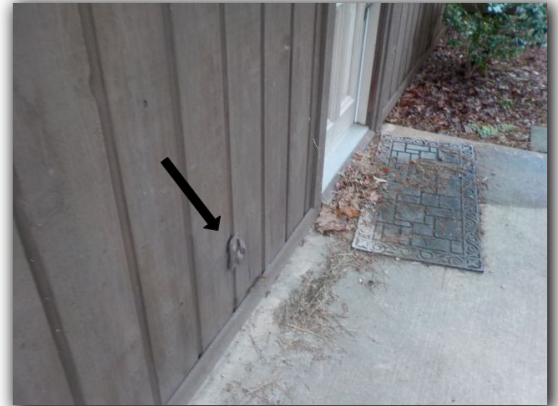
I observed a loose receptacle found on exterior of home near side entry door at time of assessment. Does not appear to have a single gang box behind recept. Possible shock hazard at time of assessment. Recommend securing for added safety.

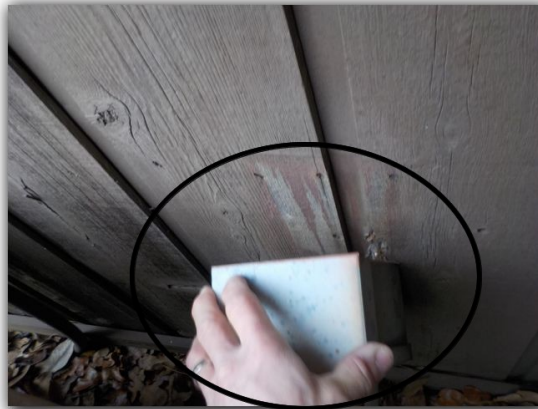
I observed where disconnect for downstairs condenser / outside unit found loose to touch at time of inspection. Noted area could obviously be a possible shock hazard. Recommend evaluation for securing noted disconnect allowing for safe function.

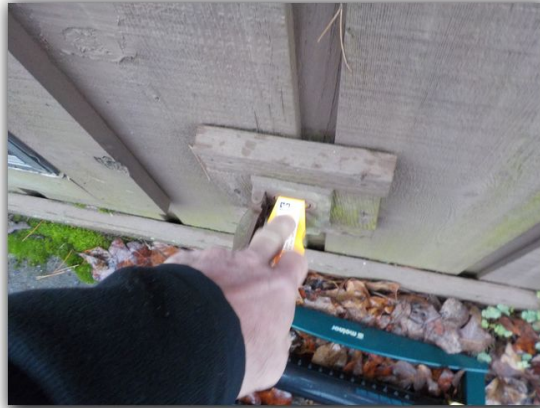
Missing GFCI protection on exterior of home

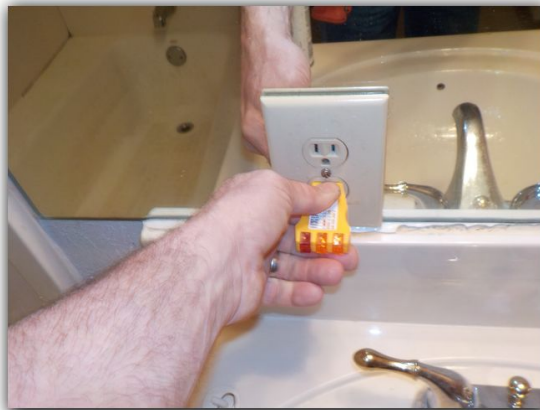
Hallway bathroom

Master bathroom
Missing GFCI protection in bathrooms

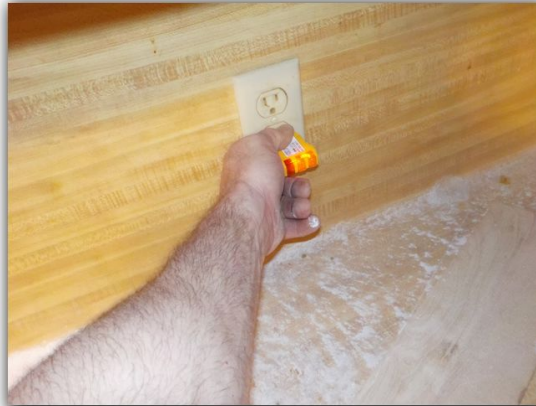
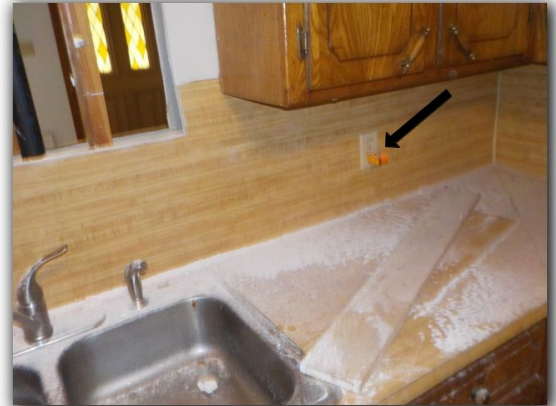
Missing GFCI protection in kitchen area

No GFCI/ARC Fault protection at one or more location. This is considered a recognized safety hazard. GFCI protection was not provided in the home at locations where it is now deemed necessary. GFCI protection may not have been required at the time the home was built, but for safety reasons it is recommended that GFCI protection be installed at all the following locations: • Bathrooms • Exterior • Garages • Crawlspace (at or below grade) • Unfinished basements • Kitchens • Laundry rooms • Within 6 feet of all plumbing fixtures. Recommend evaluation for possible repairs and / or replacement of deficient receptacles for added safety.

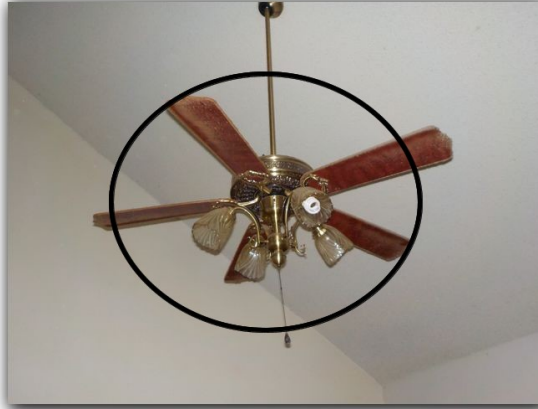
I was unable to get ceiling fan / light kit to come on in front left bedroom at time of assessment. Found unit to be on remote.

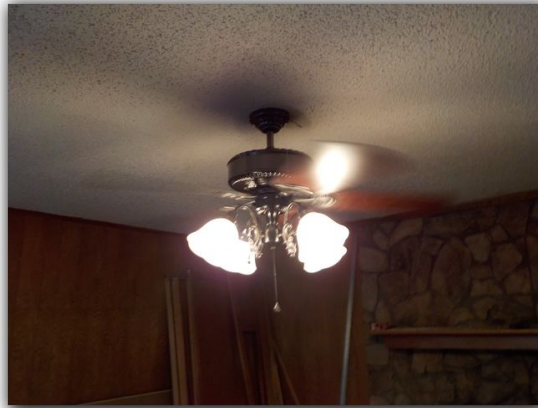
I was unable to get ceiling fan / light kit to come on in master bedroom at time of assessment. Found unit to be on remote

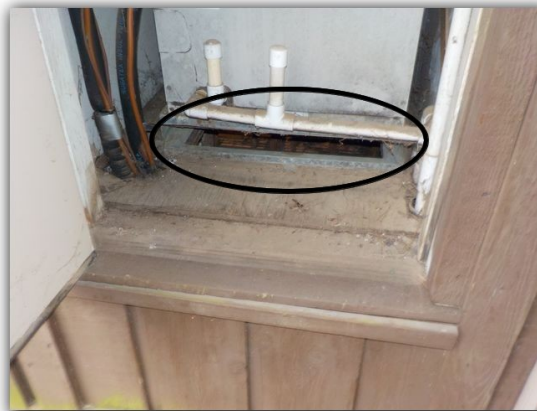
I observed where downstairs AC system shows signs of being dirty at time of inspection. Areas noted typically seen when unit run for any amount of time without appropriate air filter and/or air escaping around noted filter. Recommend evaluation for from qualified technician for servicing if needed.

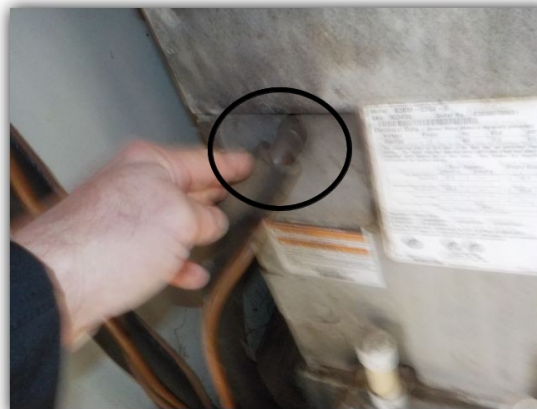
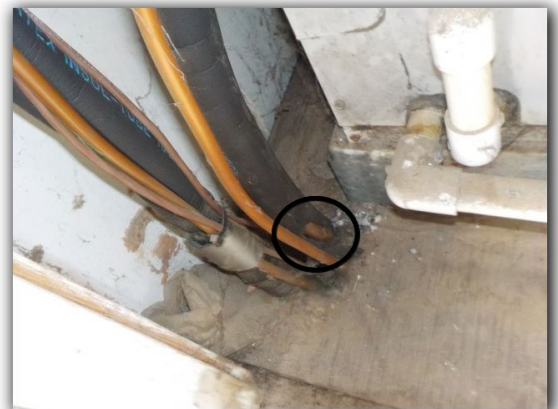
I observed where downstairs air handler found without any filter coverage at time of inspection. Areas of debris noted on A coil near affected area. Recommend evaluation for sealing noted area with appropriate filter allowing unit to work as should.

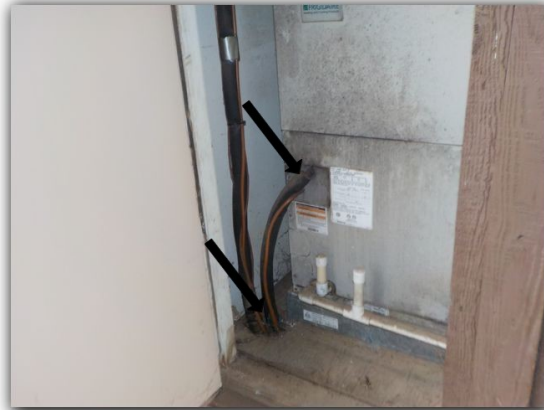
I observed where it appears several areas of insulation missing from AC return line near handler located in outside closet at time of inspection. Without appropriate insulation copper lines will sweat allowing for possible moisture concerns. In fact this appears to be the case. Areas of moisture staining noted on decking near handler under noted areas of exposed copper. This unit placed in an unconditioned closet which will allow for moisture to accumulate. Noted areas should be sealed with possible areas of ventilation added allowing for possible horizontal air movement. Prolonged exposures to moisture in dark environment could be area of DARK mold. Recommend evaluation for adding insulation allowing copper line to work as should.

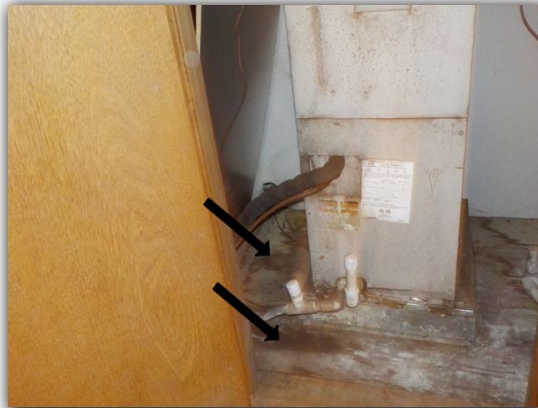
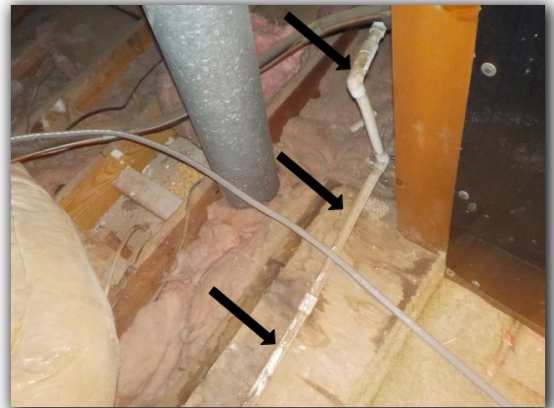
I observed areas of moisture staining noted on decking near handler in upstairs utility closet at time of inspection. This unit placed in an unconditioned closet near attic area which will allow for moisture to accumulate. Noted are should be sealed with possible areas of ventilation added allowing for possible horizontal air movement. Prolonged exposures to moisture in dark environment could me area of DARK mold. Recommend evaluation for adding insulation allowing copper line to work as should.

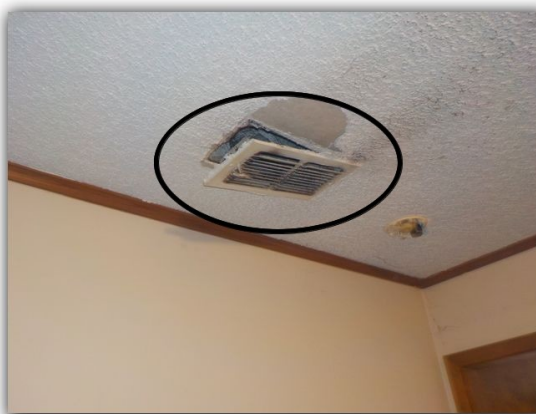
I observed where grill / register in kitchen area has separated from ceiling area at time of assessment.

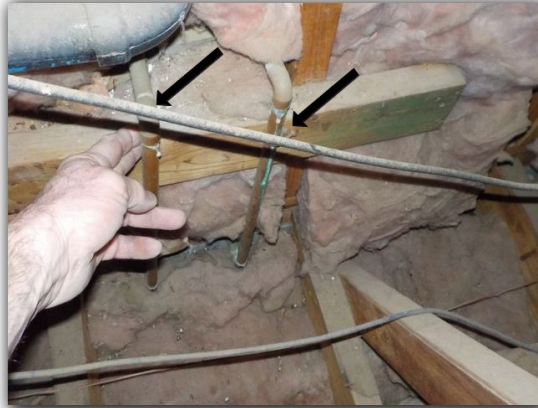
I observed where copper water lines in attic over living room area found without adequate insulation at time of inspection. Areas such as attic area could be exposed to freezing temperatures creating conducive conditions for pipes to possibly burst. Recommend evaluation for adding appropriate insulation on exposed pipes allowing home to work as efficiently as possible.

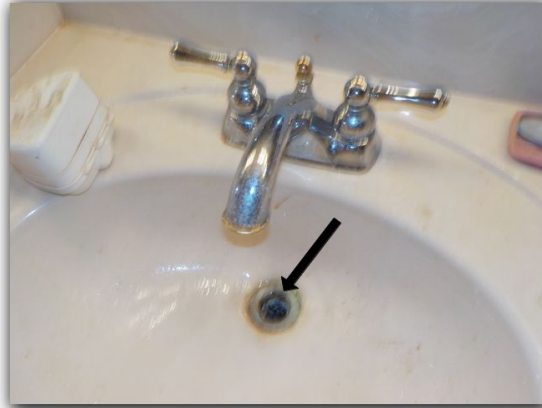
I observed where it appears that master bathroom sink drain stop was not installed appropriately at time of inspection. Recommend evaluation for installing drain stop per manufacturer specifications allowing drain stop to work as should.

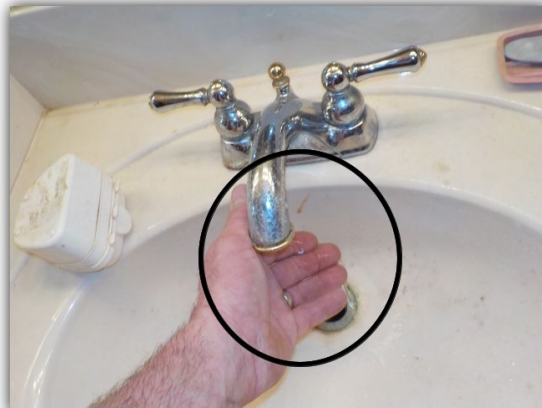
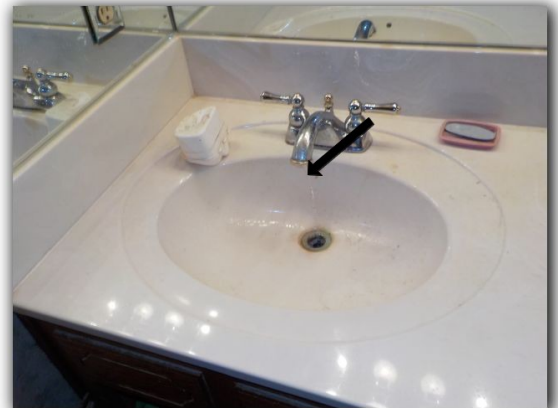
I observed where master bathroom sink fixture presenting with minor water flow when not in use at time of inspection. Most likely damaged or faulty seal. Recommend evaluation for possible repairs allowing tub/shower to work as should.
