*Home inspection for
Sample Report
Somewhere
Longview TX 75601*

David Smith Inspections

PROPERTY INSPECTION REPORT

Concerning: Somewhere, Longview, TX 75601
(Address or Other Identification of Inspected Property)

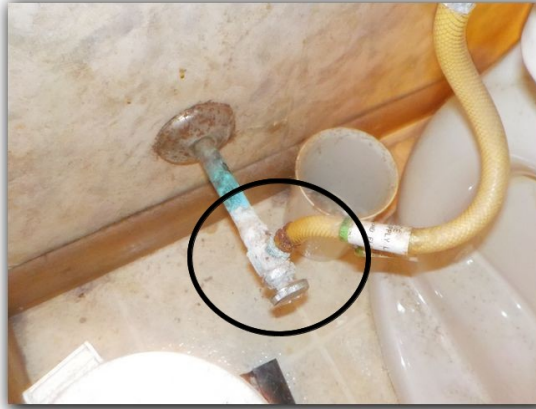
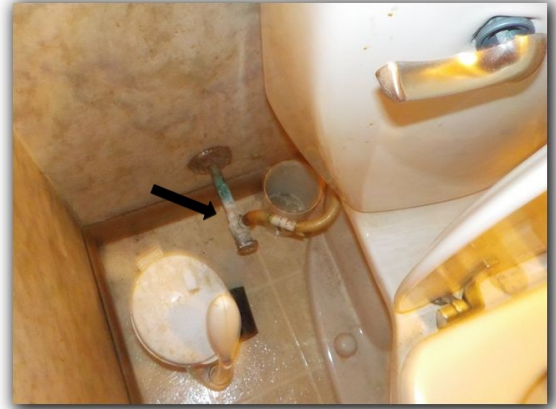
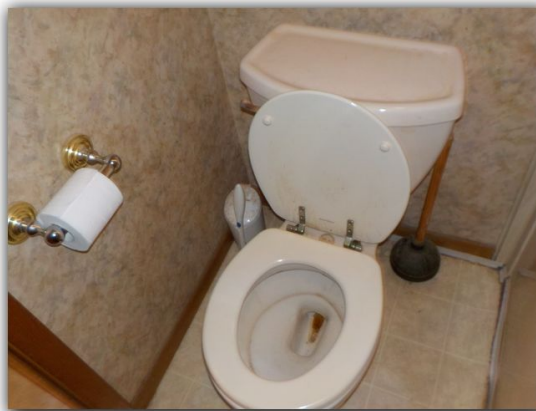
I observed what appears to be rusty crust on cold water shut off for master bathroom commode. This could be galvanic corrosion, an electrochemical disintegration that happens when two different metals are in contact with each other while also in contact with an electrically conductive liquid, typically water. Recommend evaluation of noted area for possible repair.

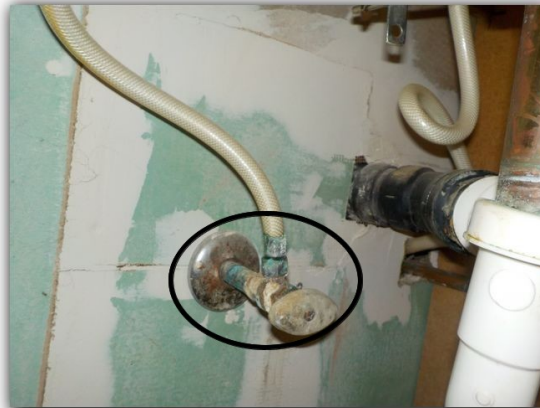
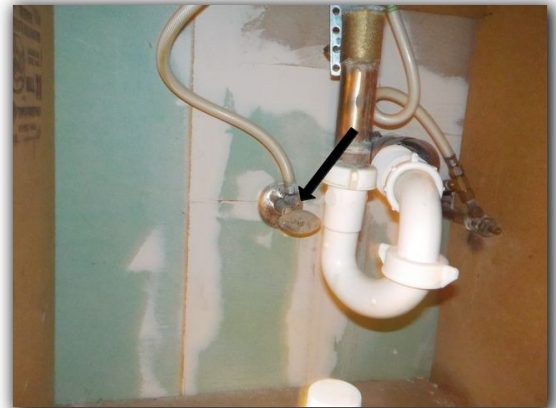
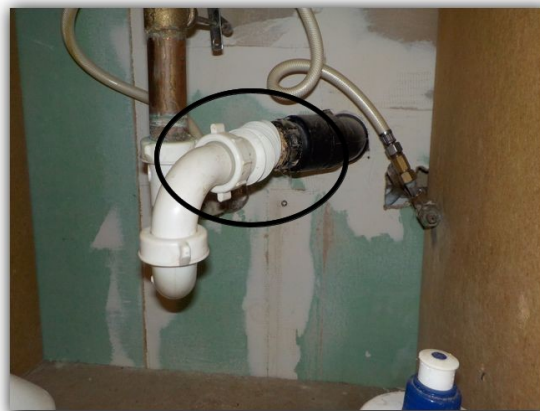
I observed what appears to be rusty crust on hot water shut off / connection(s). This could be galvanic corrosion, an electrochemical disintegration that happens when two different metals are in contact with each other while also in contact with an electrically conductive liquid, typically water. Recommend evaluation of noted area for possible repair.

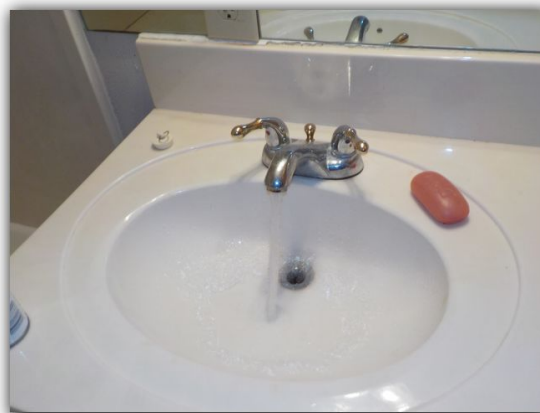
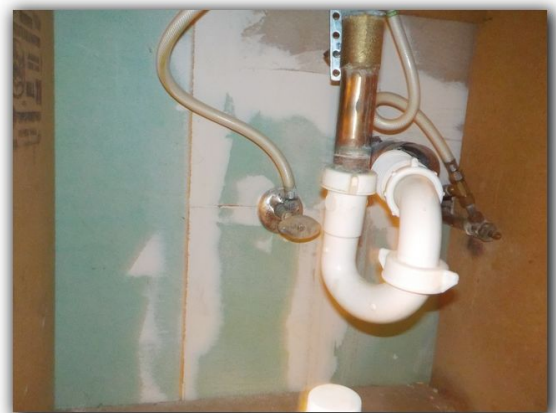
I observed where hallway bathroom sink / drain presenting with flex drain line at time of inspection Flexible and / or corrugated drainpipe may contribute to possible blockages at a bathroom sink(s). Although currently functioning, it is recommended that this be replaced with the proper drain material.

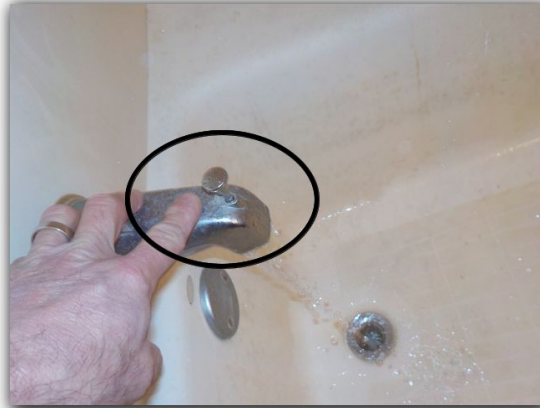
I observed where hallway bathroom tub / shower diverter would not open and/or close all the way when in use. Water found to flow when shower in use. Recommend evaluation for possible repairs and/or replacement allowing for normal function. *Note: Noticeable mineral buildup / deposits noted on bathroom fixtures at time of inspection. This lime scale type build up is not considered to be harmful but may clog various fixtures as well as making cleaning noted areas more difficult. Vinegar, baking soda, or lemon juice are a few ideas for cleaning noted surfaces. Areas noted appear to be cosmetic in nature and not considered a deficiency.*

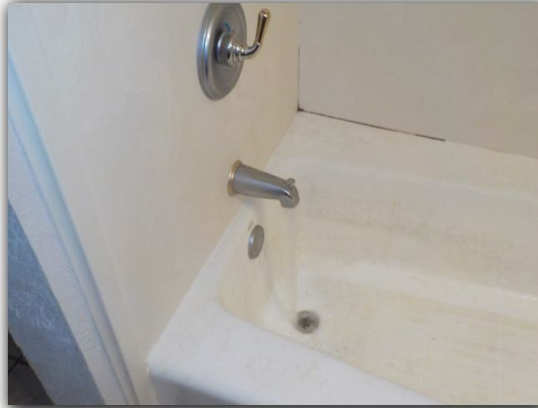
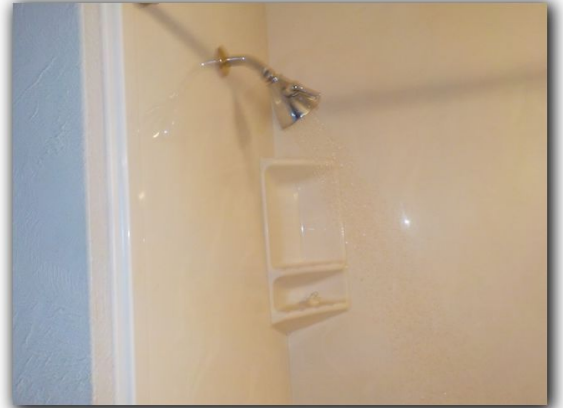
comments: Commode working well at time of inspection with deficiencies noted

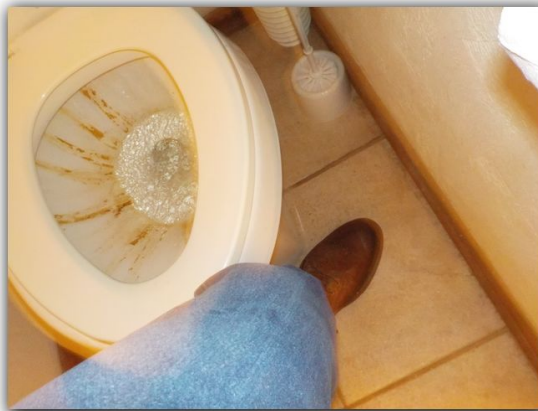
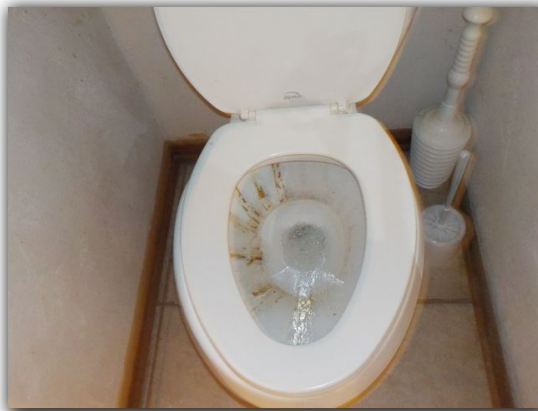
I observed where hallway bathroom commode found loose to touch at time of inspection. No evidence of leaks noted along commode flange during assessment. Recommend evaluation for securing commode appropriately allowing for normal use.

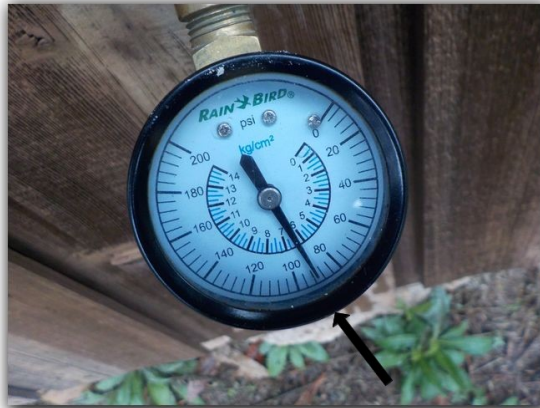
Comments: Approximately 90 psi noted on home at time of inspection. *Note: Water pressure between 40 and 80 psi (pounds per square inch) is considered normal in a residential setting. May consider possible pressure reducer on home if elevated psi found.*

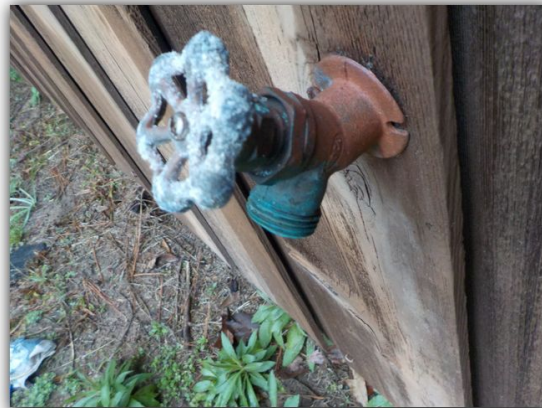
Missing back flow preventer. The back flow preventer keeps contaminated water from entering potable (drinking) water.

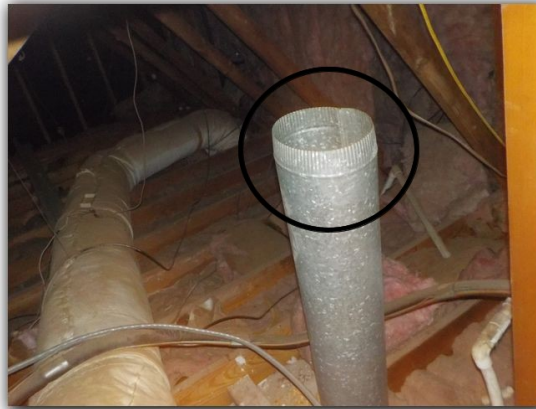
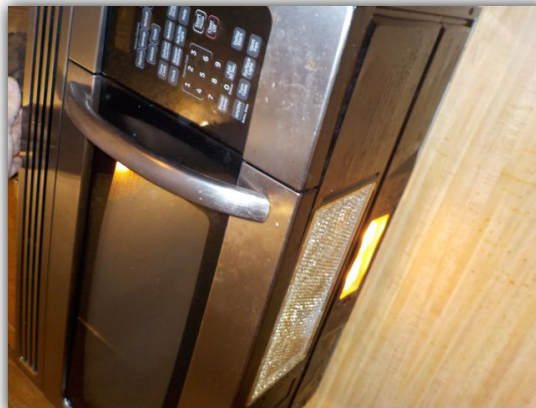
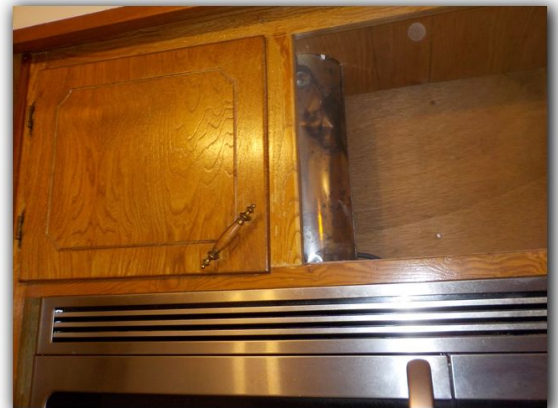
I observed where kitchen range hood exhaust terminates into attic area. The duct for kitchen range should not terminate in attic area, crawl spaces, or any other areas inside the building unless specifically allowed by manufacturer. Would recommend duct work terminate outdoors.

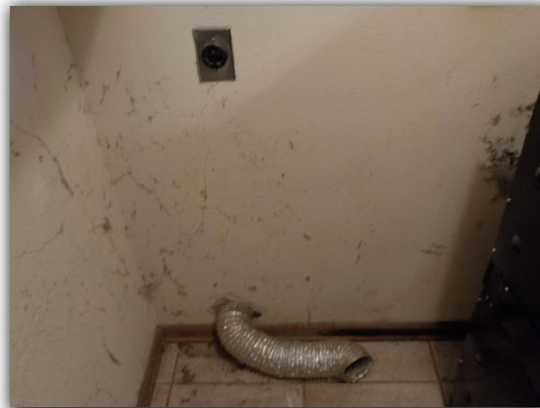
Dryer not connected at time of inspection.

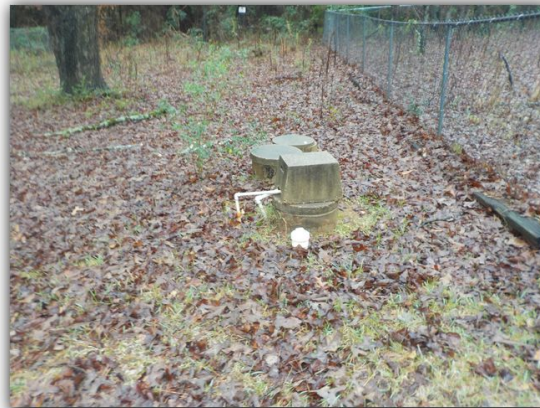
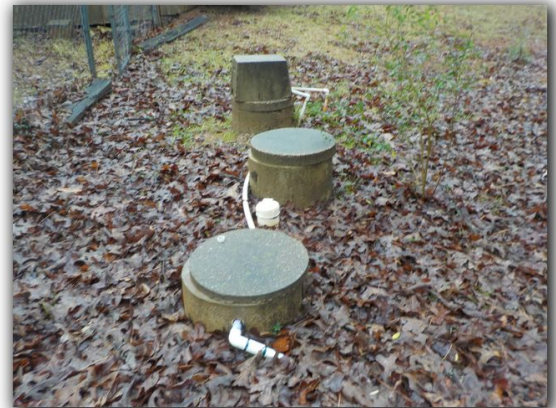
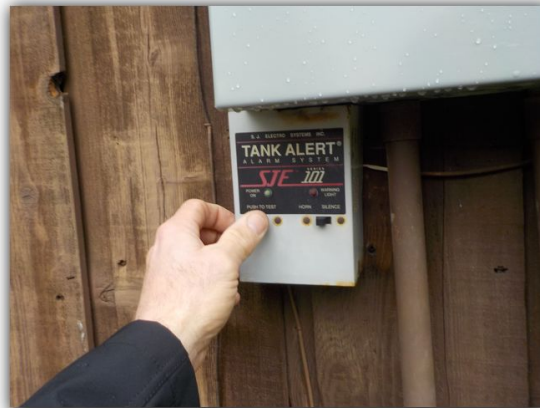
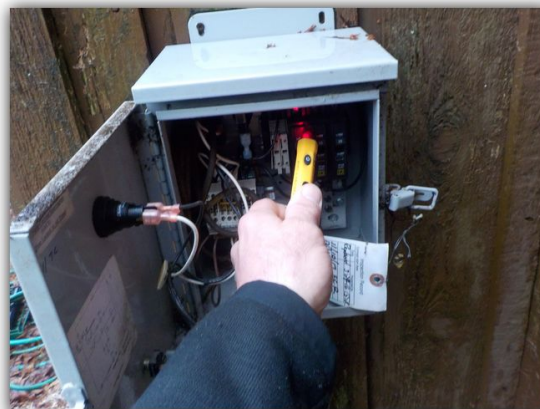
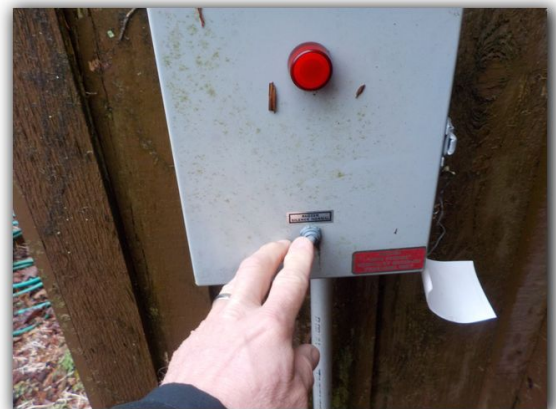
Aerobic system near back of lot assessed and appears to be in serviceable condition. Found aerator running on system as well as active alarm checked. No manual pump check found. Ran water in 2 tubs for approx. 40 min averaging some 60-80 gallons every 10 minutes. Unable to verify whether pump working at time of assessment. If unit has been vacant for any longer period tanks will drain keeping inspector from running appropriate amount of water allowing tank to drain as should. Recommend evaluation from qualified contractor for checks to verify if unit in good working condition.

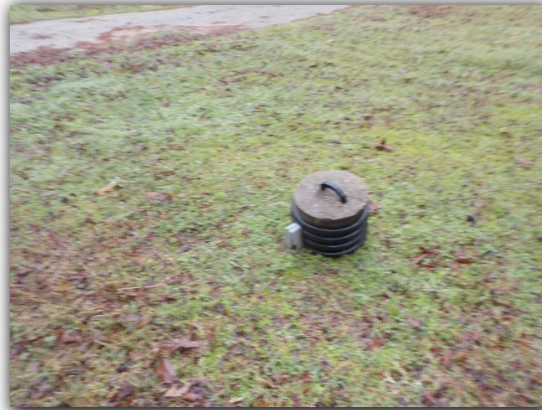
System in front yard found with power to box and to access junction box on side of cleanout. Could not verify whether system working as should.

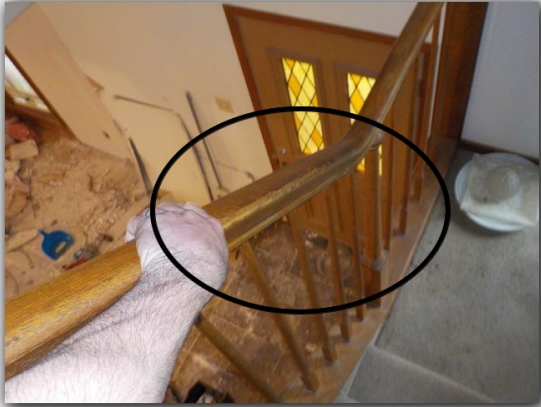
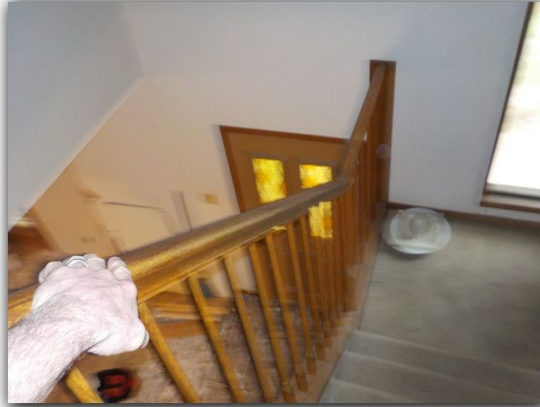
I observed where stair railing over foyer / landing found loose to touch at time of inspection. Recommend evaluation for securing noted railing allowing for safe access / egress.

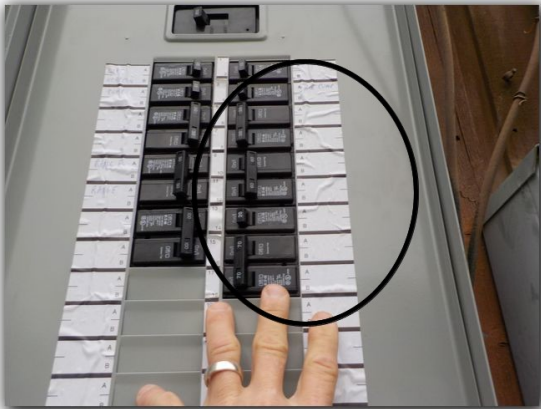
Not all breakers are labeled found to be labeled in load center / panel at time of inspection. Recommend labeling all breakers appropriately allowing for ease of shut off if needed.

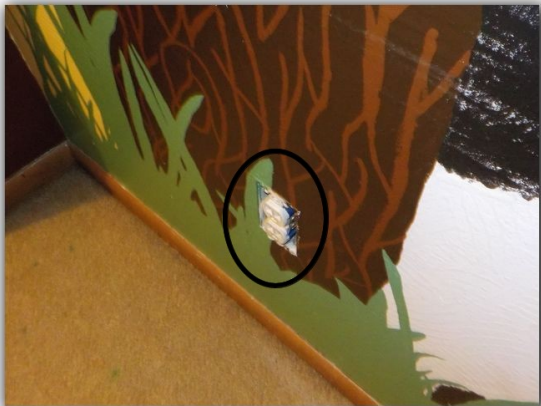
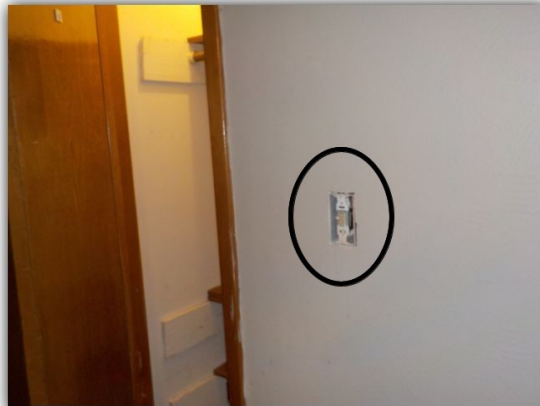
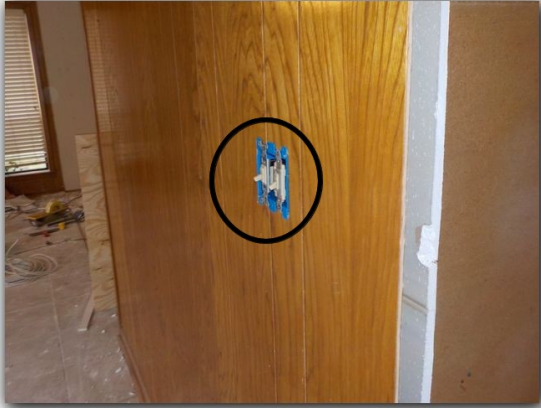
I observed various receptacles in home with missing face plates at time of inspection. Recommend evaluation for adding appropriate covers for added safety.

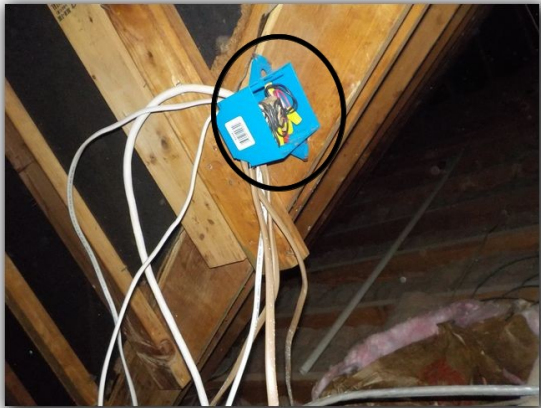
I observed an open connection or inappropriate splice in attic area at time of inspection. Areas noted should be made up in approved or appropriate junction boxes.

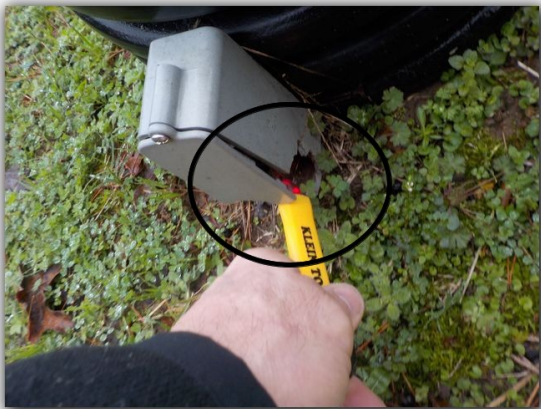
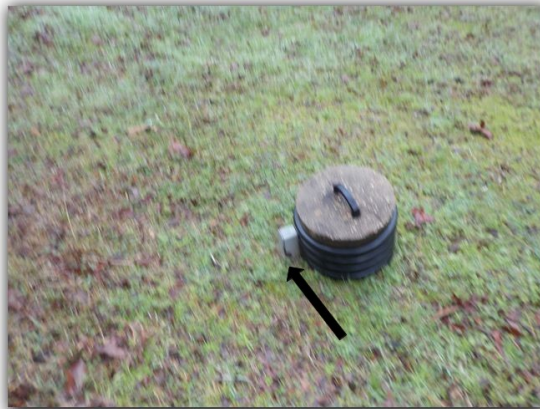
I observed where exterior junction box damaged near aerobic system found in front yard at time of inspection. Found open junction box with hot wires when assessed. Recommend evaluation for repairs allowing area to be as safe as possible.

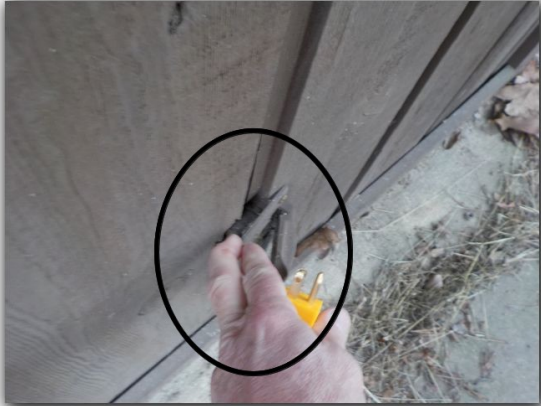
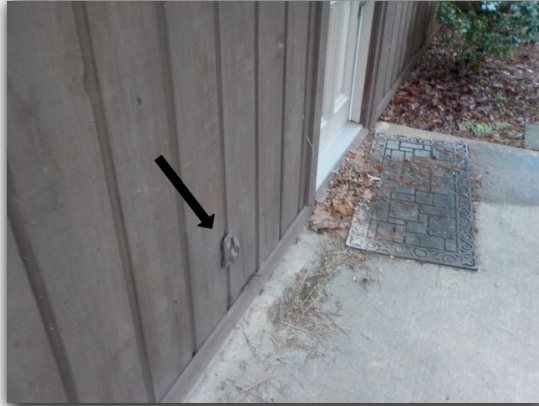
I observed a loose receptacle found on exterior of home near side entry door at time of assessment. Does not appear to have a single gang box behind recept. Possible shock hazard at time of assessment. Recommend securing for added safety.

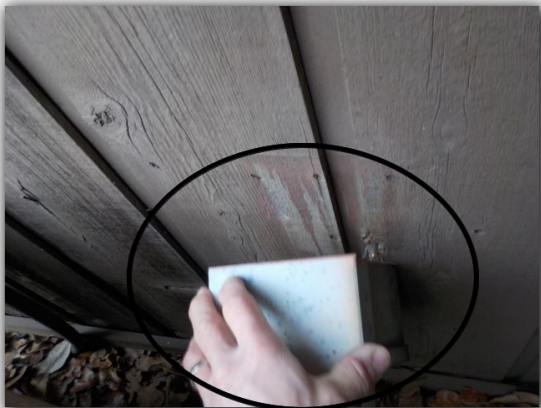
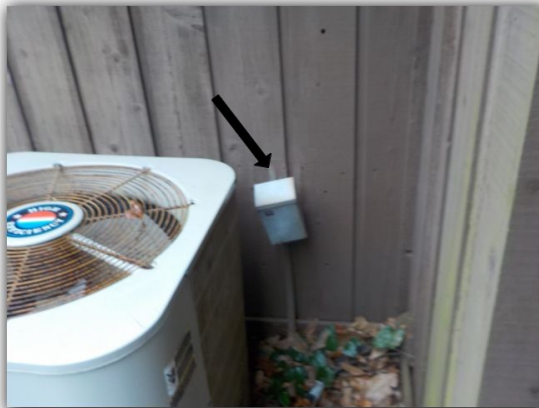
I observed where disconnect for downstairs condenser / outside unit found loose to touch at time of inspection. Noted area could obviously be a possible shock hazard. Recommend evaluation for securing noted disconnect allowing for safe function.

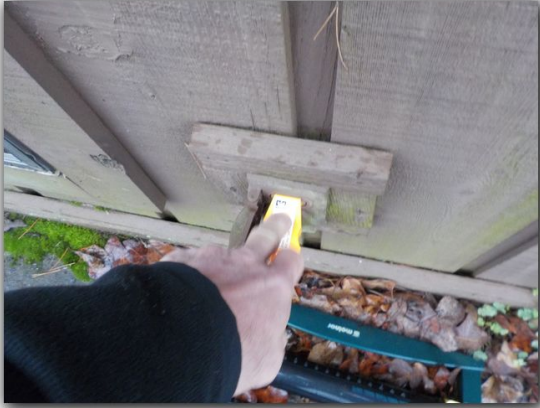
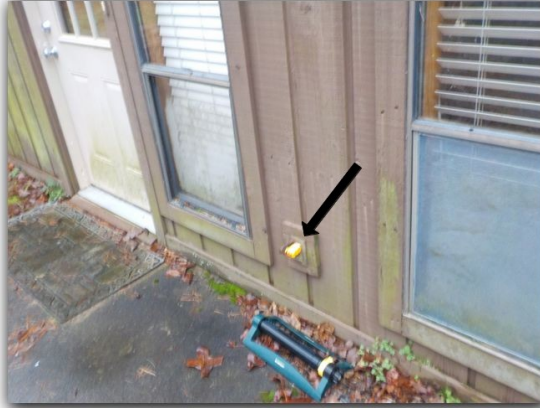
Missing GFCI protection on exterior of home

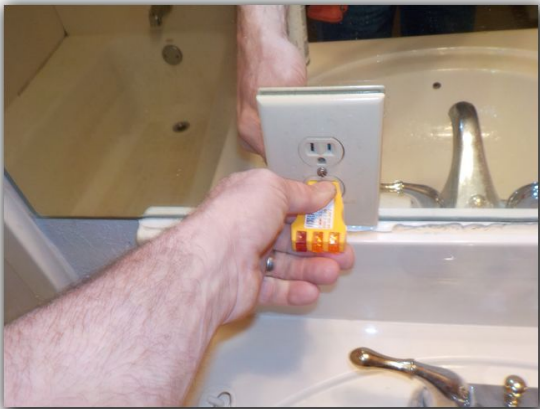
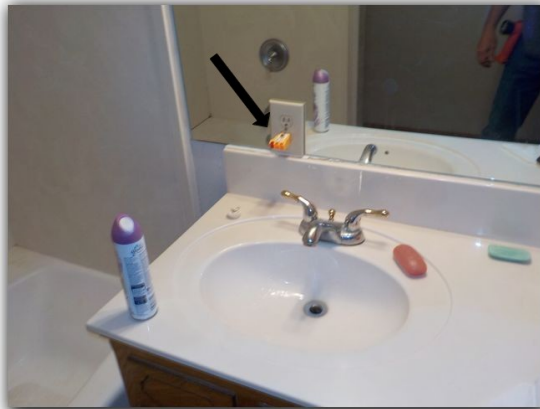
Hallway bathroom

Master bathroom
Missing GFCI protection in bathrooms

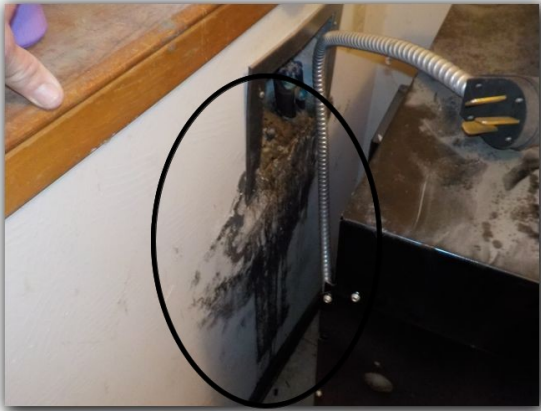
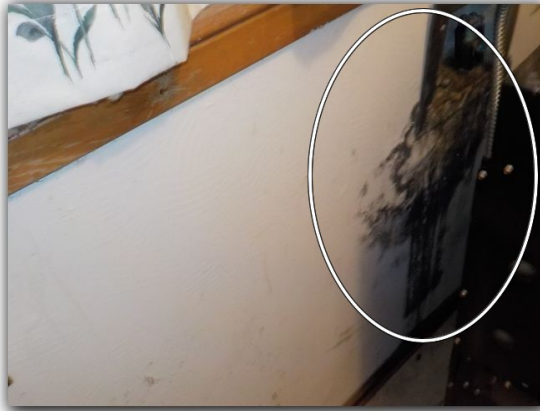
I observed an area near washing machine connections with active leak noted on water fixtures at time of inspection. Appears that wall drain box filled with debris and not allowing for drainage as should. Noted area presenting with what appears to be possible black mold. This is common and found with extended exposures to water along with being in cooler and darker areas. Recommend evaluation for repairs to damaged wall and washing machine wall drain box.

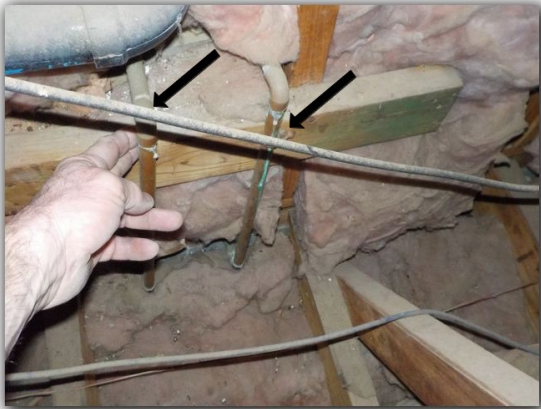
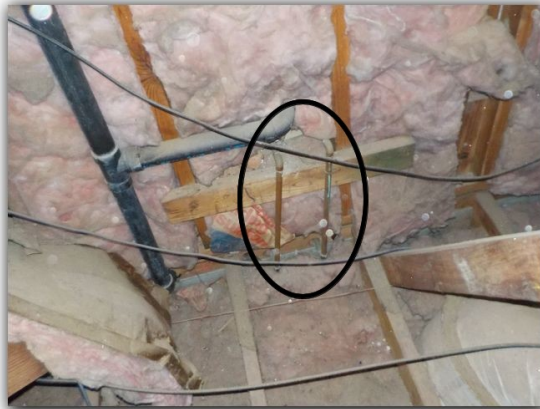
I observed where copper water lines in attic over living room area found without adequate insulation at time of inspection. Areas such as attic area could be exposed to freezing temperatures creating conducive conditions for pipes to possibly burst. Recommend evaluation for adding appropriate insulation on exposed pipes allowing home to work as efficiently as possible.

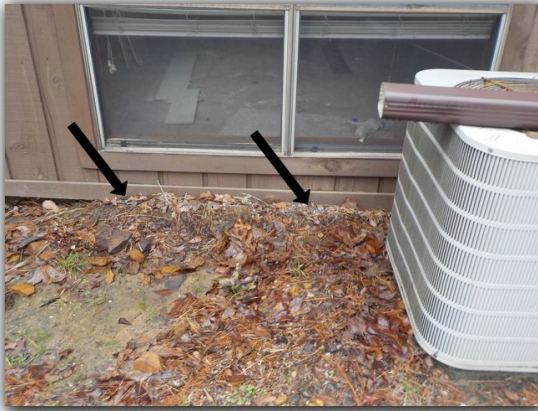
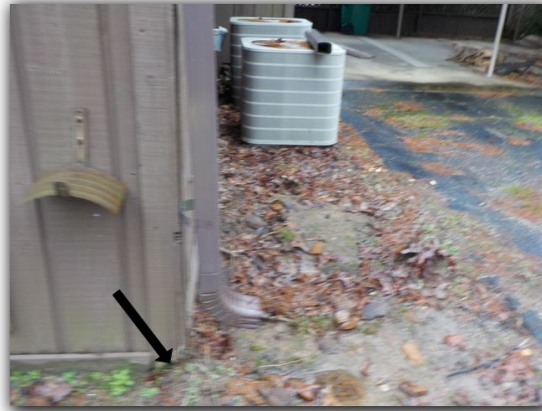
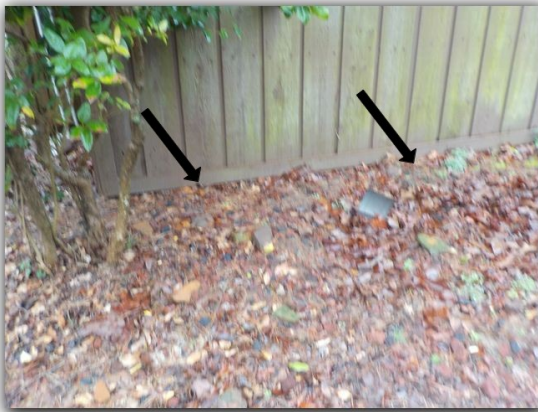
Soil levels against the exterior grade are considered to be too high at the time of inspection. When soil levels are high against the face of the foundation it promotes water penetration of the structure and insect infestation. This item should be corrected so there is some exposure of the foundation face. It is generally accepted that a brick veneer house should have about 4 inches of clearance. Wood siding houses should have approximately 6 inches of clearance.

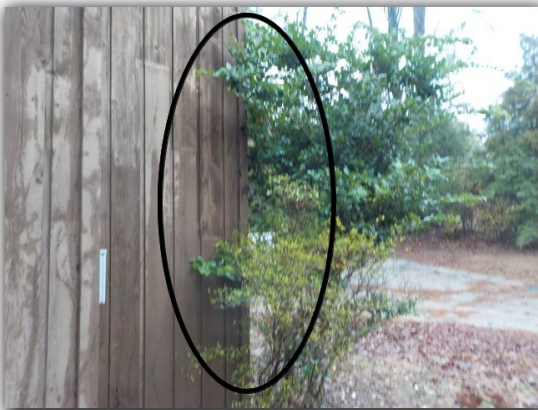
I observed where foliage found to be too close to the structure at time of inspection. It is recommended that bushes and vegetation should be at least 12 inches from wall contact. Recommend cutting or trimming noted vegetation allowing for appropriate barrier.

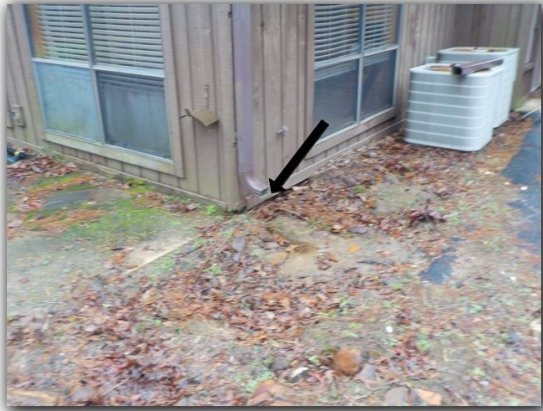
Gutters / down spouts found draining too close to the structure at the time of inspection. Water terminating near slab can create conducive conditions for slab undermining. Recommend termination point at least 16-24 inches from foundation. Recommend installing extensions onto gutters or adding splash blocks allowing water to move away from home efficiently.

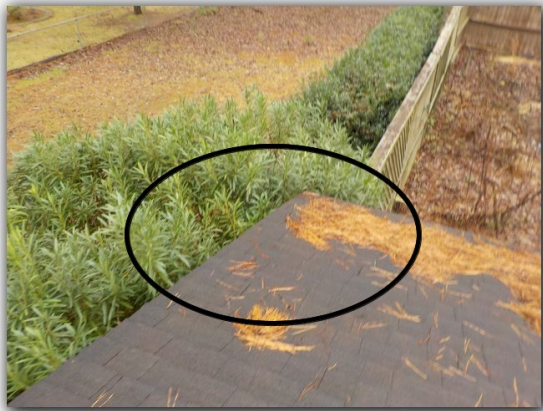
I observed where tree limbs are physically touching roof at time of inspection. Wind blown limbs can cause significant damage to shingles, fascia, trim, and soffits. Recommend trimming limbs away from home.

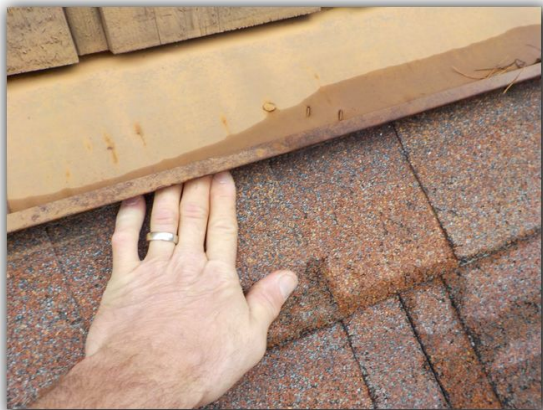
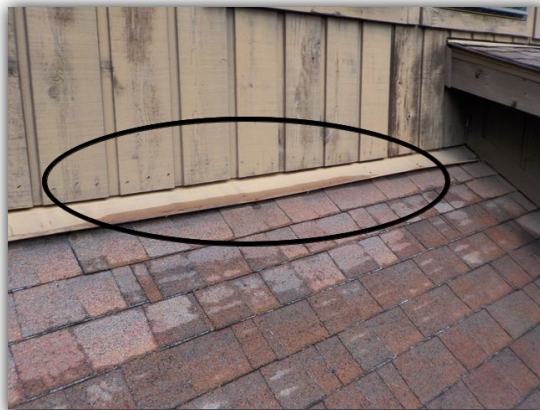
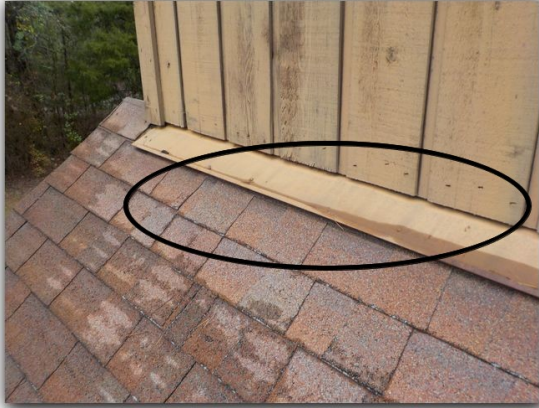
☑ I observed areas on roof with exposed nails in flashing at time of inspection. Over time, nails have a tendency to work themselves out creating possible conducive conditions for water penetrations. Recommend evaluation for repairs placing some fashion of water proofing material over noted nails (silicone) allowing home to work as efficiently as possible.

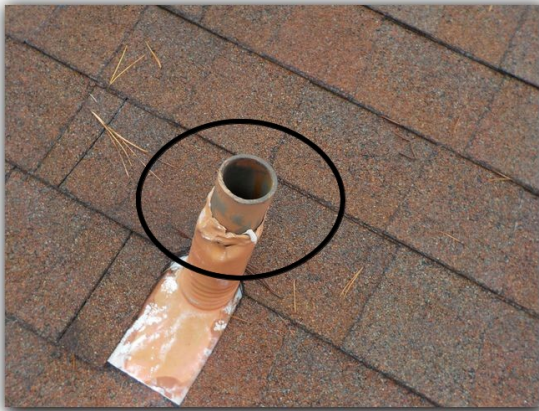
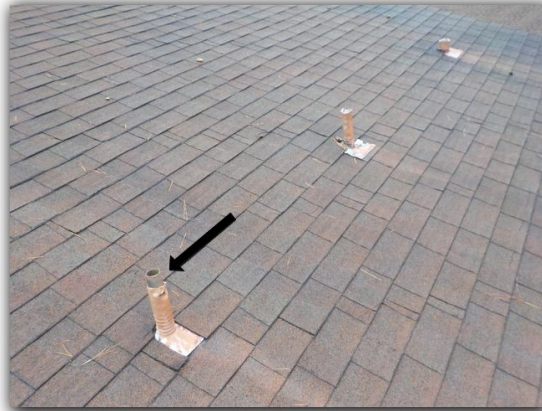
☑ I observed where the lead jack flashing that covers plumbing vent stack(s) was observed to be improperly installed at one or more of the roof level plumbing vent pipes. The lead flashing should run full length of the vent pipe and turn down into the top of the vent pipe to help prevent water intrusion at this point

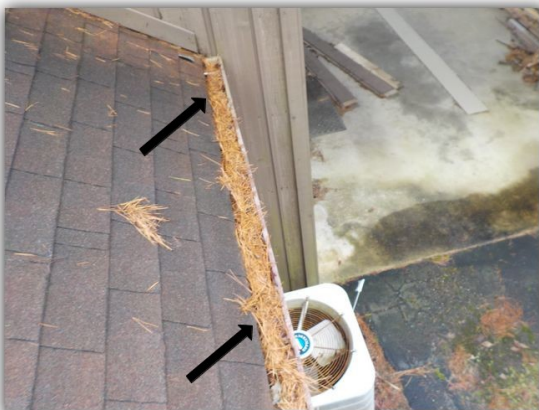
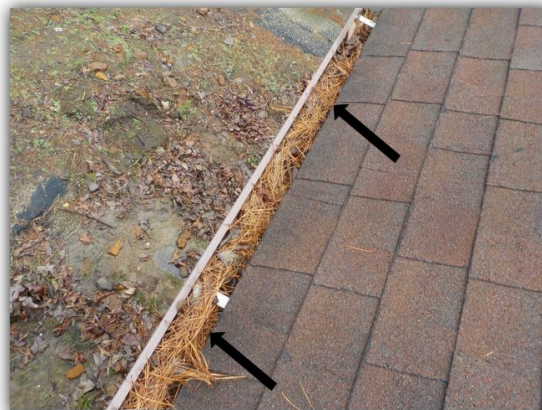
☑ I observed where gutters filled with areas of debris at time of inspection. Debris in gutters are create conducive conditions for water penetrations and / or mechanical failure due to extreme water/debris weight or possible water leaking into living space / soffit areas. Recommend cleaning of gutters allowing water to flow / terminate from roof area as should.

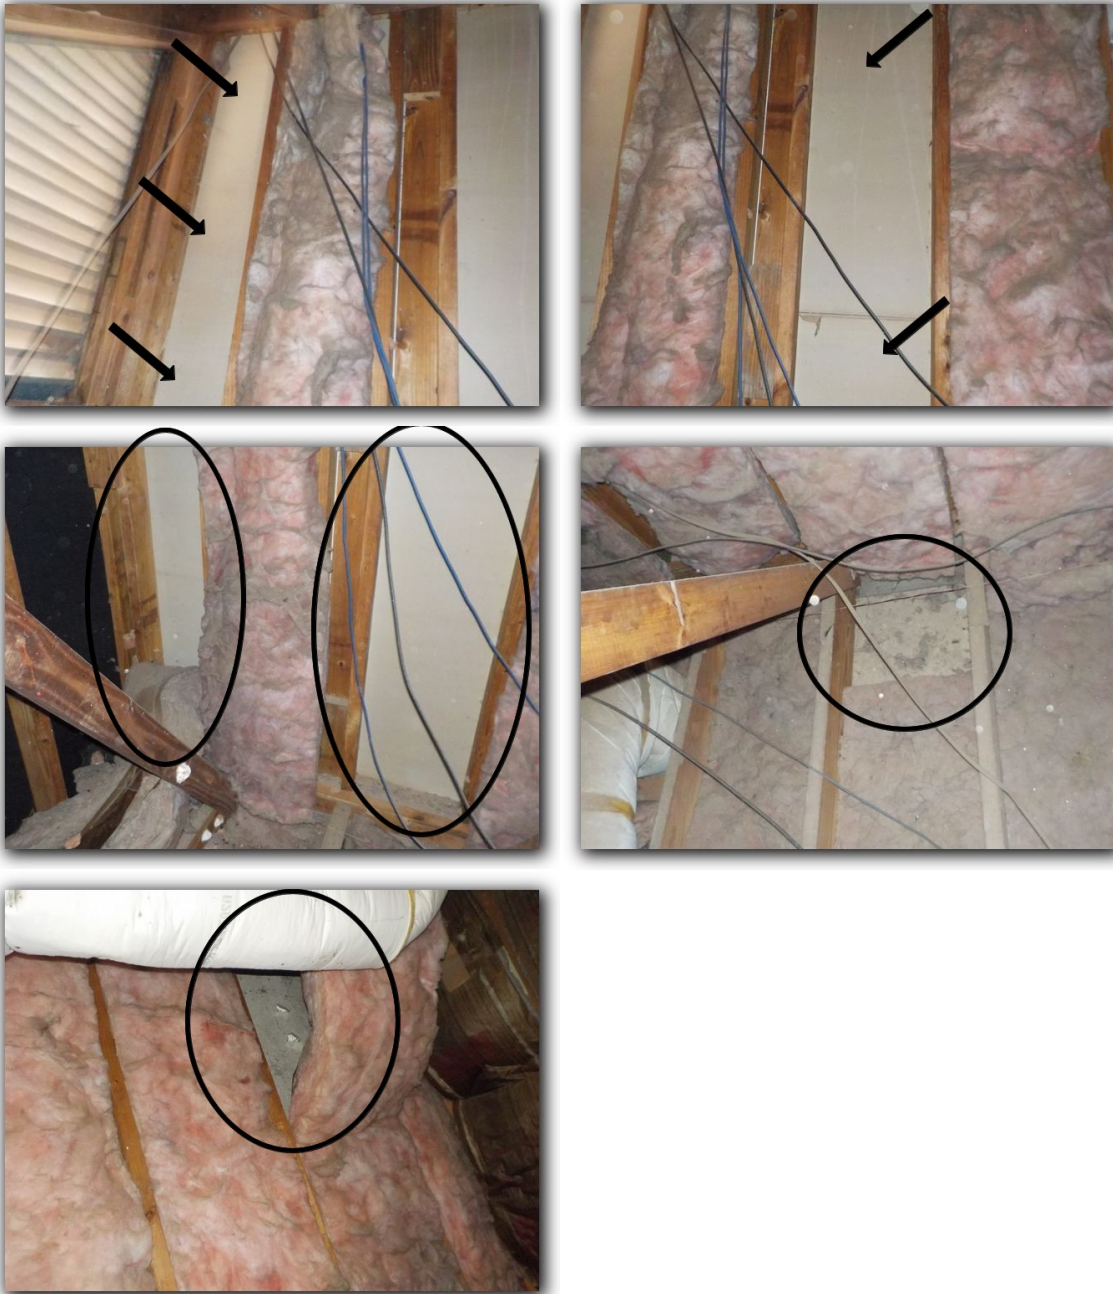
I observed various areas in attic where it appears that vertical rolled batting insulation has fallen away from interior walls. Typically rolled batting insulation stapled to stud walls in attic area adjacent to living areas in home. When rolled batting falls away it exposes home / exposed sheet rock to hot / cold attic. Recommend evaluation for replacing / repairing missing insulation in attic allowing home to work as efficiently as possible.

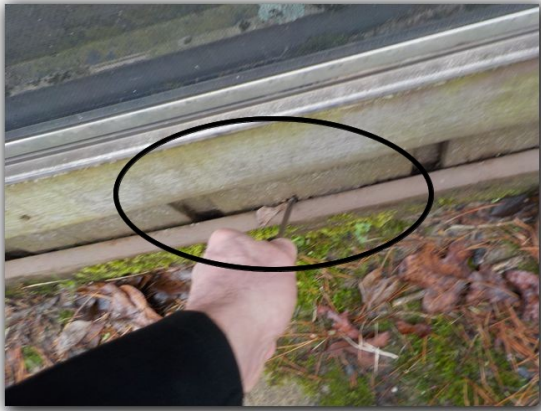
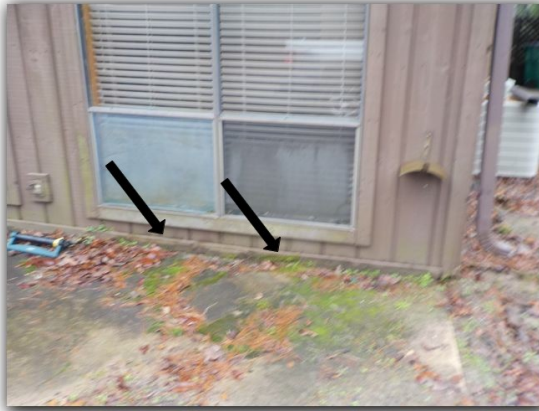
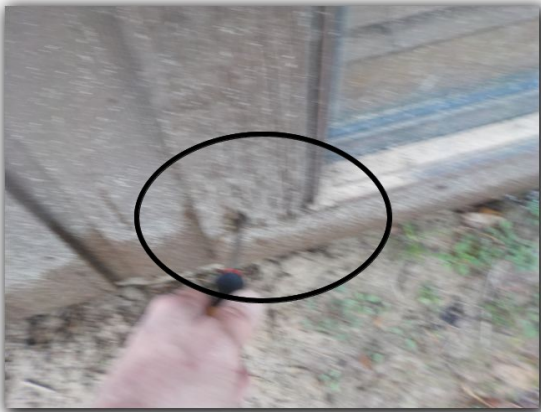
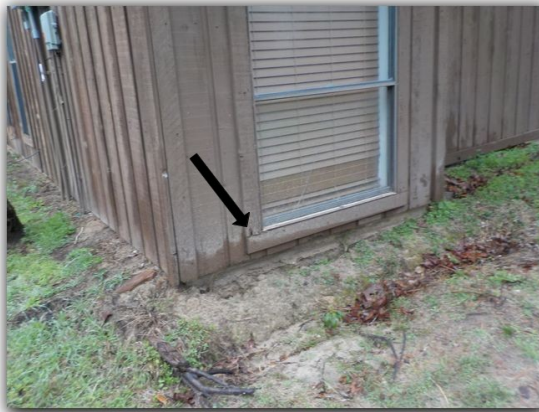
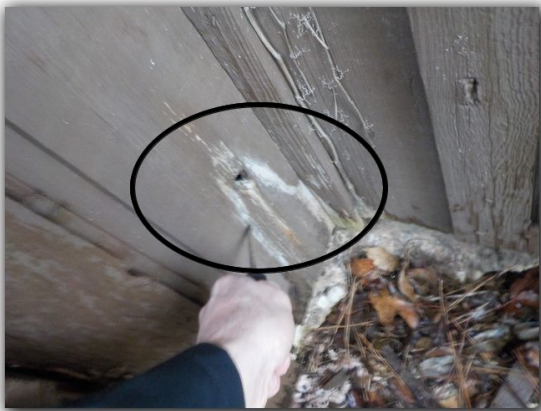
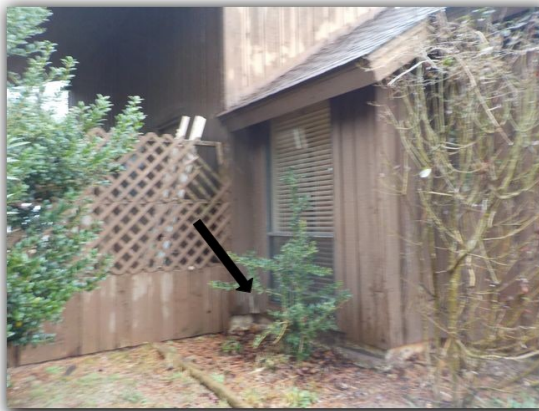
I observed various areas of very minor moisture damage noted on areas of exterior siding at time of inspection. Noted areas appear to be isolated to where water is allowed to splash onto home / siding. Area painted which will add protection. Recommend evaluation for possible repairs if desired, monitor for any more noticeable issues, and possibly paint / keep painted for additional protection.

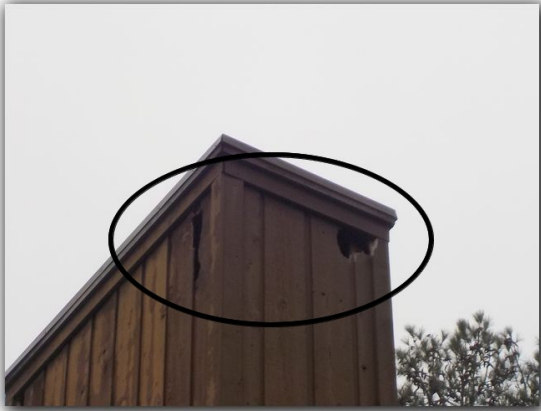
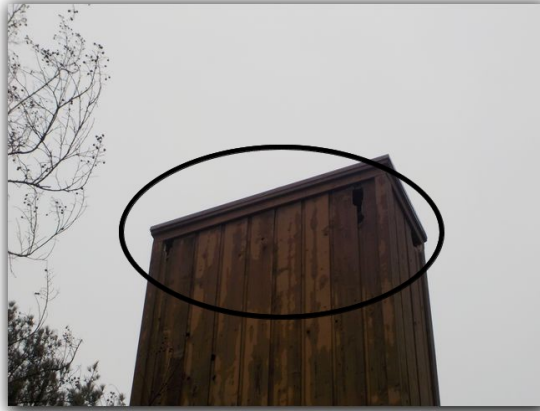
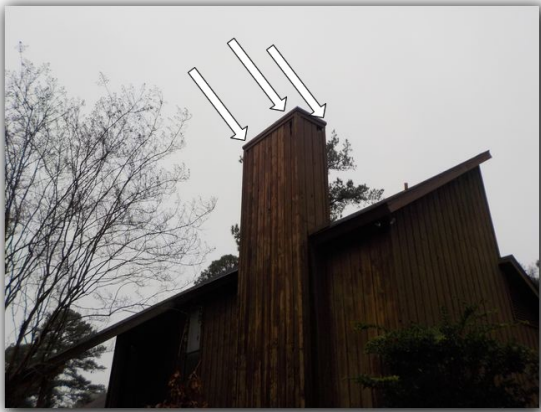
I observed obvious areas of damage noted to wood exterior chimney surround at time of inspection. Noted area conducive for possible unwanted animals and birds to make entry. Area noted also conducive for water entry under the right situation. No obvious evidence of moisture noted around veneer fireplace surround below affected area. Recommend evaluation for necessary repairs.

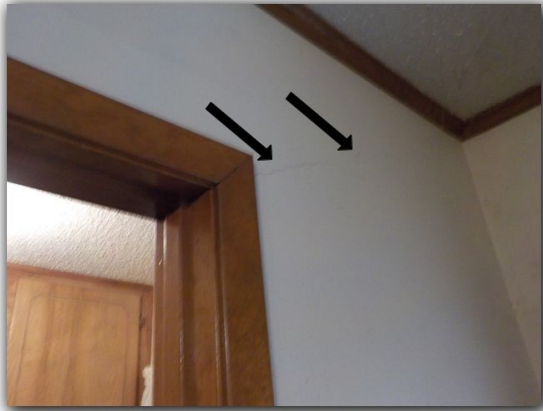
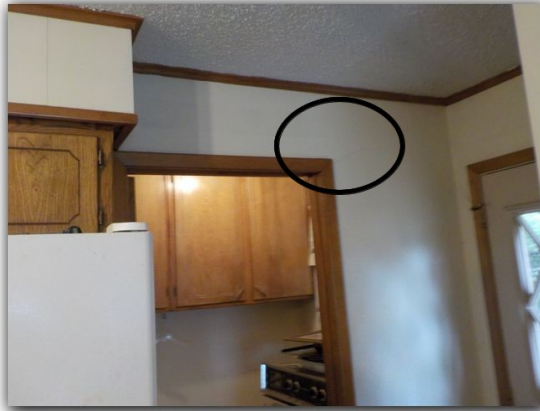
I observed minor seam crack(s) in the interior sheet rock walls at time of inspection. Areas noted appear to have been cause from settlement of the homes foundation and/or thermal expansion. Recommend monitoring noted areas for any noticeable changes

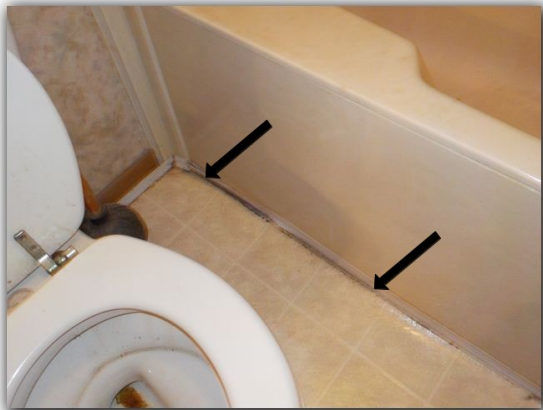
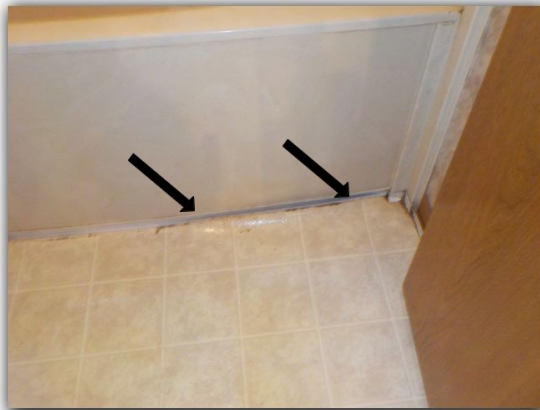
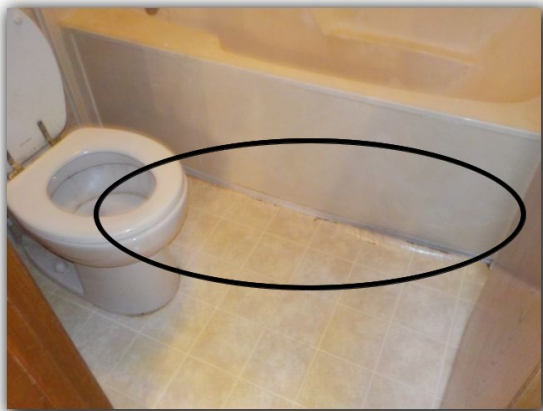
I observed possible areas with damaged linoleum flooring near upstairs master bathroom / tub at time of inspection. No obvious evidence of moisture near affected area when assessed with moisture meter. No obvious evidence of moisture staining / damage noted in living area below affected area. Recommend evaluation for possible repairs allowing flooring to work as efficiently as possible.

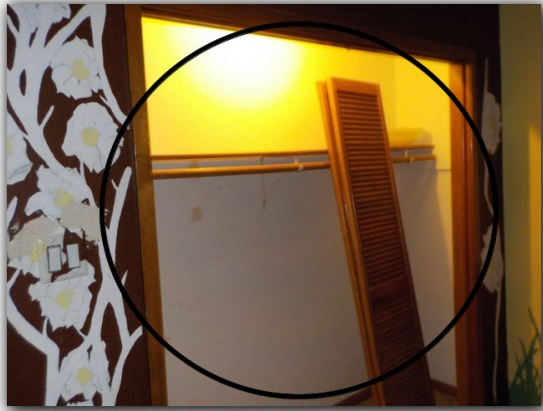
I observed where front left bedroom closet doors damaged / missing at time of inspection.

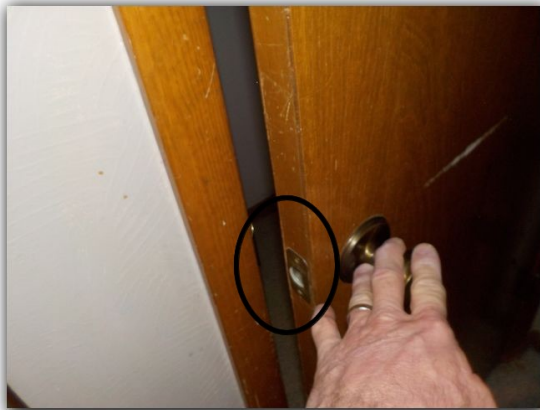
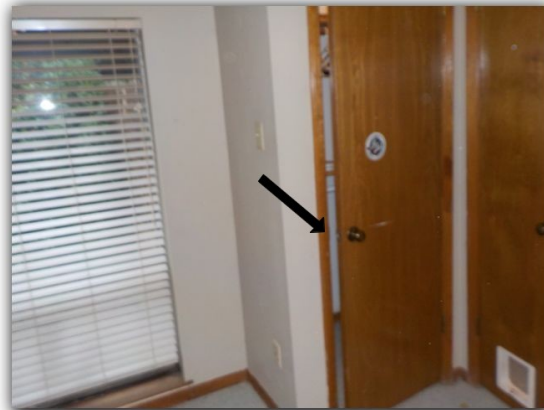
I observed where left rear bedroom closet door assembly missing at time of inspection.

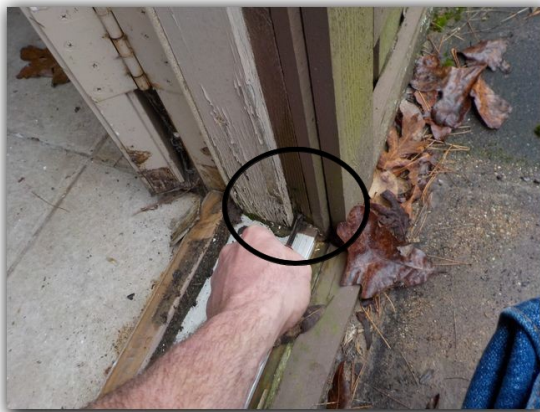
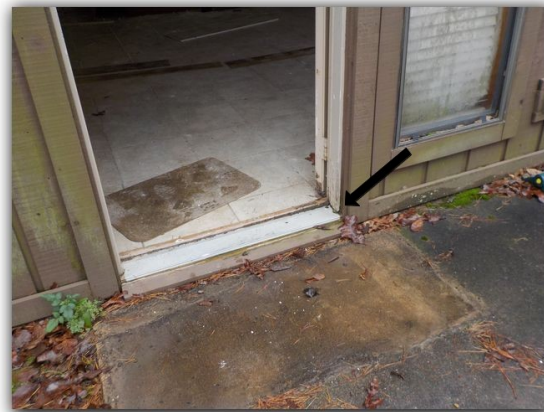
I observed areas near exterior door with minor moisture damage noted to wood surround / trim at time of inspection. Typical with contact from wind blown rain and possible wood to grade contact. Recommend evaluation for possible repairs if desired keeping area(s) painted for added protection.

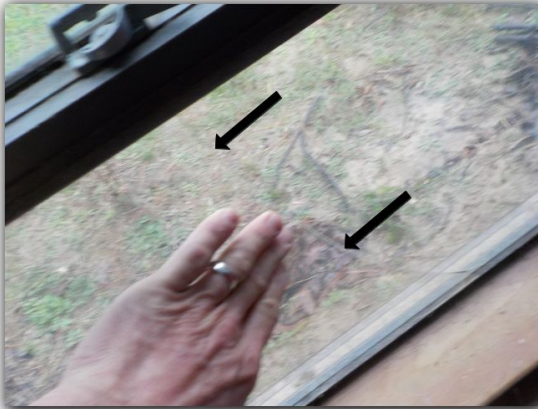
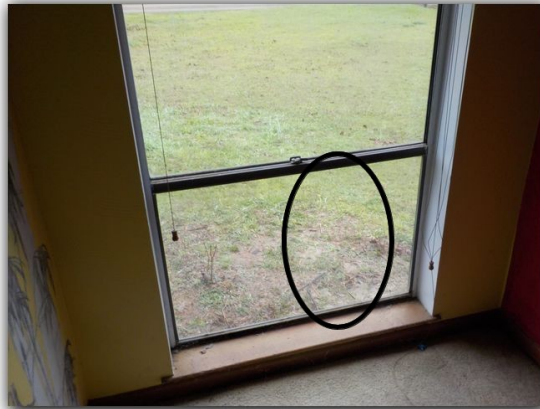
I observed a single cracked window pane in front left bedroom at time of inspection.

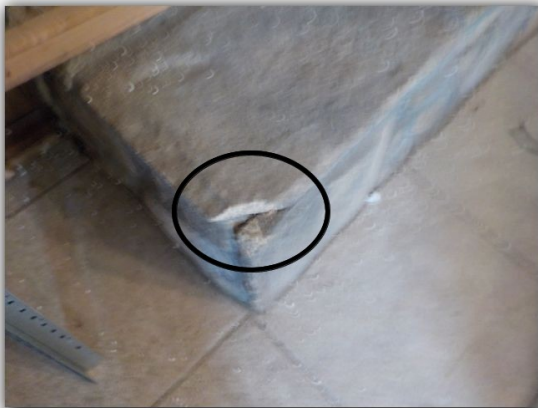
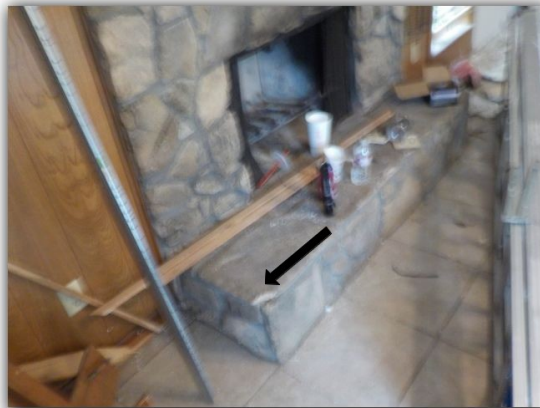
I observed a minor area of damage noted on fireplace hearth. Appears corner crack to rock veneer.

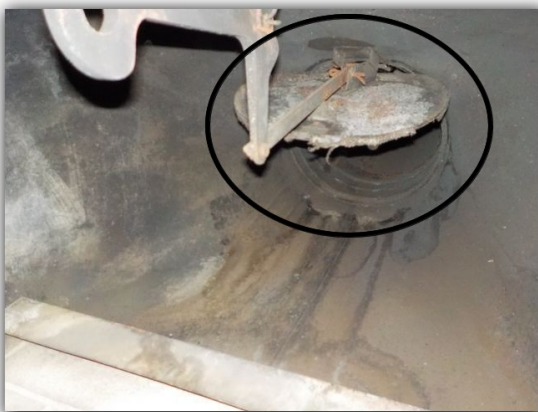
I observed where fireplace damper found open at time of inspection. Inspector was unable to close damper with attempts at time of inspection. Recommend evaluation for obvious repairs allowing home to work as efficiently as possible.
