*Home inspection for
Sample Report
Somewhere
Longview TX 75601*

David Smith Inspections

PROPERTY INSPECTION REPORT

Concerning: Somewhere, Longview, TX 75601
(Address or Other Identification of Inspected Property)

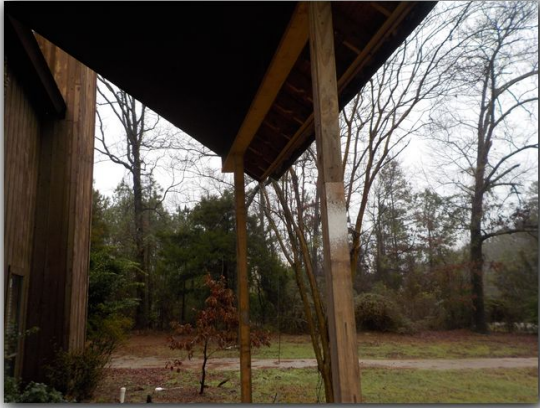
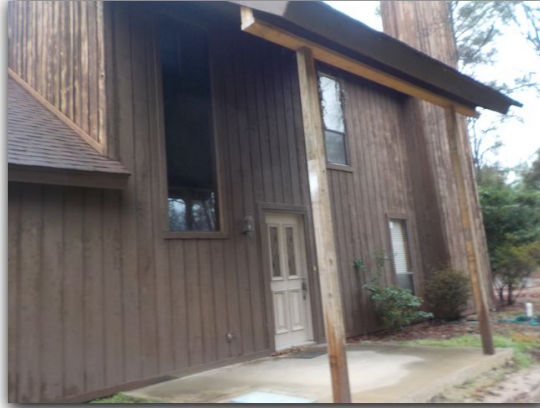
I observed where front porch secured with temporary posts at time of inspection. Recommend finishing out with appropriate and approved posts.

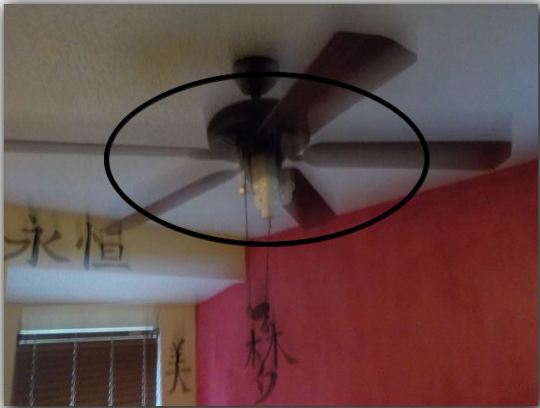
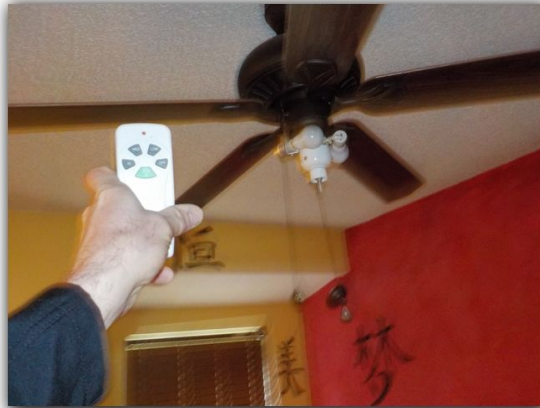
I was unable to get ceiling fan / light kit to come on in front left bedroom at time of assessment. Found unit to be on remote.

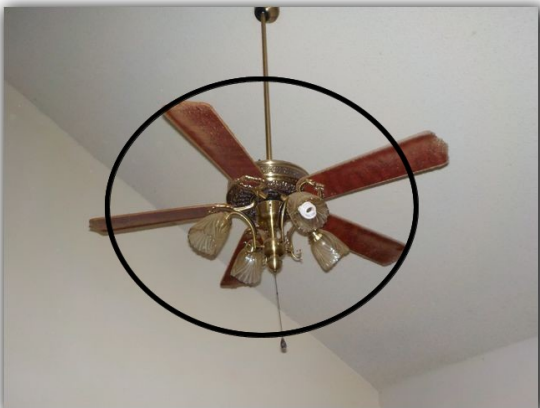
I was unable to get ceiling fan / light kit to come on in master bedroom at time of assessment. Found unit to be on remote

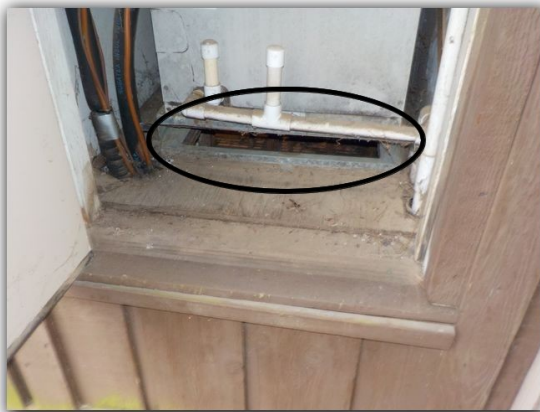
I observed where downstairs air handler found without any filter coverage at time of inspection. Areas of debris noted on A coil near affected area. Recommend evaluation for sealing noted area with appropriate filter allowing unit to work as should.

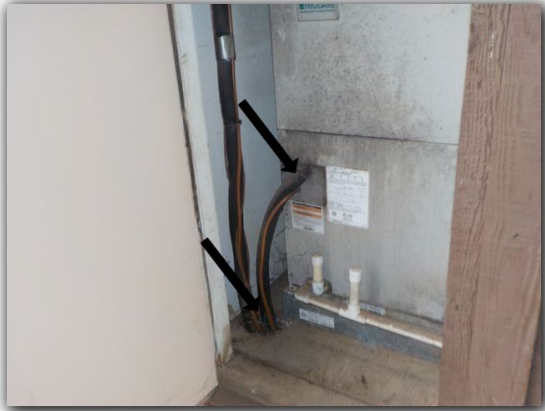
I observed where it appears several areas of insulation missing from AC return line near handler located in outside closet at time of inspection. Without appropriate insulation copper lines will sweat allowing for possible moisture concerns. In fact this appears to be the case. Areas of moisture staining noted on decking near handler under noted areas of exposed copper. This unit placed in an unconditioned closet which will allow for moisture to accumulate. Noted areas should be sealed with possible areas of ventilation added allowing for possible horizontal air movement. Prolonged exposures to moisture in dark environment could be an area of DARK mold. Recommend evaluation for adding insulation allowing copper line to work as should.

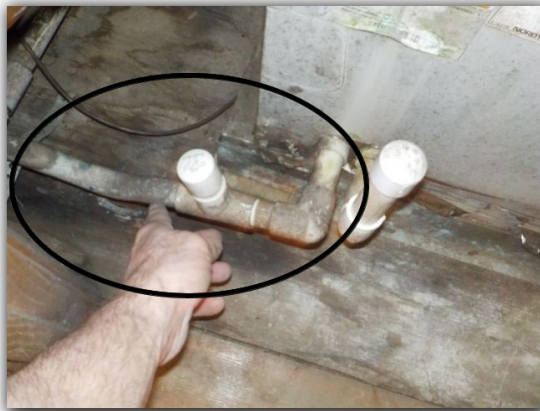
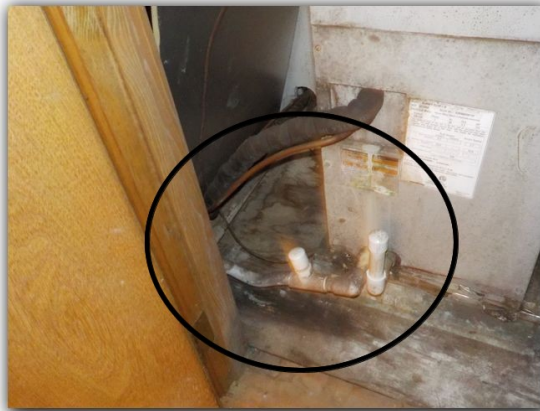
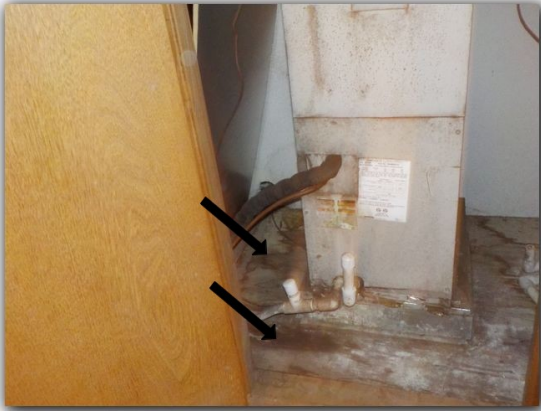
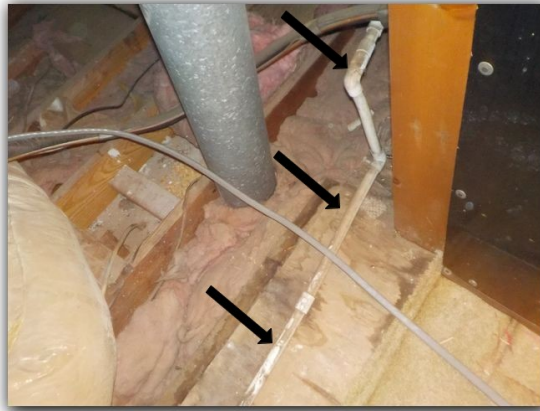
I observed areas of moisture staining noted on decking near handler in upstairs utility closet at time of inspection. This unit placed in an unconditioned closet near attic area which will allow for moisture to accumulate. Noted are should be sealed with possible areas of ventilation added allowing for possible horizontal air movement. Prolonged exposures to moisture in dark environment could me area of DARK mold. Recommend evaluation for adding insulation allowing copper line to work as should.

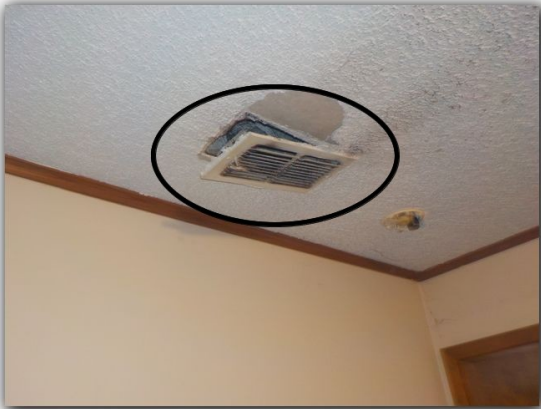
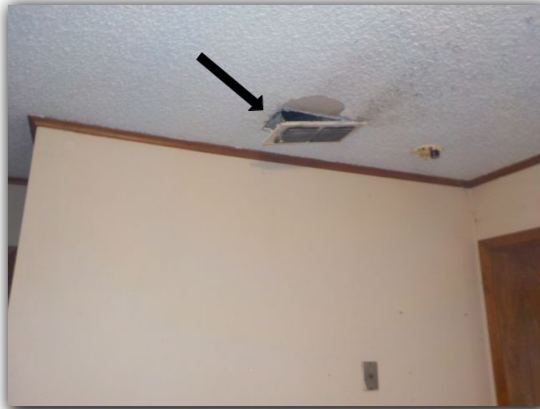
I observed where grill / register in kitchen area has separated from ceiling area at time of assessment.

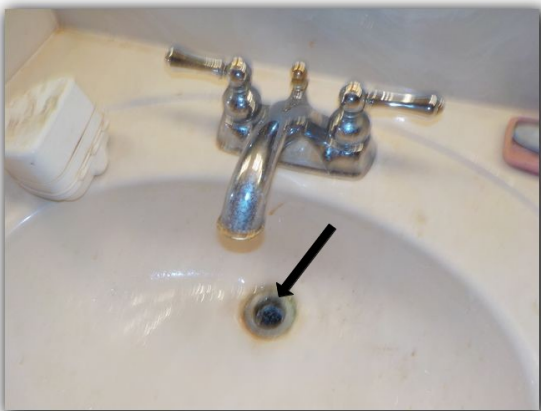
I observed where it appears that master bathroom sink drain stop was not installed appropriately at time of inspection. Recommend evaluation for installing drain stop per manufacturer specifications allowing drain stop to work as should.

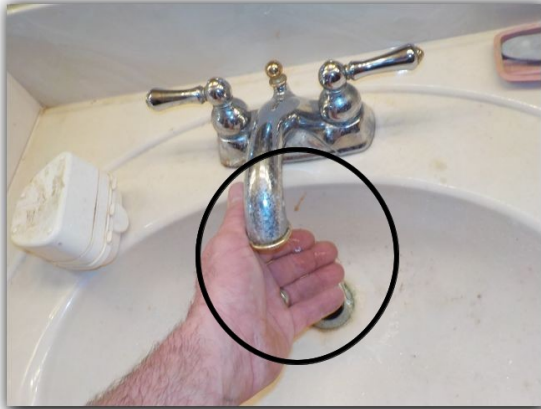
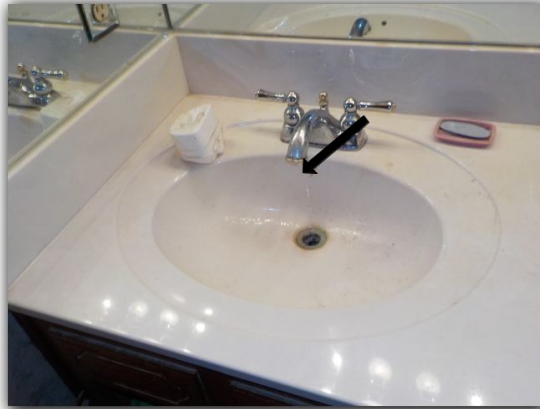
I observed where master bathroom sink fixture presenting with minor water flow when not in use at time of inspection. Most likely damaged or faulty seal. Recommend evaluation for possible repairs allowing tub/shower to work as should.

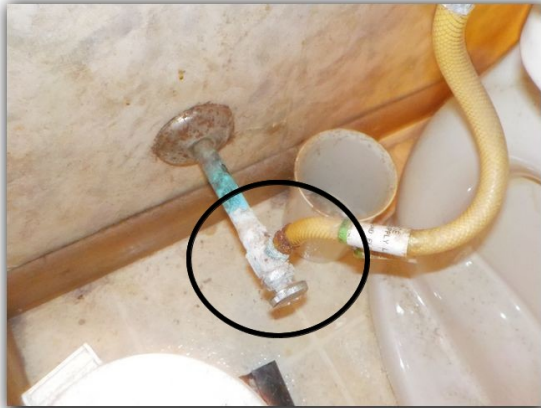
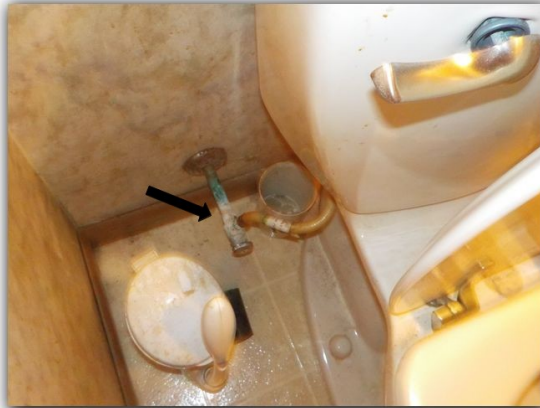
I observed what appears to be rusty crust on cold water shut off for master bathroom commode. This could be galvanic corrosion, an electrochemical disintegration that happens when two different metals are in contact with each other while also in contact with an electrically conductive liquid, typically water. Recommend evaluation of noted area for possible repair.

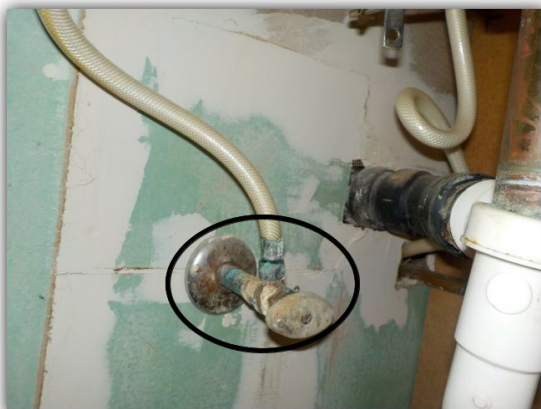
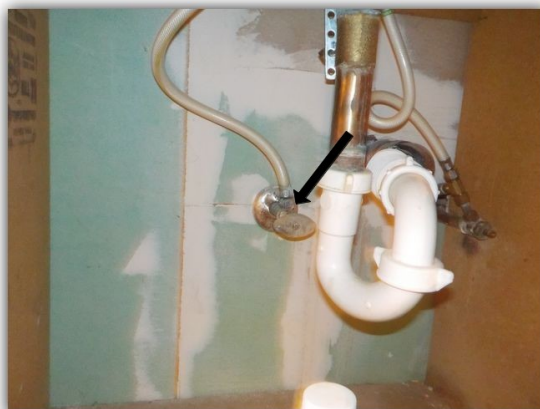
I observed what appears to be rusty crust on hot water shut off / connection(s). This could be galvanic corrosion, an electrochemical disintegration that happens when two different metals are in contact with each other while also in contact with an electrically conductive liquid, typically water. Recommend evaluation of noted area for possible repair.

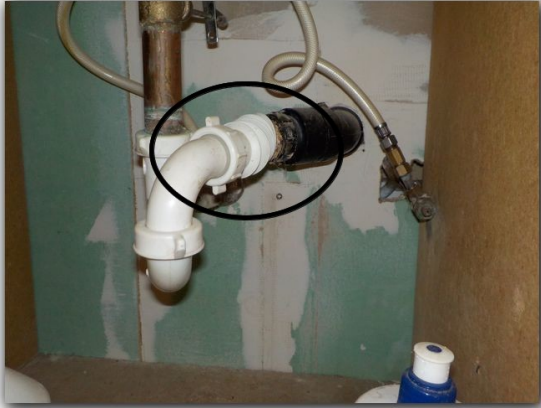
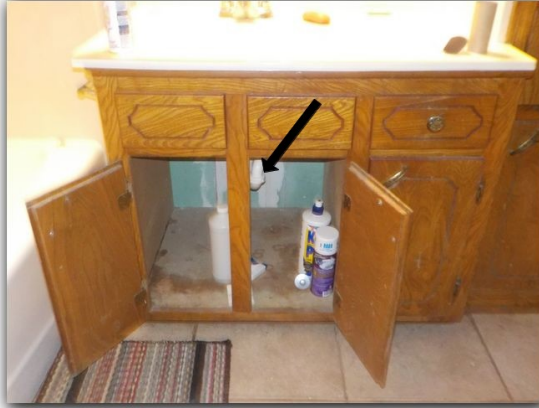
I observed where hallway bathroom sink / drain presenting with flex drain line at time of inspection. Flexible and / or corrugated drainpipe may contribute to possible blockages at a bathroom sink(s). Although currently functioning, it is recommended that this be replaced with the proper drain material.

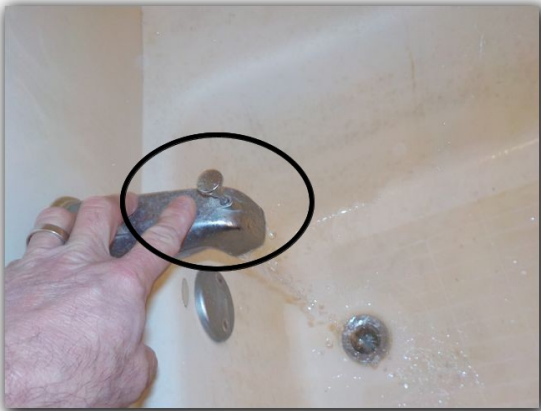
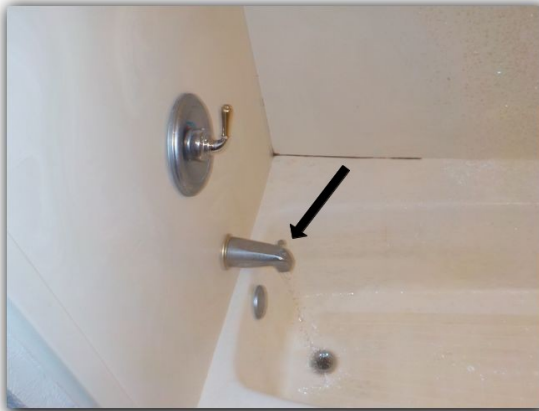
I observed where hallway bathroom tub / shower diverter would not open and/or close all the way when in use. Water found to flow when shower in use. Recommend evaluation for possible repairs and/or replacement allowing for normal function. *Note: Noticeable mineral buildup / deposits noted on bathroom fixtures at time of inspection. This lime scale type build up is not considered to be harmful but may clog various fixtures as well as making cleaning noted areas more difficult. Vinegar, baking soda, or lemon juice are a few ideas for cleaning noted surfaces. Areas noted appear to be cosmetic in nature and not considered a deficiency.*

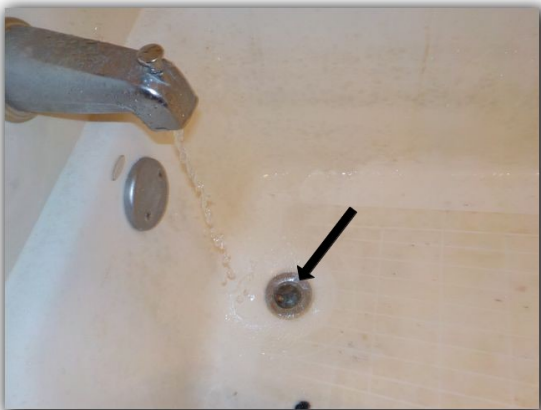
I observed where it appears that hallway bathroom bathtub / shower drain stop was not installed appropriately at time of

inspection. Recommend evaluation for installing drain stop per manufacturer specifications allowing drain stop to work as should.

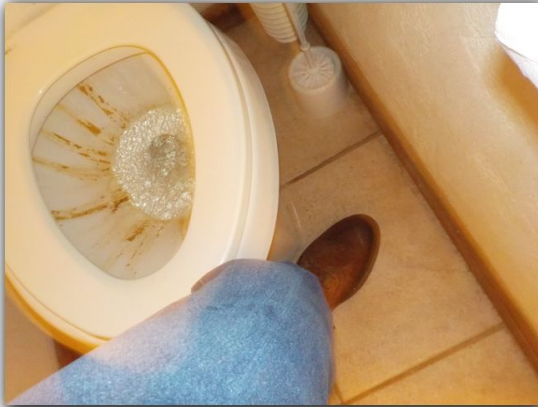
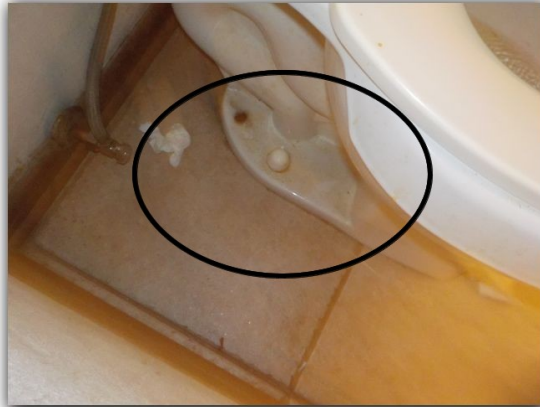
I observed where hallway bathroom commode found loose to touch at time of inspection. No evidence of leaks noted along commode flange during assessment. Recommend evaluation for securing commode appropriately allowing for normal use.

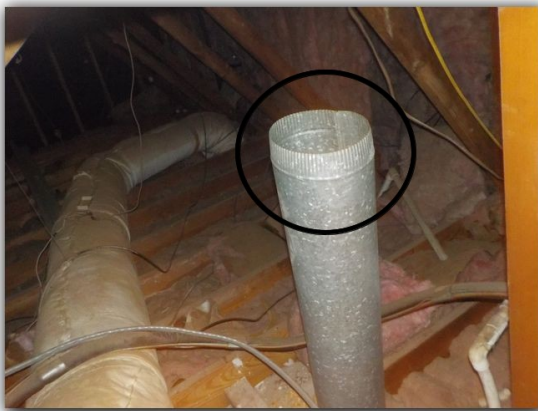
I observed where kitchen range hood exhaust terminates into attic area. The duct for kitchen range should not terminate in attic area, crawl spaces, or any other areas inside the building unless specifically allowed by manufacturer. Would recommend duct work terminate outdoors.

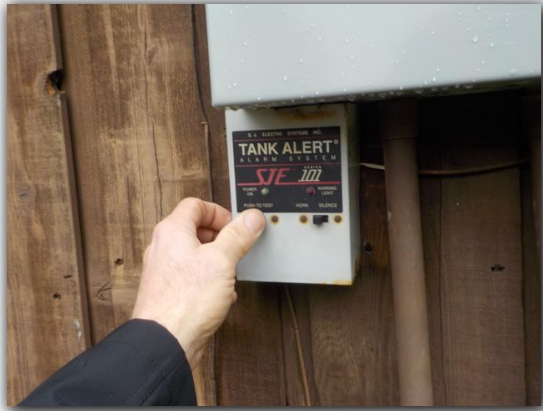
Aerobic system near back of lot assessed and appears to be in serviceable condition. Found aerator running on system as well as active alarm checked. No manual pump check found. Ran water in 2 tubs for approx. 40 min averaging some 60-80 gallons every 10 minutes. Unable to verify whether pump working at time of assessment. If unit has been vacant for any longer period tanks will drain keeping inspector from running appropriate amount of water allowing tank to drain as should. Recommend evaluation from qualified contractor for checks to verify if unit in good working condition.

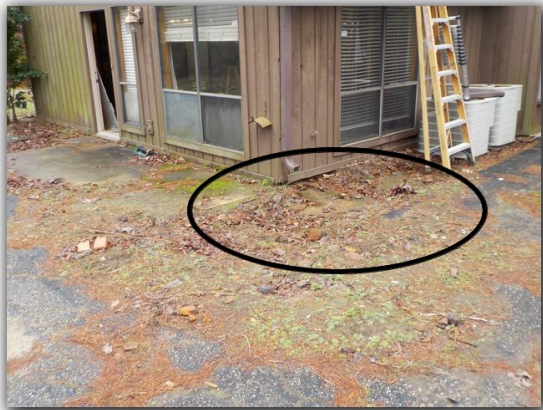
Possible improper slope of grade along the homes foundation; these areas should be monitored and if water is draining or pooling along the homes foundation then corrective action will be needed.

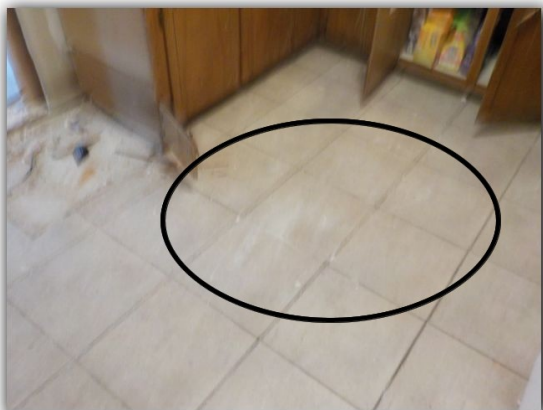
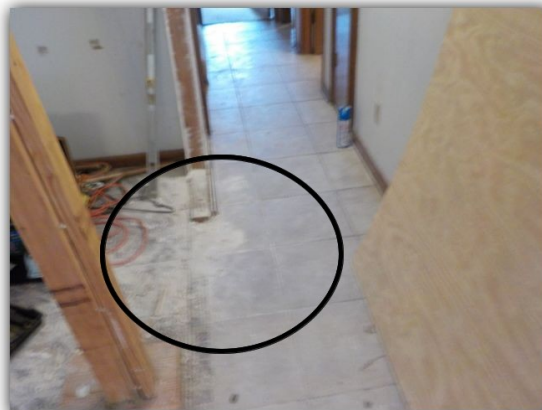
I observed 2 areas in home near kitchen and foyer / hallway where there appears to minor low spot in concrete at time of inspection. Does not appear to be structural in nature with no obvious residual damage noted to interior walls, ceilings, and / or floor tile. Slabs are not perfectly flat when poured with possible areas of depressions found. Any certain issues with cracked, heaved, and/or settled slab would create obvious damage to noted tile over affected areas with possible differential heights. Areas difficult to observe but inspector just making note for possible reference.

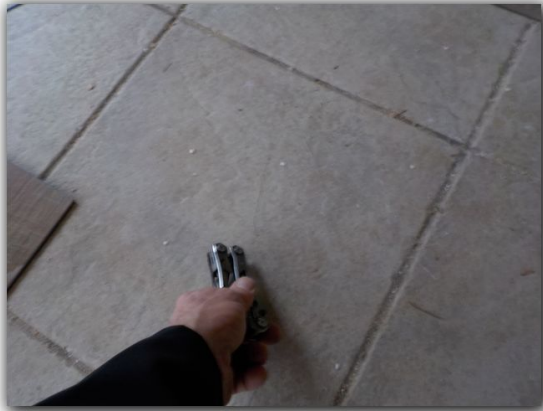
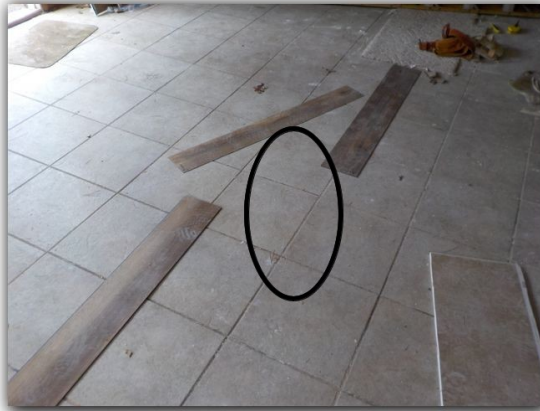
Living room area

I observed minor tile cracks in various areas of living room at time of inspection. Area(s) appear to have been cause from normal settlement of the homes foundation, typical stress or shrinkage crack, and/or thermal expansion / shrinkage of cured concrete. Areas found do not exhibit horizontal movement (normal) found on all slabs without the proper control joints. These are very typical and even happen in slabs with control joints. No other evidence of possible movement noted near affected areas in kitchen and foyer area. Cracks should be monitored for any noticeable changes.

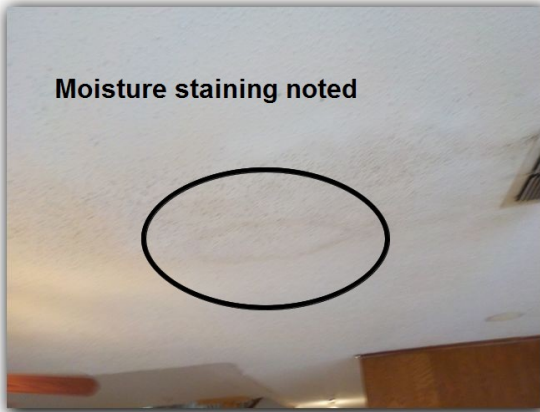
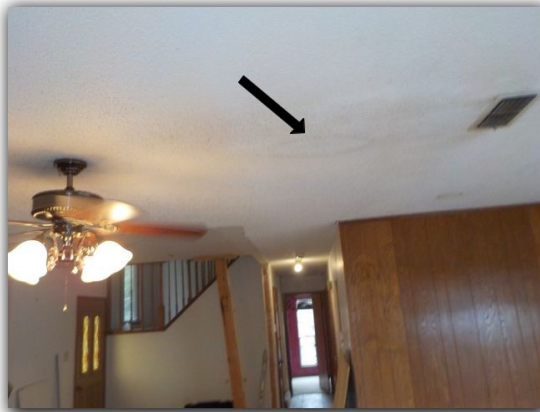
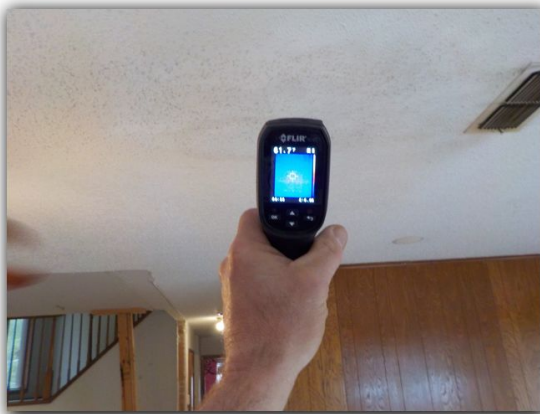
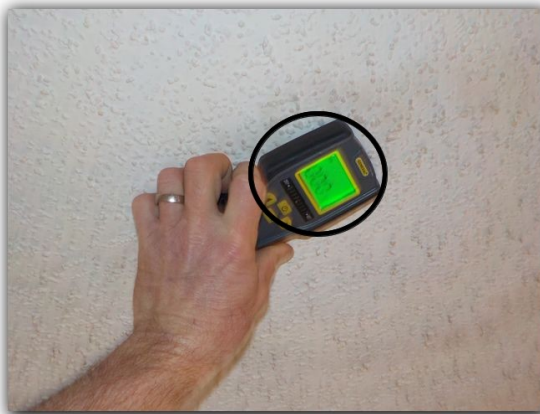
Living room area

I observed an area of moisture staining noted near center of living room ceiling at time of inspection. Further investigation found no obvious evidence of moisture when assessed with moisture meter and thermal camera. Area land marked by HVAC grill in living room finding no obvious evidence of moisture concerns found in attic area above. Appears moisture staining falls under inside corner of master bedroom. No obvious evidence of moisture noted as well. Recommend monitoring noted area for any noticeable changes.

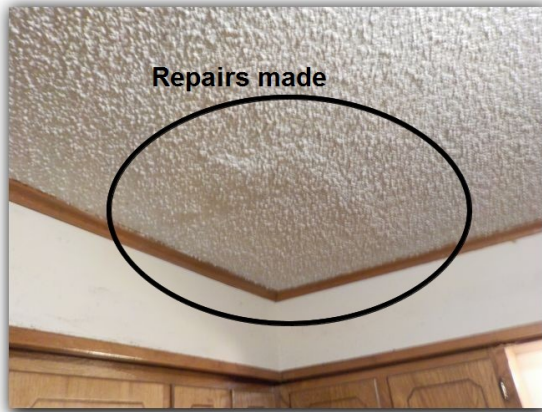
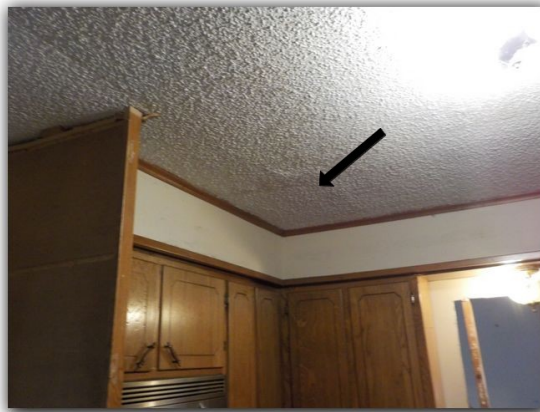
Kitchen ceiling

I observed an area of possible moisture damage with what appears to an attempt to repair damaged sheet rock in kitchen area. No obvious discoloration noted to affected area but obvious where moisture allows for rock to fall near made

up seams. Further evaluation found where HVAC closet installed directly above with area of condensate line called out for obvious moisture concerns. Appears cold condensate line in unconditioned attic / closet allowing for moisture to buildup allowing water to drip down onto noted damaged ceiling. Area called out in AC section of report.

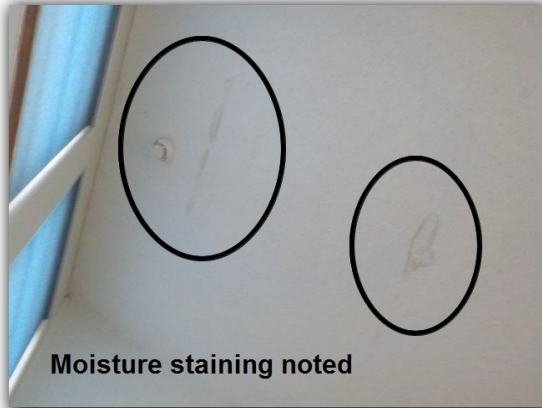
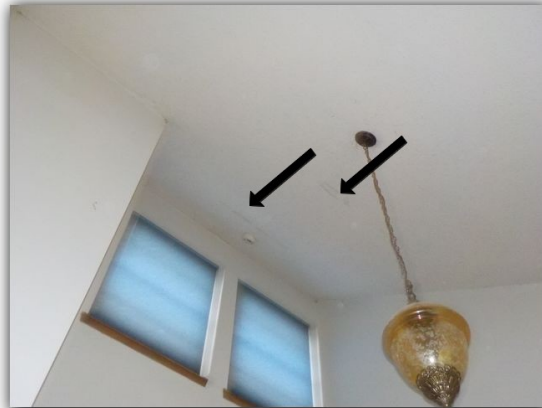
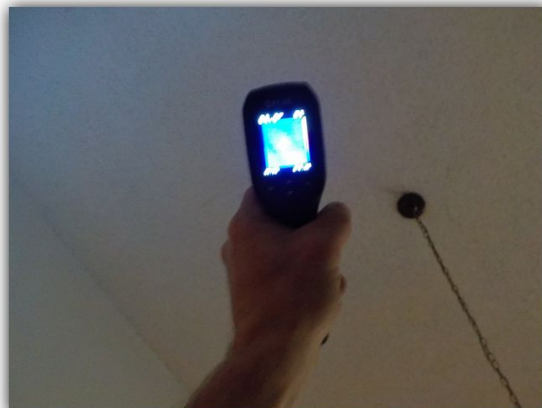
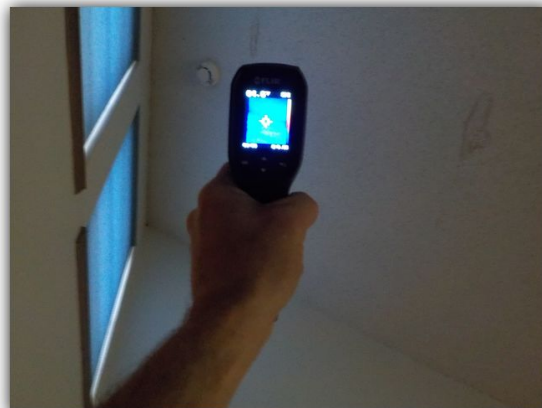
Area over stairs

I observed areas of moisture staining noted on vaulted ceilings over stairway at time of inspection. Areas too high to put hands on but moisture meter finding no obvious water entry. Roof evaluation found no obvious evidence of moisture entry noted. Recommend monitoring noted areas for any noticeable changes.

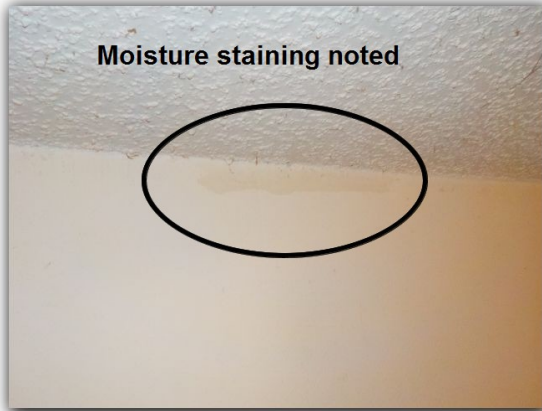
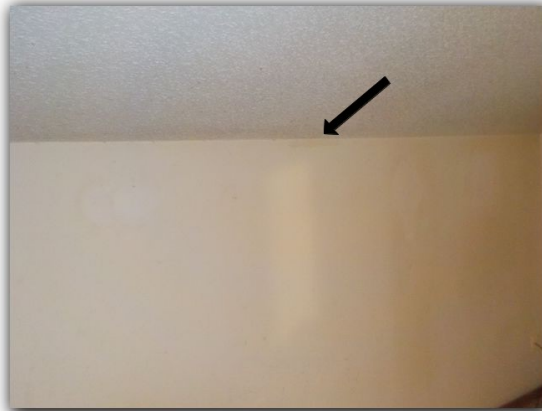
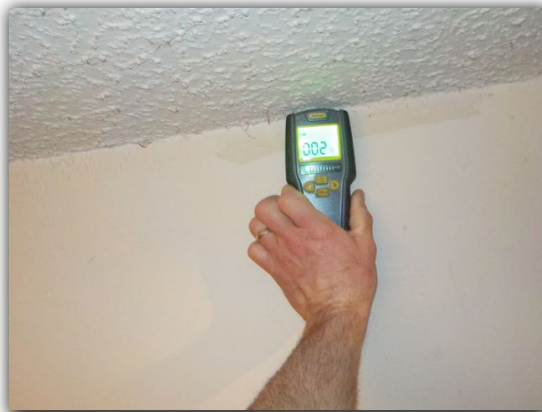
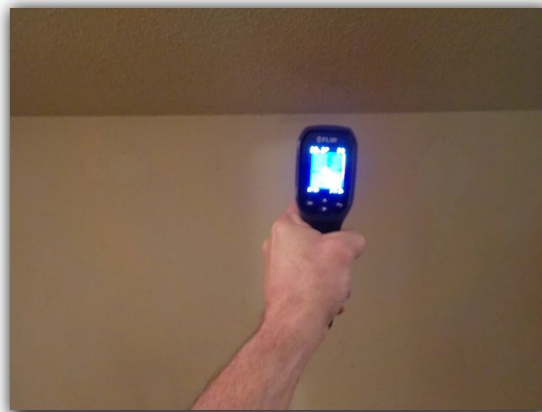
Left upstairs bedroom

I observed an area of possible moisture staining / moisture damage noted in upstairs left bedroom at time of inspection. Further investigation found no obvious evidence of moisture noted with moisture meter and/or thermal camera. No obvious evidence of deficiencies noted on roof area above all noted areas. Recommend monitoring noted areas for any noticeable changes.
