*Home inspection for
Sample
Somewhere
Henderson TX*

PROPERTY INSPECTION REPORT

Concerning: Somewhere, Henderson, TX
(Address or Other Identification of Inspected Property)

By: David Smith, Lic #21666 12/07/2019
(Name and License Number of Inspector) (Date)

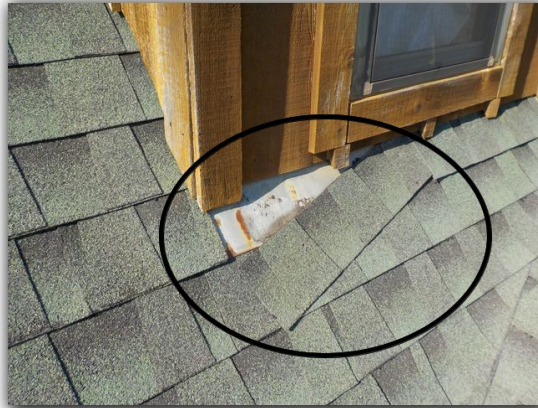
☒ I observed where a single shingle has pulled loose from top left upstairs bedroom near dormer at time of inspection. Shingle appears to be cosmetic in nature covering window / dormer base flashing. Recommend repairs keeping shingle from possible tearing away completely.

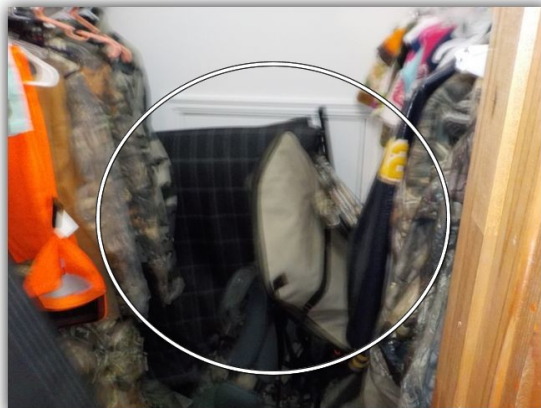
Unable to make entry into attic area in closet

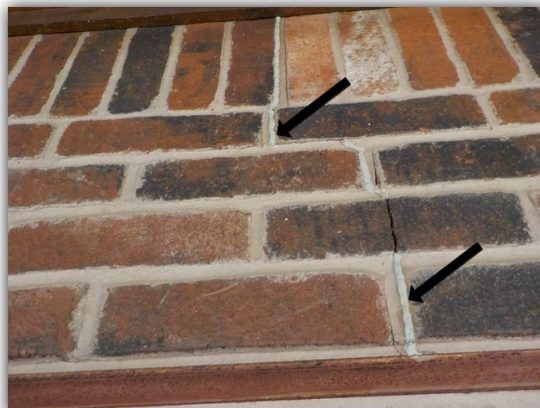
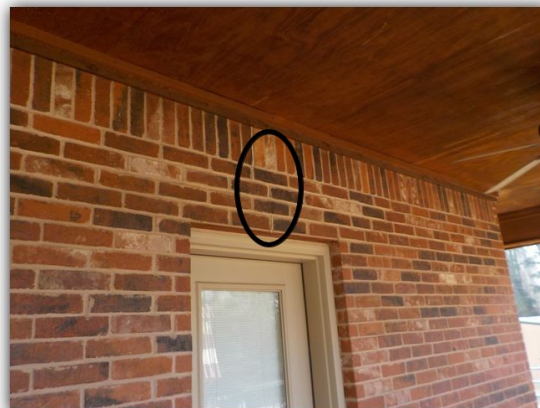
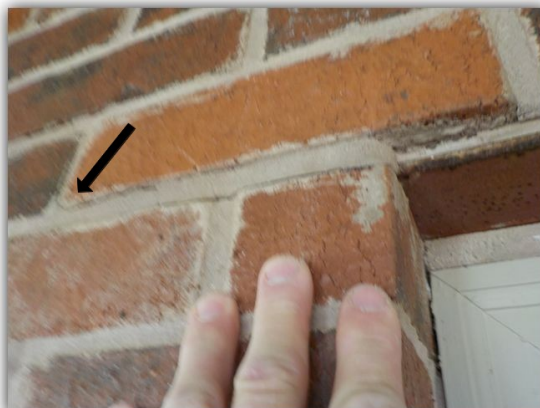
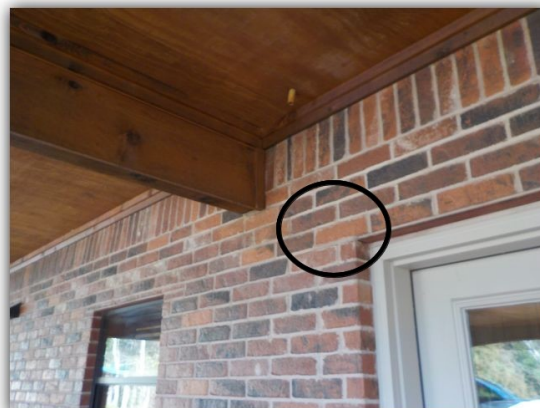
☒ I observed minor mortar cracking in veneer siding at time of inspection. These cracks are typically due to thermal expansion and/or minor structural movement. Brick walls may expand (when heated) and contract (when cooled) and by doing so may do sufficiently enough to cause damage in mortar joints. These areas should be monitored for any noticeable changes that may occur.

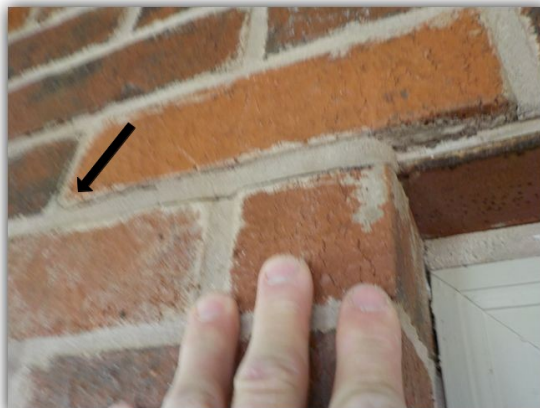
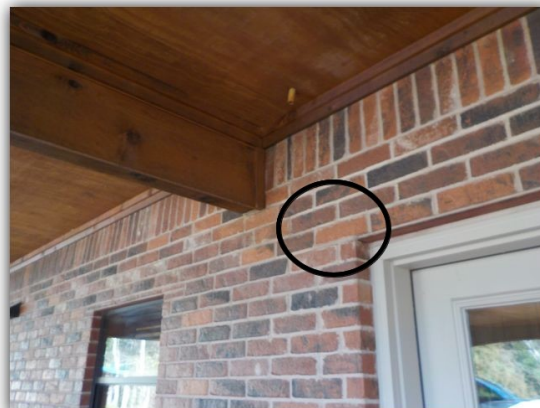
☒ I observed where brick / window lintels were not painted at time of inspection. When the metal lintels rust they tend to expand which could damage and/or crack brick and/or mortar. Recommend the lintels be cleaned, sanded/brushed, primed and painted with a quality rust inhibiting paint. Also, recommend periodic maintenance and touch-up.

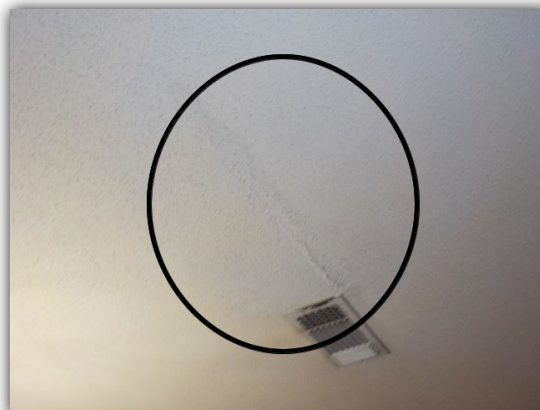
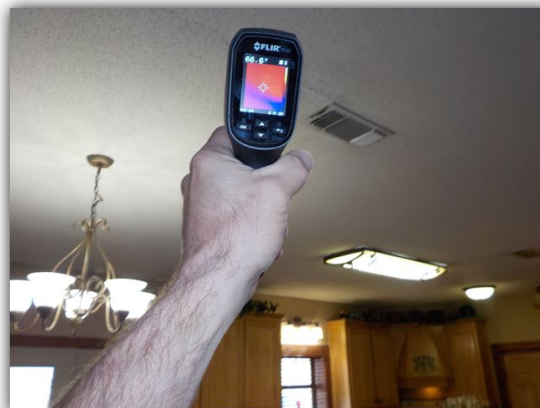
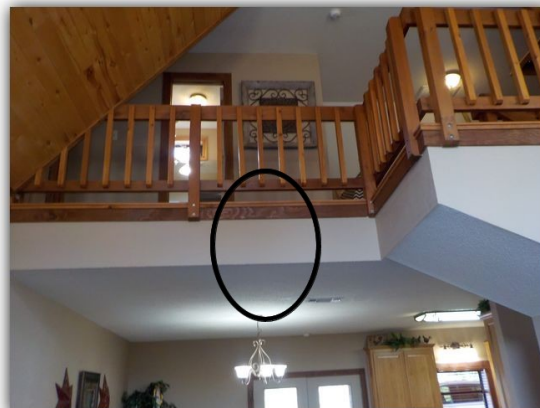
Kitchen / nook area

☒ I observed an area of moisture staining in nook / living room area at time of inspection. Further evaluation found no obvious evidence of moisture when assessed with meter and/or thermal camera. Appears area lies below upstairs hallway bathroom. Evidence of caulk placed near tub/floor and shower spout. Note: shower spouts very typically create conducive conditions for leaks when not sealed appropriately. Recommend monitoring areas for any noticeable changes.

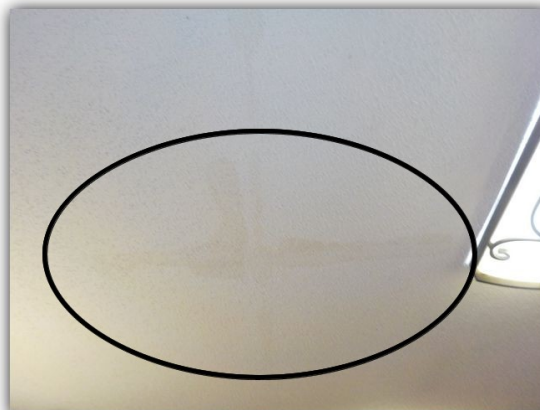
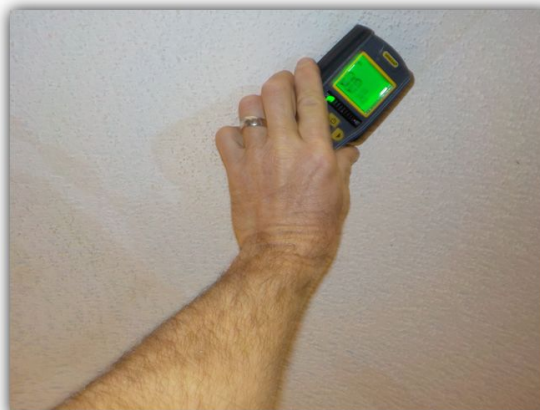
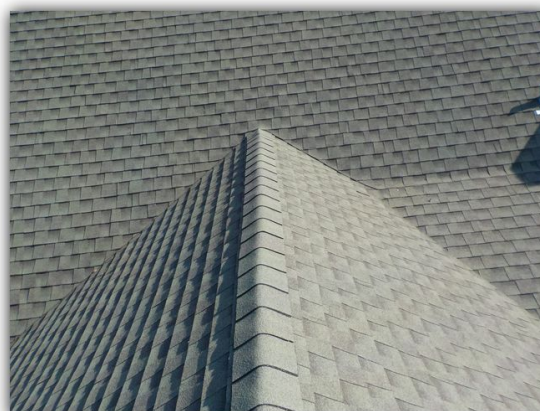
Kitchen area

☒ I observed an area of moisture staining found in kitchen area at time of inspection. Further investigation did not find positive evidence of moisture with meter and/or thermal camera during assessment. Roof evaluation found roof valley which may have allowing for possible water entry in the past. Most likely newer roof has remedied any moisture entry concerns. Recommend monitoring noted area for any noticeable changes.

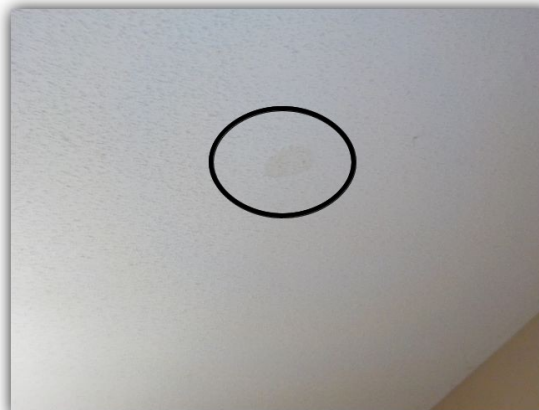
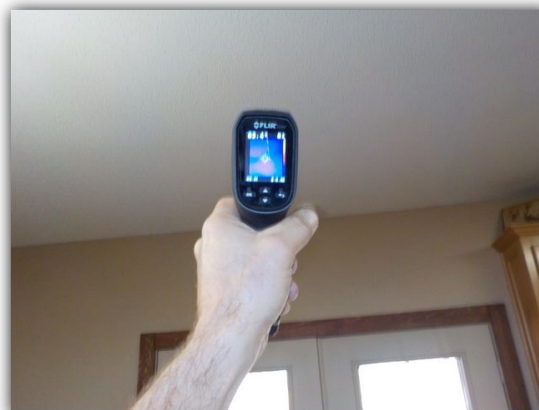
Nook area

☒ I observed a minor area of moisture staining near breakfast nook / back door off kitchen area at time of inspection. No obvious moisture noted with moisture meter and / or thermal camera. Roof area above finding no obvious evidence of moisture entry concerns. Possible damaged plumbing vent stack over affected area. Appears newer roof remedied any past concerns. Recommend monitoring noted area for any noticeable changes.

- *Note: unable to verify if newer roof has remedied any past moisture entry concerns at time of inspection.*

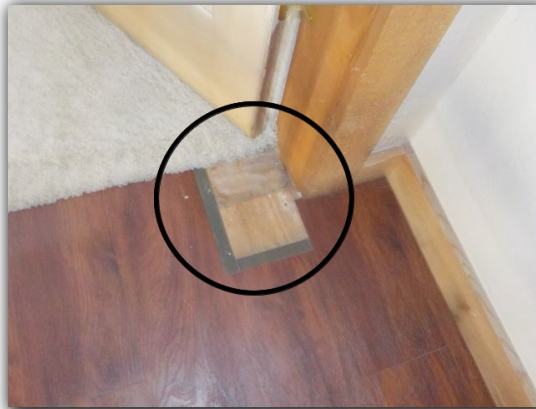
☒ I observed a minor area near top left bedroom where piece of vinyl flooring missing at time of inspection.

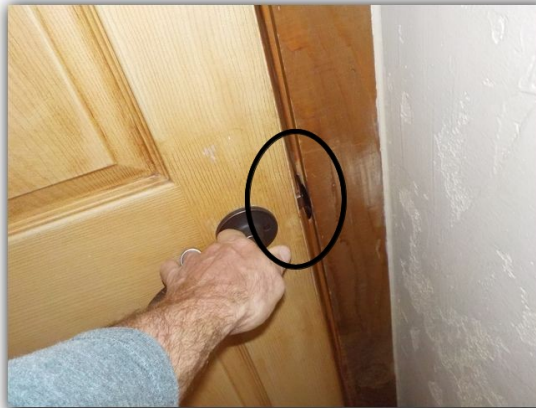
Downstairs bedroom door

☒ I observed where door would not close properly at time of inspection. Most likely door out of alignment. Recommend possibly moving strike plate on door jam allowing door assembly to latch and close as should.

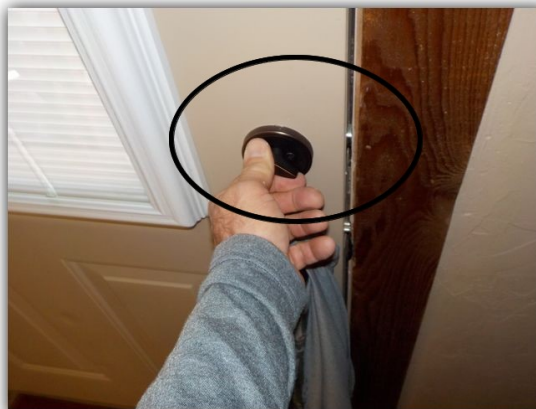
☒ I observed where master bathroom exterior door found out of alignment making use of deadbolt difficult to lock / unlock. Found damaged / loose hinge near top of door. Recommend evaluation for securing noted anchors for door allowing door to work as should.

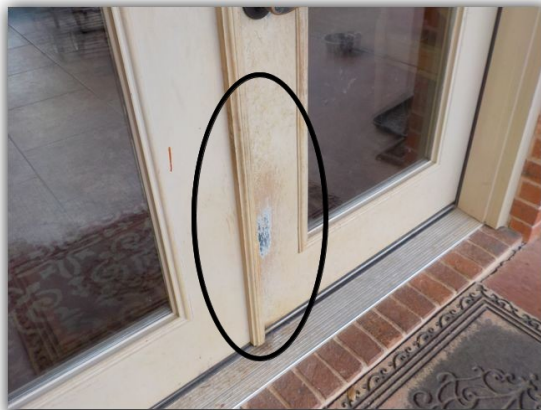
☒ I observed an area of cosmetic damage noted to French doors near back porch at time of inspection. Damaged noted appears to have been created by family pet(s).

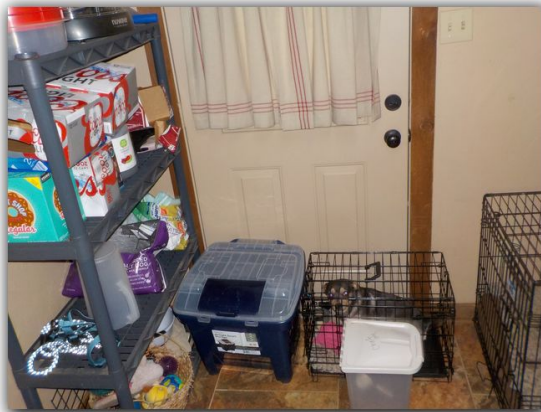
Unable to verify utility room door.

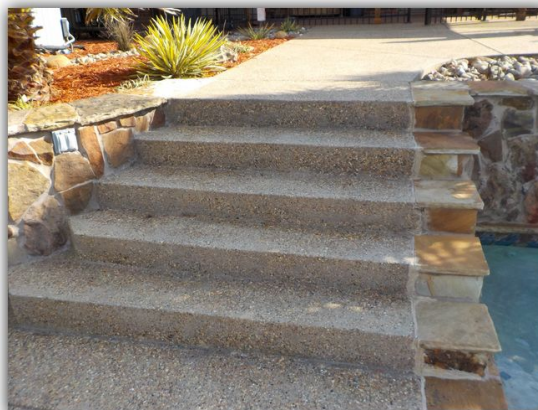
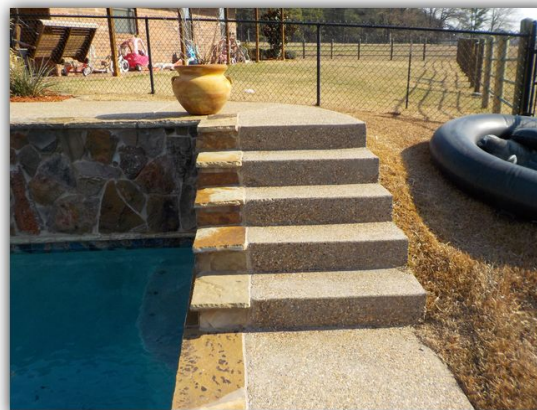
☒ I observed where some of the exterior stairs do not have a hand rail on either side. Typically on any interior or exterior flight of stairs having more than 4 risers they should have a hand rail on one side of the stair. Would consider adding appropriate hand rail for safety purposes.

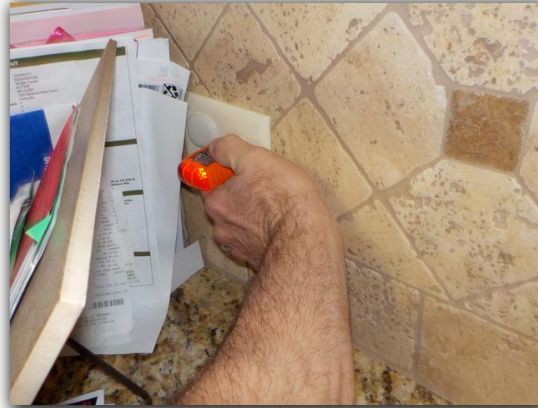
Missing GFCI protection in kitchen area

☒ No GFCI/ARC Fault protection at one or more location. This is considered a recognized safety hazard. GFCI protection was not provided in the home at locations where it is now deemed necessary. GFCI protection may not have been required at the time the home was built, but for safety reasons it is recommended that GFCI protection be installed at all the following locations: • Bathrooms • Exterior • Garages • Crawlspace (at or below grade) • Unfinished basements • Kitchens • Laundry rooms • Within 6 feet of all plumbing fixtures. Recommend evaluation for possible repairs and / or replacement of deficient receptacles for added safety.

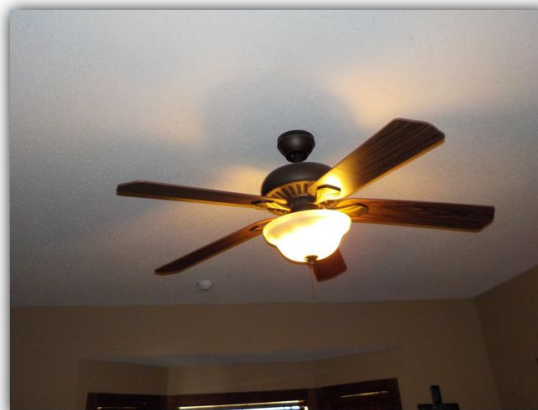
☒ I observed where ceiling fan in master bedroom would not work with attempts at time of inspection. Appears pull cord for fan is missing. Recommend evaluation for repairs allowing ceiling fan to work as should.

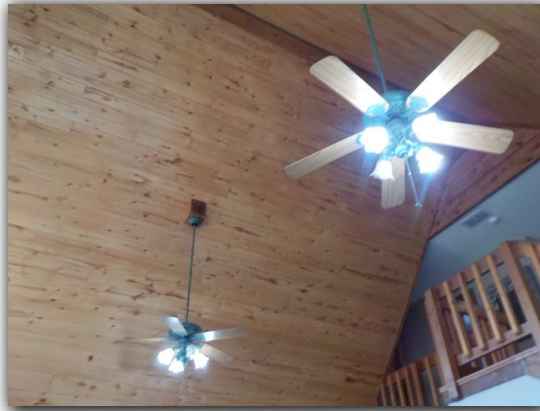
Note: unable to verify ceiling fans in living room area. Appears that fans in off position and unable to reach fixtures to attempt to pull cord.

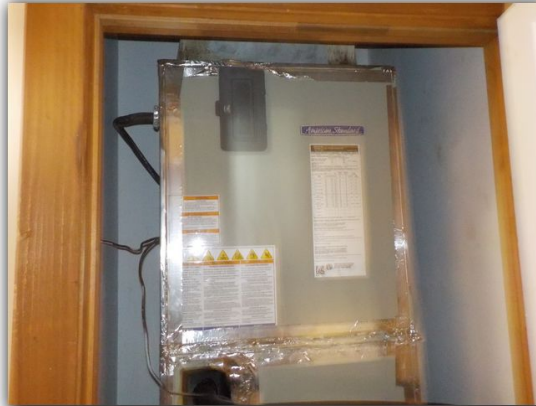
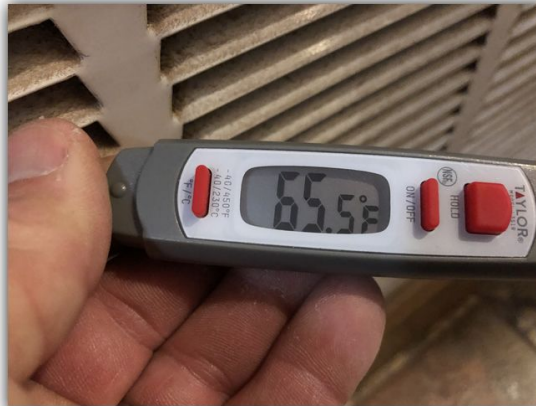
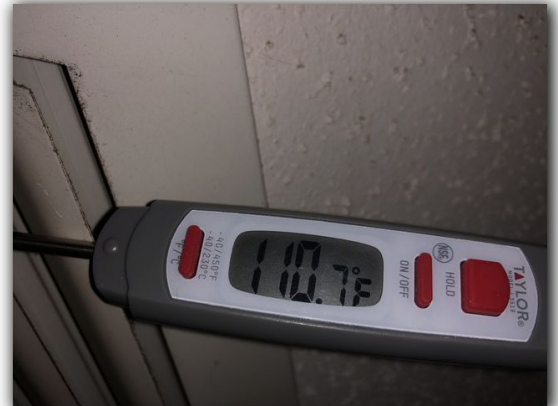
TEMPERATURE RISE BETWEEN SUPPLY AND RETURN AIR WAS: 45 degrees

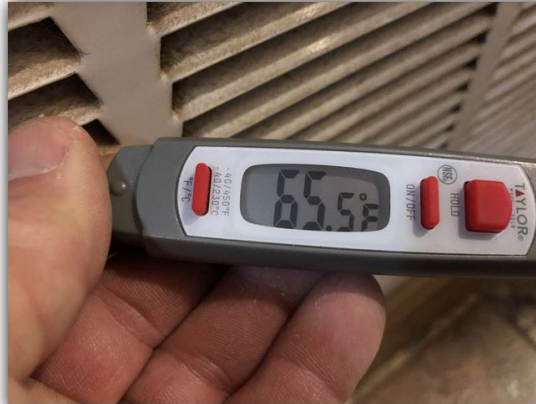
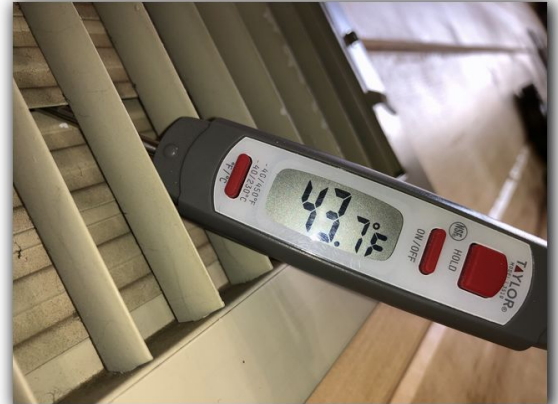
TEMPERATURE DROP BETWEEN SUPPLY AND RETURN AIR WAS: 22 degrees -OK- Normal temperature drop is between 14-23 degrees. AC system allowed to run for over an hour taking differential as close to air handler as possible.

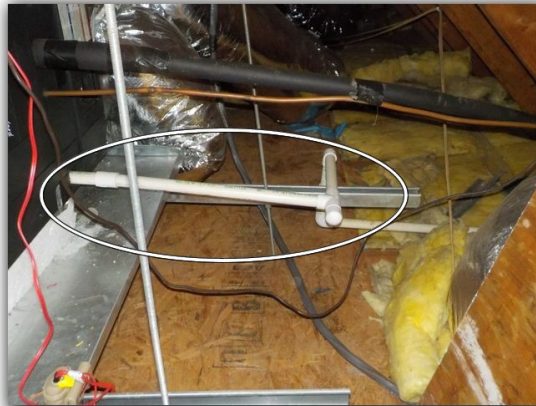
Note: I observed where condensate line for AC system found without insulation in attic area at time of inspection. Very common for condensate line to 'sweat' in attic area creating possible conducive conditions for moisture which could potentially leak onto sheet rock below. *A hot attic plus cold condensate water from AC = condensation.* A good recommendation would be to insulate condensate line for approx. 6 feet near air handler keeping moisture from possibly dripping onto sheet rock ceiling below.

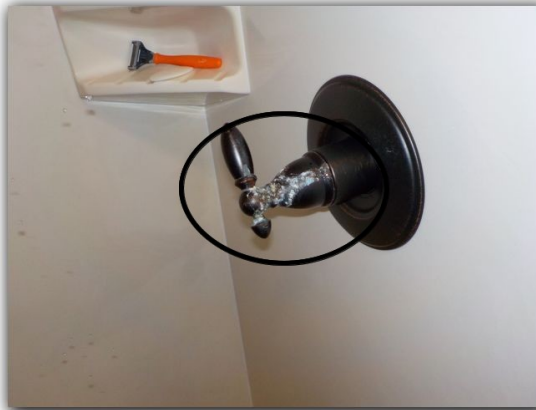
Note: Noticeable mineral buildup / deposits noted on bathroom fixtures at time of inspection. This lime scale type build up is not considered to be harmful but may clog various fixtures as well as making cleaning noted areas more difficult. Vinegar, baking soda, or lemon juice are a few ideas for cleaning noted surfaces. Areas noted appear to be cosmetic in nature and not considered a deficiency.

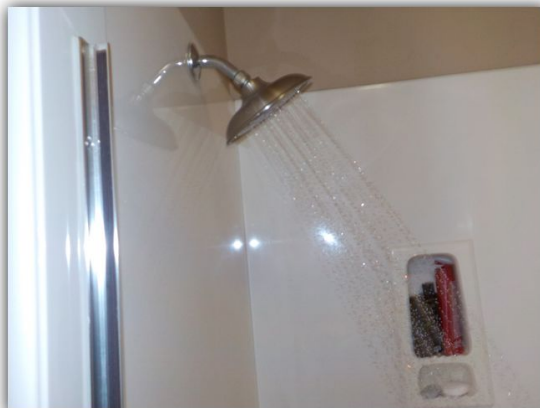
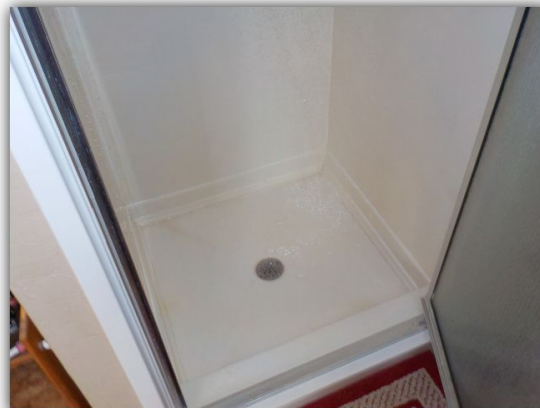
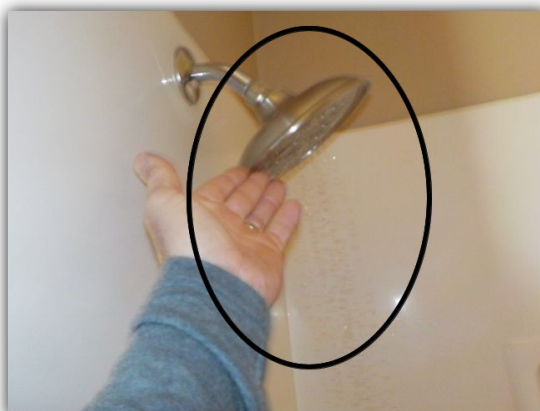
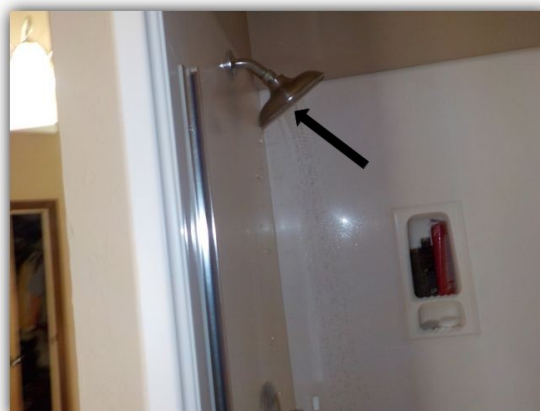
☒ I observed where master bathroom shower would not completely shut off at time of inspection. Most likely damaged / worn seal. Recommend evaluation for possible repairs allowing shower to work as should.

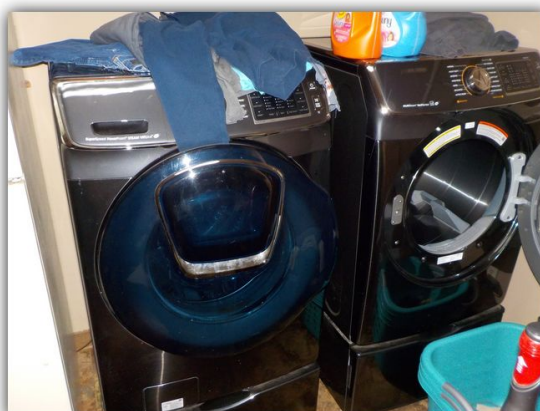
Washing Machine Connections

Comments: Washing machine connections appear to be working well at time of inspection.

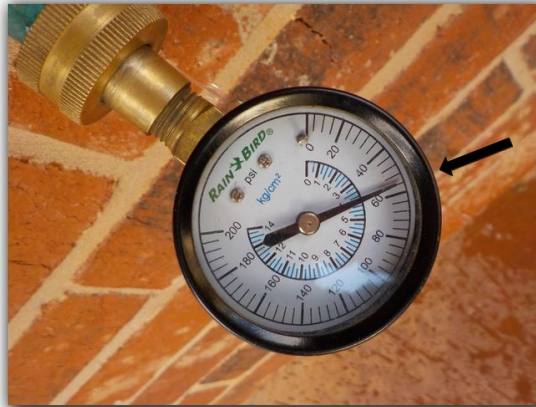
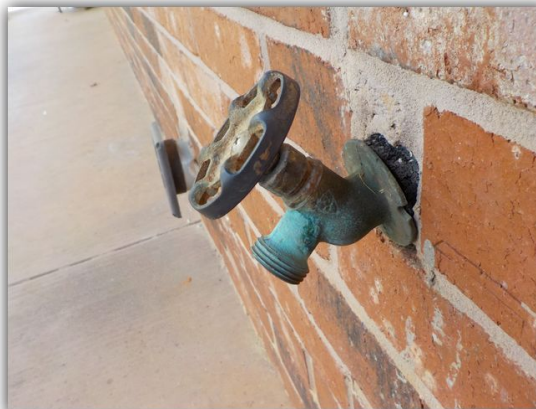
Exterior Plumbing

Comments: Approximately 56 psi noted on home at time of inspection.

☒ Missing back flow preventer. The back flow preventer keeps contaminated water from entering potable (drinking) water.

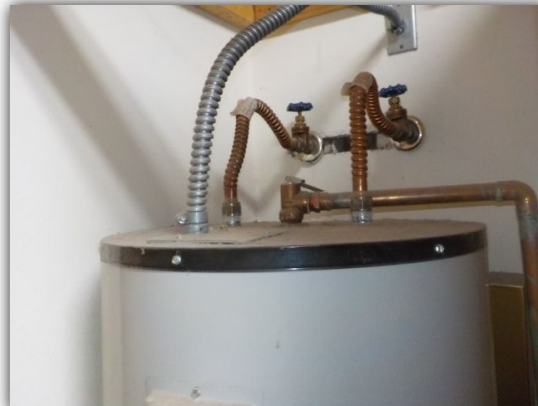
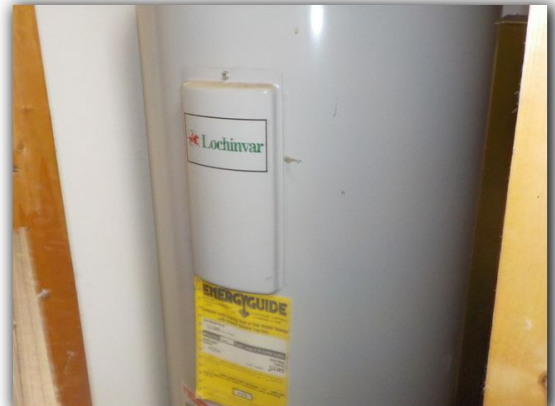
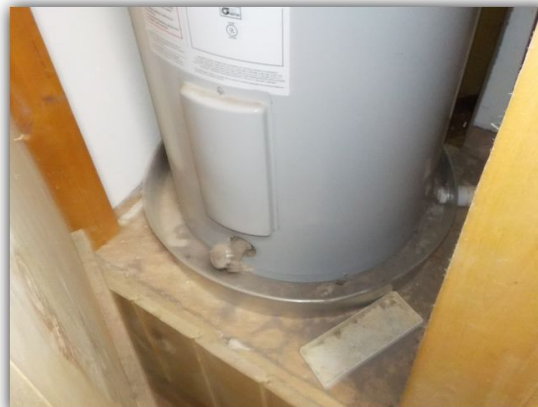
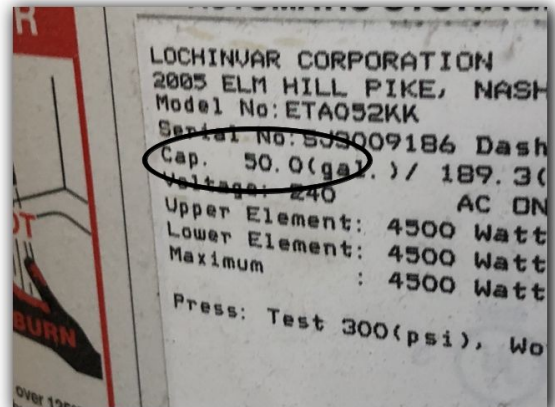
View of water heater

Comments: Performing as it should at time of inspection

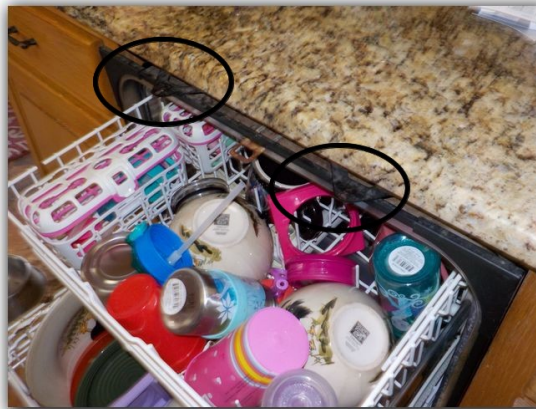
Comments: This appliance was inspected and/or operated in its normal mode of operation and appeared to be performing properly at the time of this inspection with deficiencies noted **(Checked in Normal Wash Mode Only)**

☒ I observed where dishwasher found loose to the touch at time of inspection. Found where unit was not securely appropriately during assessment. Recommend evaluation for securing appropriate anchors allowing unit to work as should.

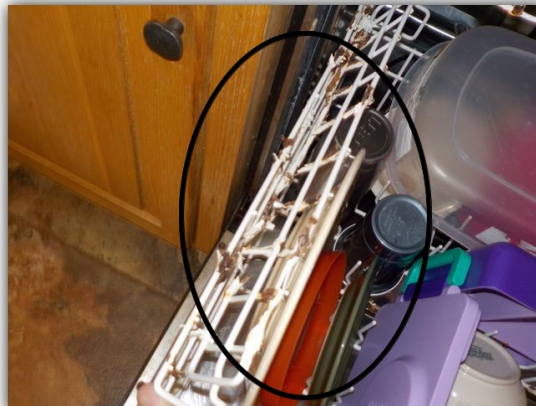
☒ I observed where lower dishwasher rack presenting with significant signs of rust / damage at time of inspection. Recommend evaluation for possible repairs and/or replacement allowing dishwasher to work efficiently.

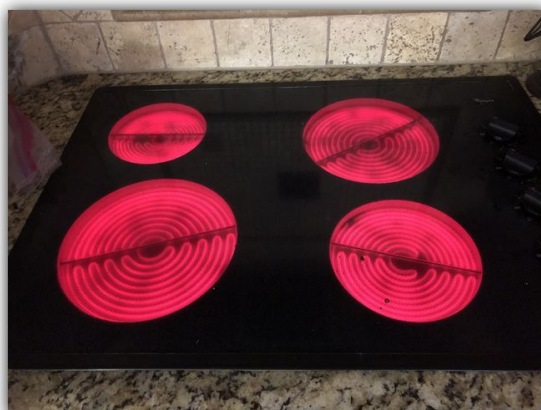
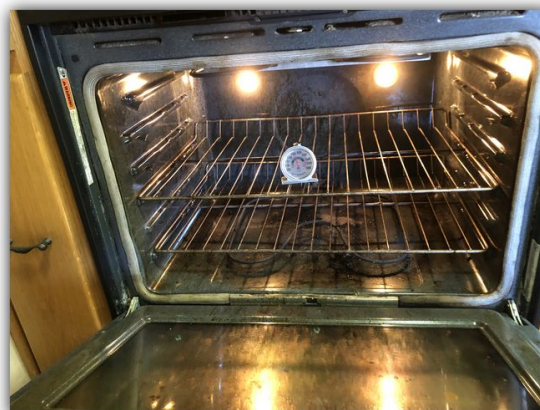
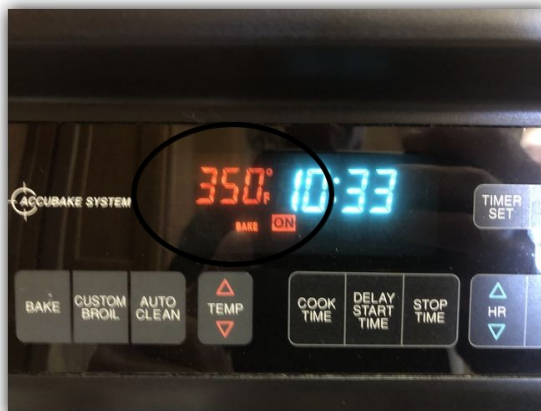
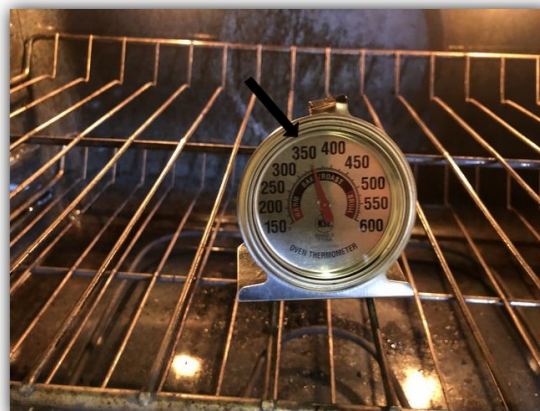
D. Ranges, Cooktops, and Ovens

Comments: This appliance was inspected and/or operated in its normal mode of operation and appeared to be performing properly at the time of this inspection

Oven assessed at 350 at time of inspection.

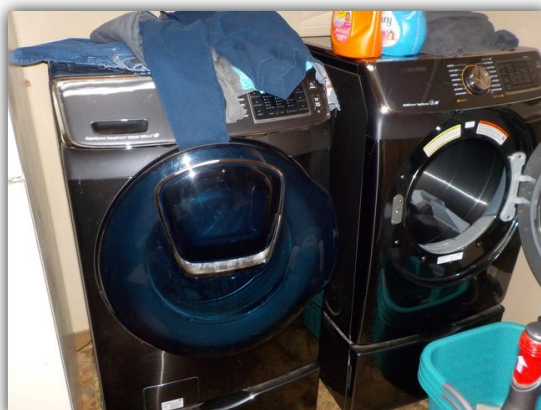
Unable to view dryer discharge at time of inspection.

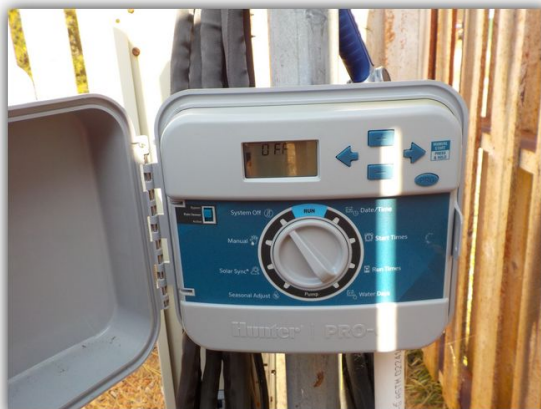
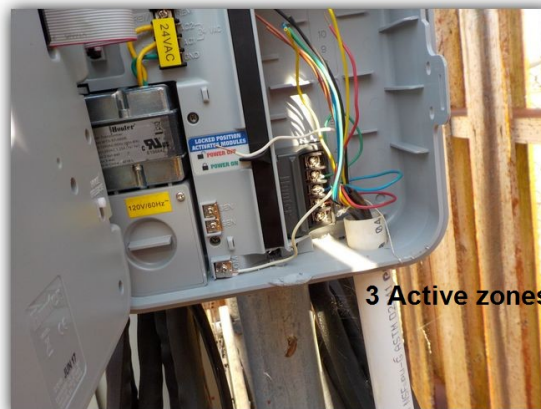
3 Active zones

Comments: The irrigation system appeared to performed as should at time of inspection

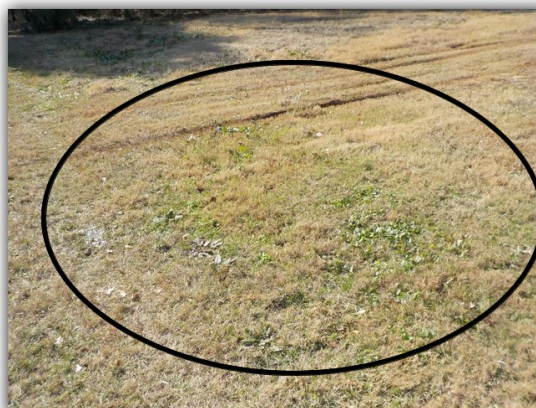
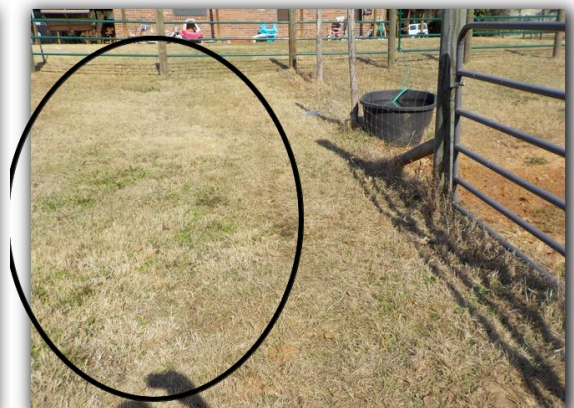
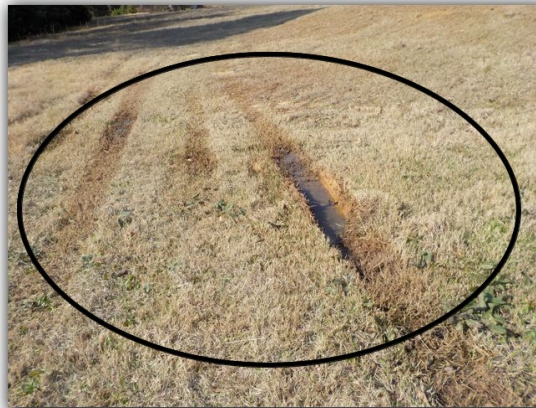
Comments: Volume test performed with water tub fixtures run for approx. 30 minutes at time of inspection with noticeable visual or olfactory evidence of effluent seepage or flow at the surface of the ground

☒ I observed obvious areas of water flow on ground from septic system near left rear corner of home at time of inspection. Noted area with obvious moving water during assessment. Appears to be a failed system with noted areas of ruts in yard from possible water flow for some time. Recommend evaluation for repairs allowing home septic system to work as should.

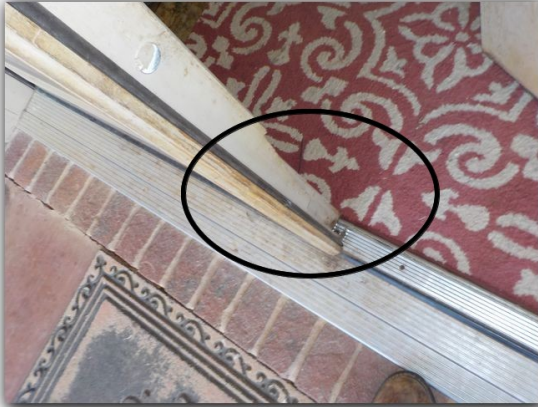
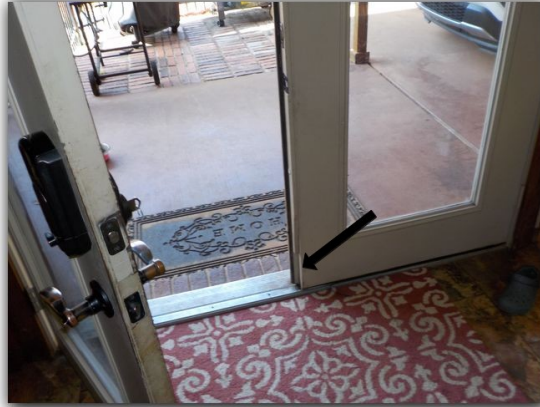
☒ I observed where bottom flush bolt damaged / missing from rear French door(s) at time of inspection. Noted missing sliding flush bolt keeps double doors from locking appropriately. Recommend evaluation for repairs allowing door(s) to work as should.

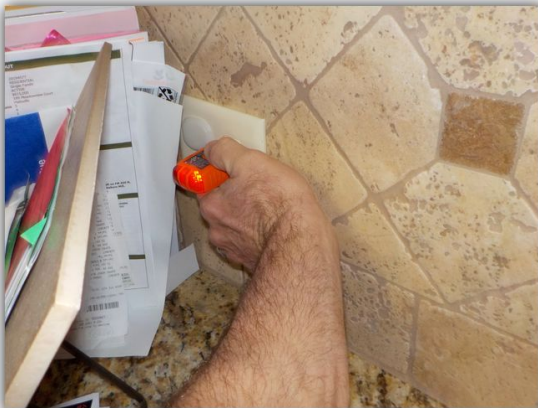
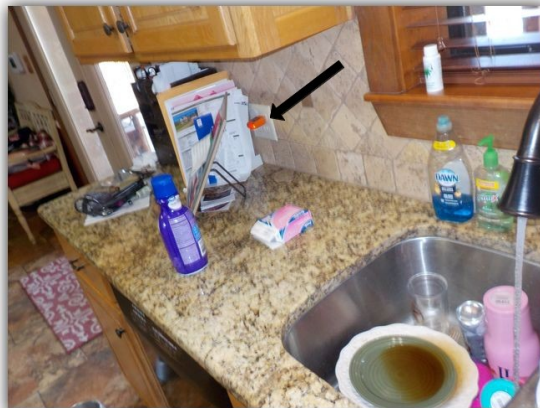
Missing GFCI protection in kitchen area

☒ No GFCI/ARC Fault protection at one or more location. This is considered a recognized safety hazard. GFCI protection was not provided in the home at locations where it is now deemed necessary. GFCI protection may not have been required at the time the home was built, but for safety reasons it is recommended that GFCI protection be installed at all the following locations: • Bathrooms • Exterior • Garages • Crawlspace (at or below grade) • Unfinished basements • Kitchens • Laundry rooms • Within 6 feet of all plumbing fixtures. Recommend evaluation for possible repairs and / or replacement of deficient receptacles for added safety.

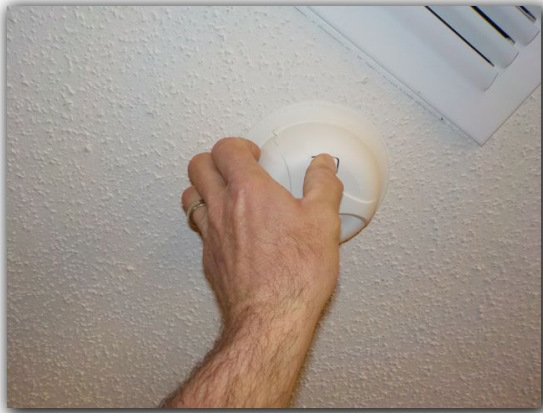
- ☒ Smoke alarms are not present in each sleeping area
- ☒ Smoke alarms are recommended in the following area(s):
 - On every level of your home, including finished attics and basements.
 - Inside every bedroom, especially if people sleep with the door partly or completely closed.
 - In the hall near every sleeping area. If your home has multiple sleeping areas, install a unit in each. If a hall is more than 40 feet long (12 meters), install a unit at each end.
 - At the top of the first-to-second floor stairway, and at the bottom of the basement stairway.
- ☒ A recommendation for a CO detector is always prudent when gas-fired appliances are supplied or vented from the interior of a building.

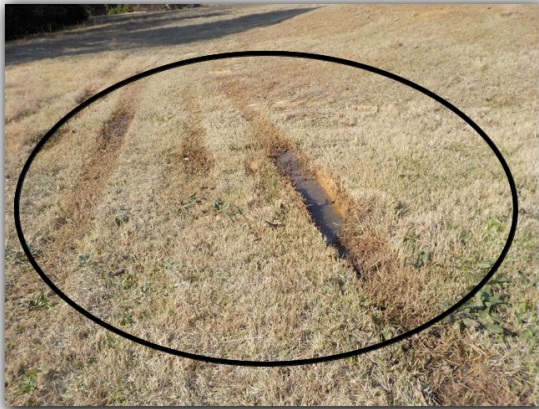
☒ I observed obvious areas of water flow on ground from septic system near left rear corner of home at time of inspection. Noted area with obvious moving water during assessment. Appears to be a failed system with noted areas of ruts in yard from possible water flow for some time. Recommend evaluation for repairs allowing home septic system to work as should.

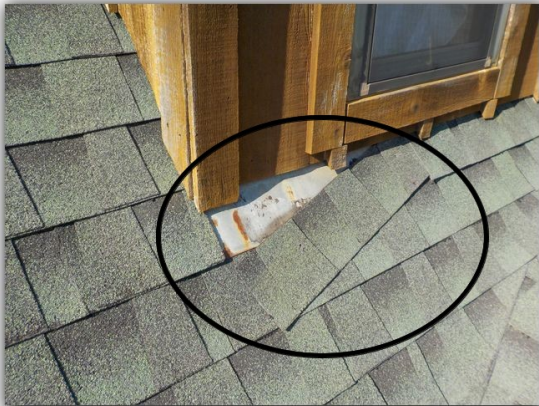
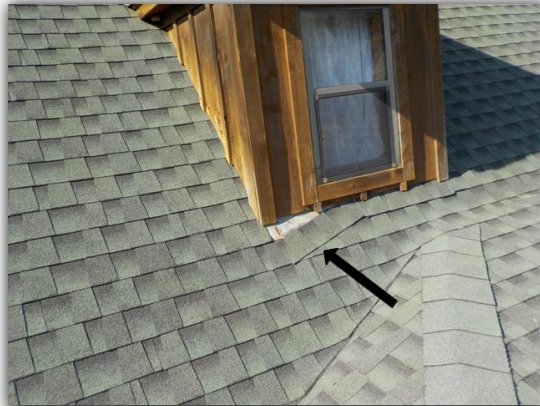
☒ I observed where a single shingle has pulled loose from top left upstairs bedroom near dormer at time of inspection. Shingle appears to be cosmetic in nature covering window / dormer base flashing. Recommend repairs keeping shingle from possible tearing away completely.

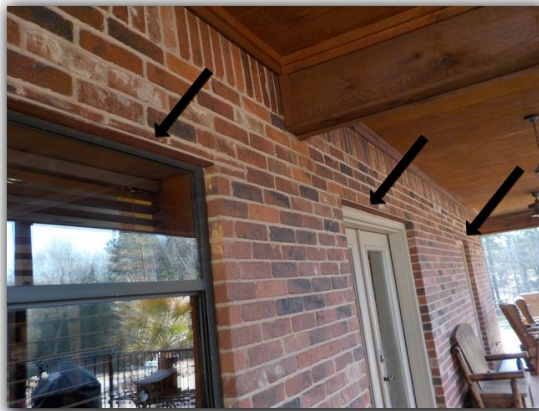
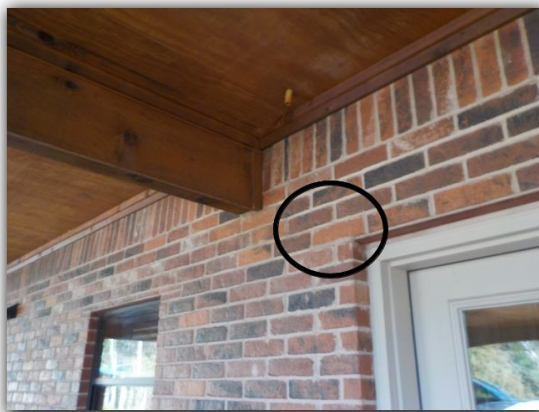
☒ I observed where brick / window lintels were not painted at time of inspection. When the metal lintels rust they tend to expand which could damage and/or crack brick and/or mortar. Recommend the lintels be cleaned, sanded/brushed, primed and painted with a quality rust inhibiting paint. Also, recommend periodic maintenance and touch-up.

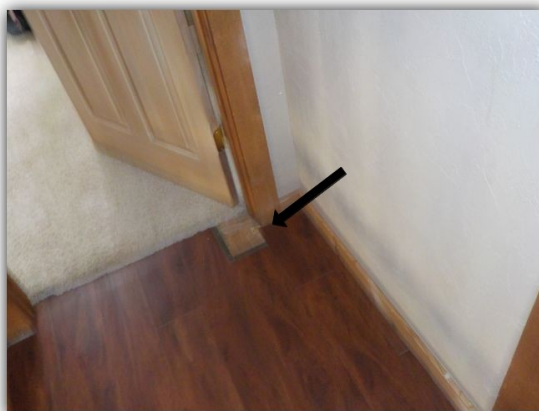
☒ I observed a minor area near top left bedroom where piece of vinyl flooring missing at time of inspection.

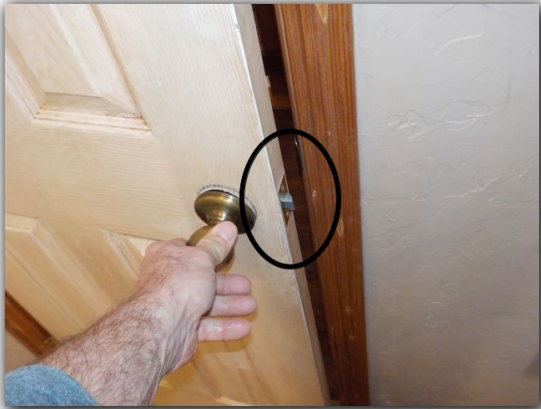
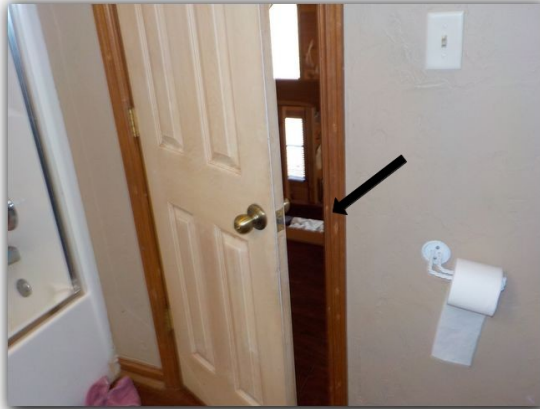
Upstairs bathroom door

☒ I observed where door would not close properly at time of inspection. Most likely door out of alignment. Recommend possibly moving strike plate on door jam allowing door assembly to latch and close as should.

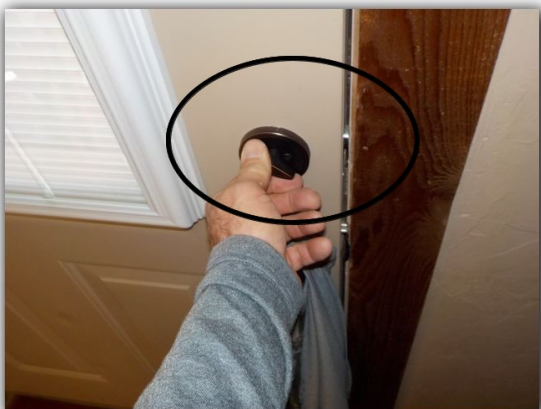
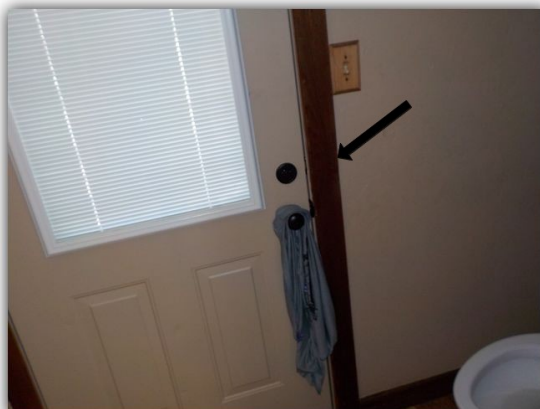
☒ I observed where master bathroom exterior door found out of alignment making use of deadbolt difficult to lock / unlock. Found damaged / loose hinge near top of door. Recommend evaluation for securing noted anchors for door allowing door to work as should.

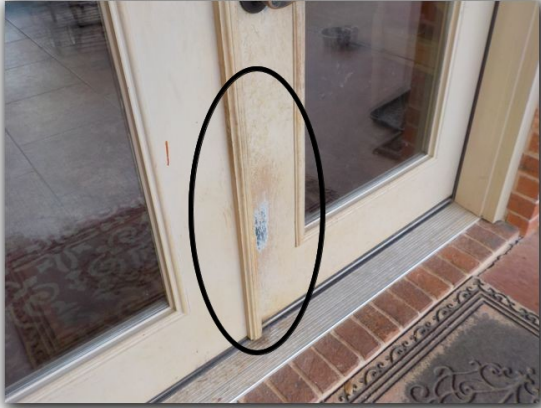
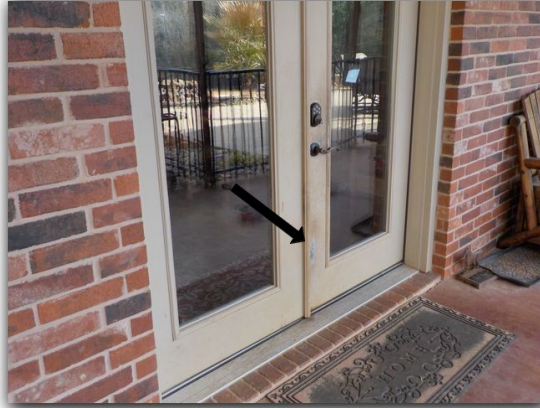
☒ I observed an area of cosmetic damage noted to French doors near back porch at time of inspection. Damaged noted appears to have been created by family pet(s).

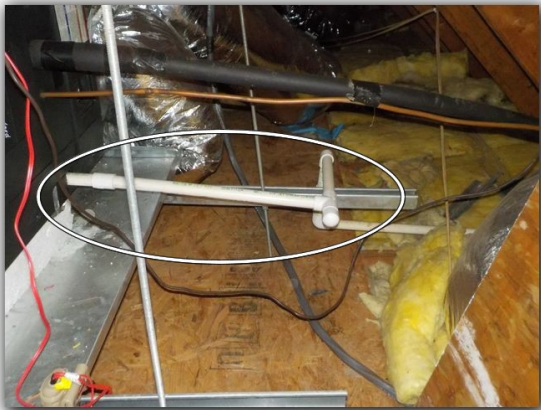
Note: I observed where condensate line for AC system found without insulation in attic area at time of inspection. Very common for condensate line to 'sweat' in attic area creating possible conducive conditions for moisture which could potentially leak onto sheet rock below. *A hot attic plus cold condensate water from AC = condensation.* A good recommendation would be to insulate condensate line for approx. 6 feet near air handler keeping moisture from possibly dripping onto sheet rock ceiling below.

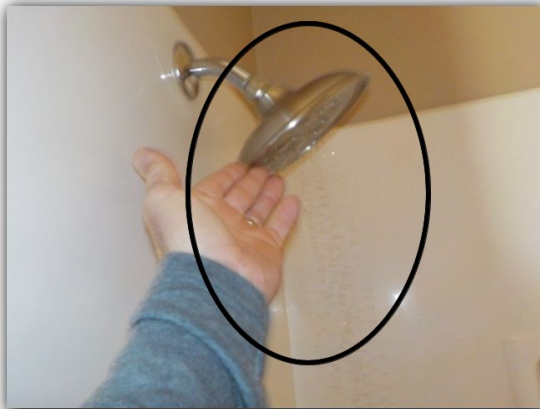
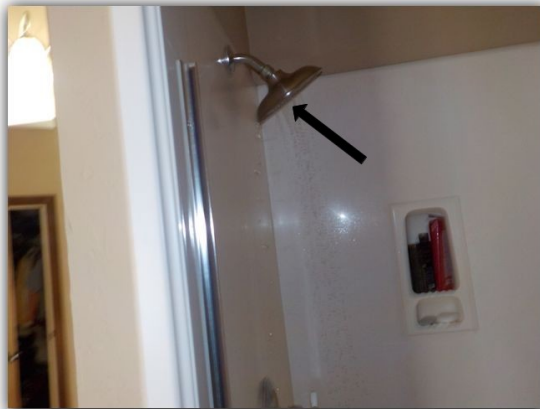
☒ I observed where master bathroom shower would not completely shut off at time of inspection. Most likely damaged / worn seal. Recommend evaluation for possible repairs allowing shower to work as should.

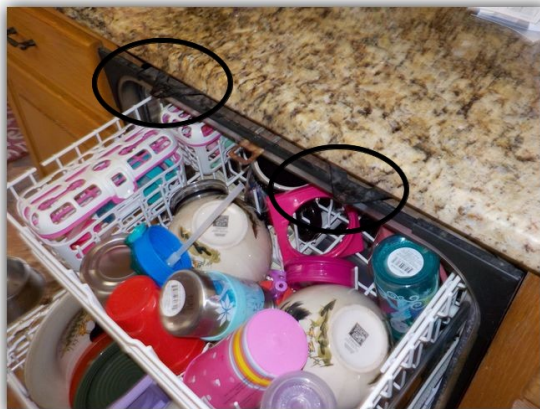
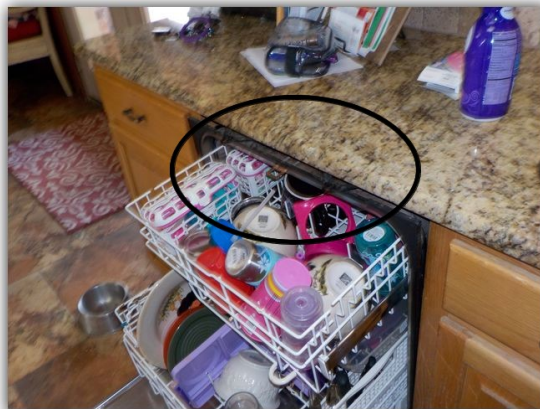
☒ I observed where dishwasher found loose to the touch at time of inspection. Found where unit was not securely appropriately during assessment. Recommend evaluation for securing appropriate anchors allowing unit to work as should.

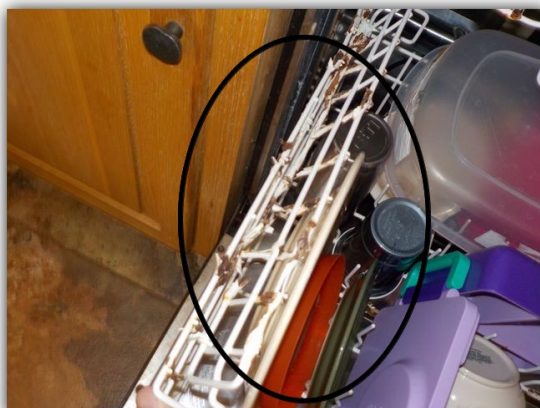
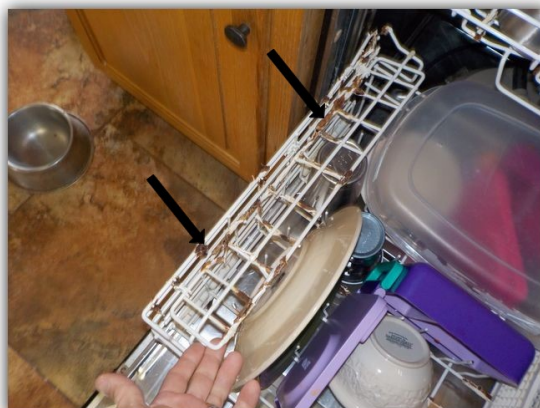
☒ I observed where lower dishwasher rack presenting with significant signs of rust / damage at time of inspection. Recommend evaluation for possible repairs and/or replacement allowing dishwasher to work efficiently.

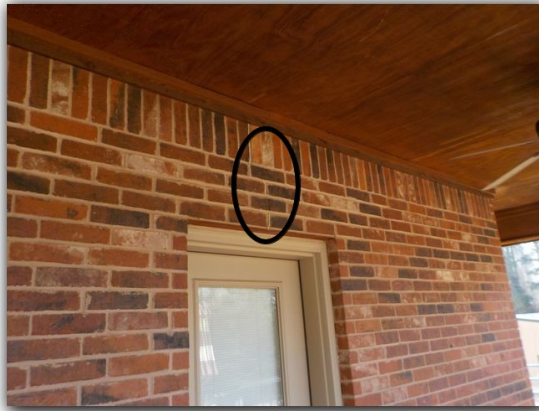
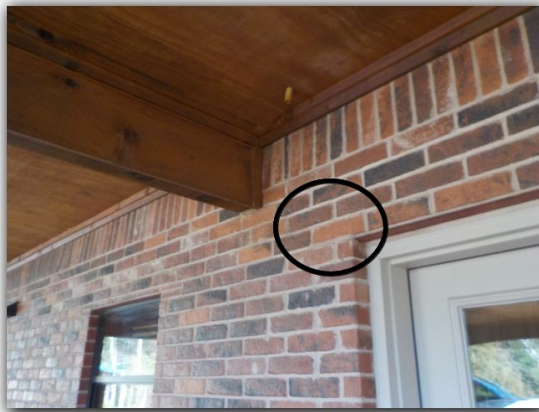
☒ I observed minor mortar cracking in veneer siding at time of inspection. These cracks are typically due to thermal expansion and/or minor structural movement. Brick walls may expand (when heated) and contract (when cooled) and by doing so may do sufficiently enough to cause damage in mortar joints. These areas should be monitored for any noticeable changes that may occur.

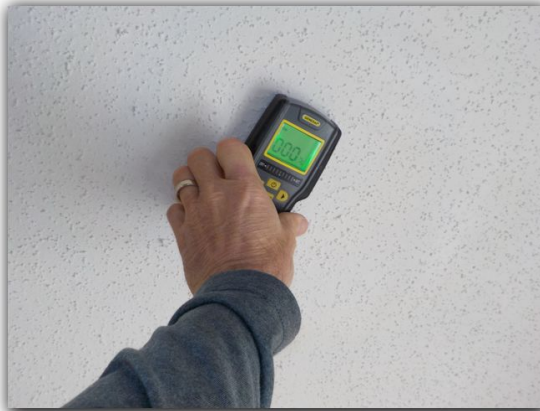
Master bathroom ceiling

☒ I observed an area of moisture staining in master bathroom over bathtub at time of inspection. Further evaluation found no obvious moisture with meter and/or thermal camera. Roof area finding areas of possible repairs with silicone having been used to seal possible seams in exterior siding. Possible that newer roof has remedied any past moisture entry concerns. Recommend monitoring noted area(s) for any noticeable changes.
