*Home inspection for
Sample
Somewhere
Henderson TX*

PROPERTY INSPECTION REPORT

Concerning: Somewhere, Henderson, TX
(Address or Other Identification of Inspected Property)

By: David Smith, Lic #21666 12/07/2019
(Name and License Number of Inspector) (Date)

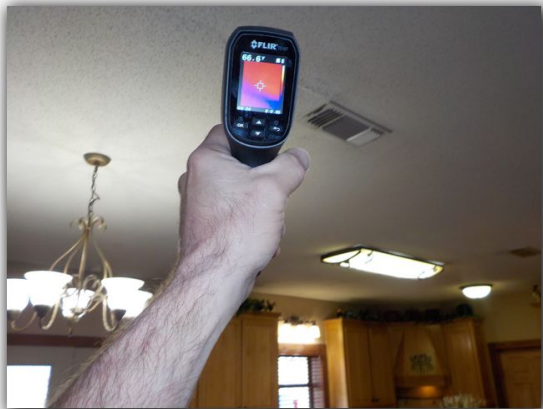
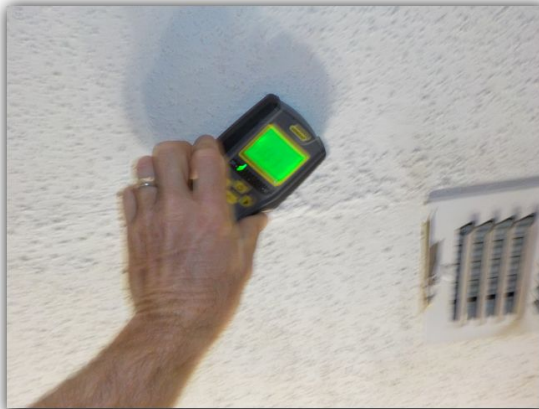
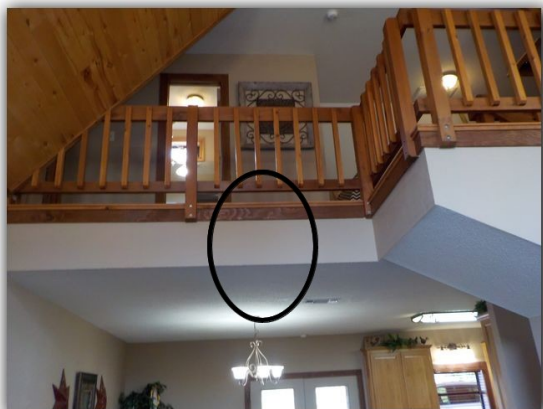
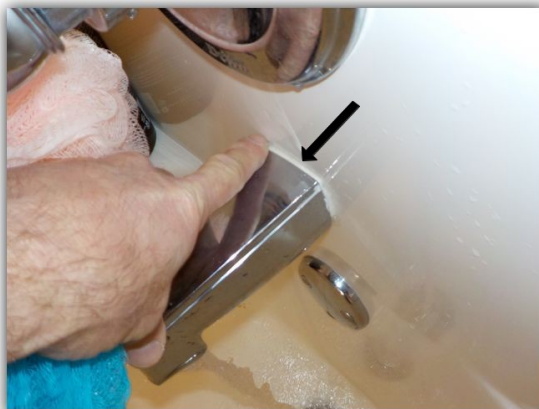
Kitchen / nook area

☒ I observed an area of moisture staining in nook / living room area at time of inspection. Further evaluation found no obvious evidence of moisture when assessed with meter and/or thermal camera. Appears area lies below upstairs hallway bathroom. Evidence of caulk placed near tub/floor and shower spout. Note: shower spouts very typically create conducive conditions for leaks when not sealed appropriately. Recommend monitoring areas for any noticeable changes.

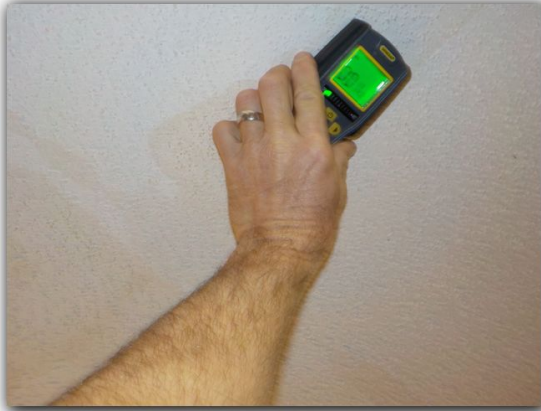
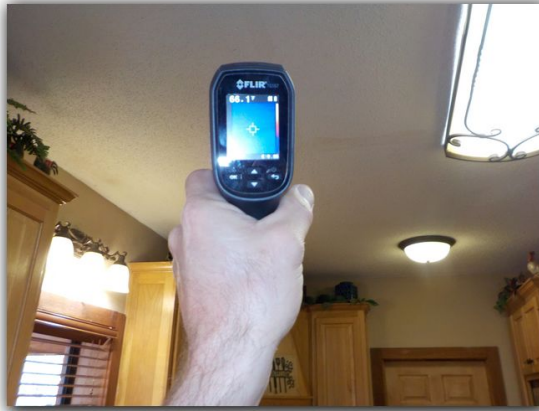
Kitchen area

☒ I observed an area of moisture staining found in kitchen area at time of inspection. Further investigation did not find positive evidence of moisture with meter and/or thermal camera during assessment. Roof evaluation found roof valley which may have allowing for possible water entry in the past. Most likely newer roof has remedied any moisture entry concerns. Recommend monitoring noted area for any noticeable changes.

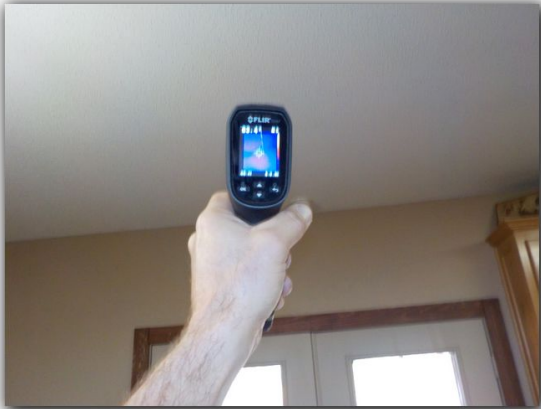
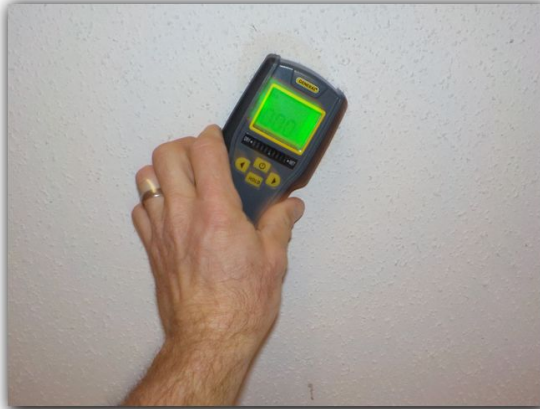
Nook area

☒ I observed a minor area of moisture staining near breakfast nook / back door off kitchen area at time of inspection. No obvious moisture noted with moisture meter and / or thermal camera. Roof area above finding no obvious evidence of moisture entry concerns. Possible damaged plumbing vent stack over affected area. Appears newer roof remedied any past concerns. Recommend monitoring noted area for any noticeable changes.

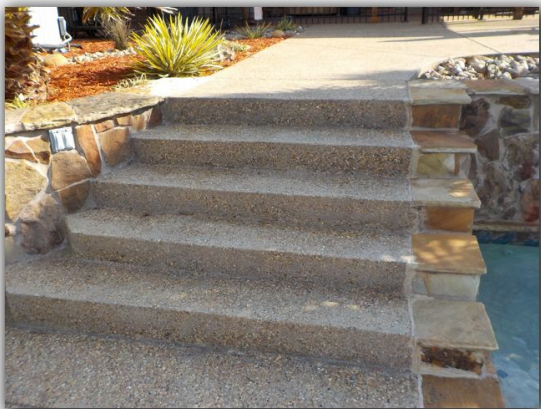
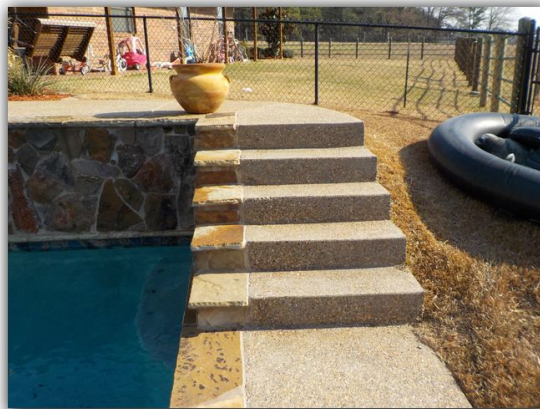
☒ I observed where some of the exterior stairs do not have a hand rail on either side. Typically on any interior or exterior flight of stairs having more than 4 risers they should have a hand rail on one side of the stair. Would consider adding appropriate hand rail for safety purposes.
